# **APPENDIX B**

## **EXISTING PARKS INVENTORY AND CONDITION ASSESSMENT**

The inventory and condition assessment in this report were documented through physically visiting each of the sites, and recorded through photographs and notes. This information was documented on December 4 and 5, 2017 by two team members from thinc design.

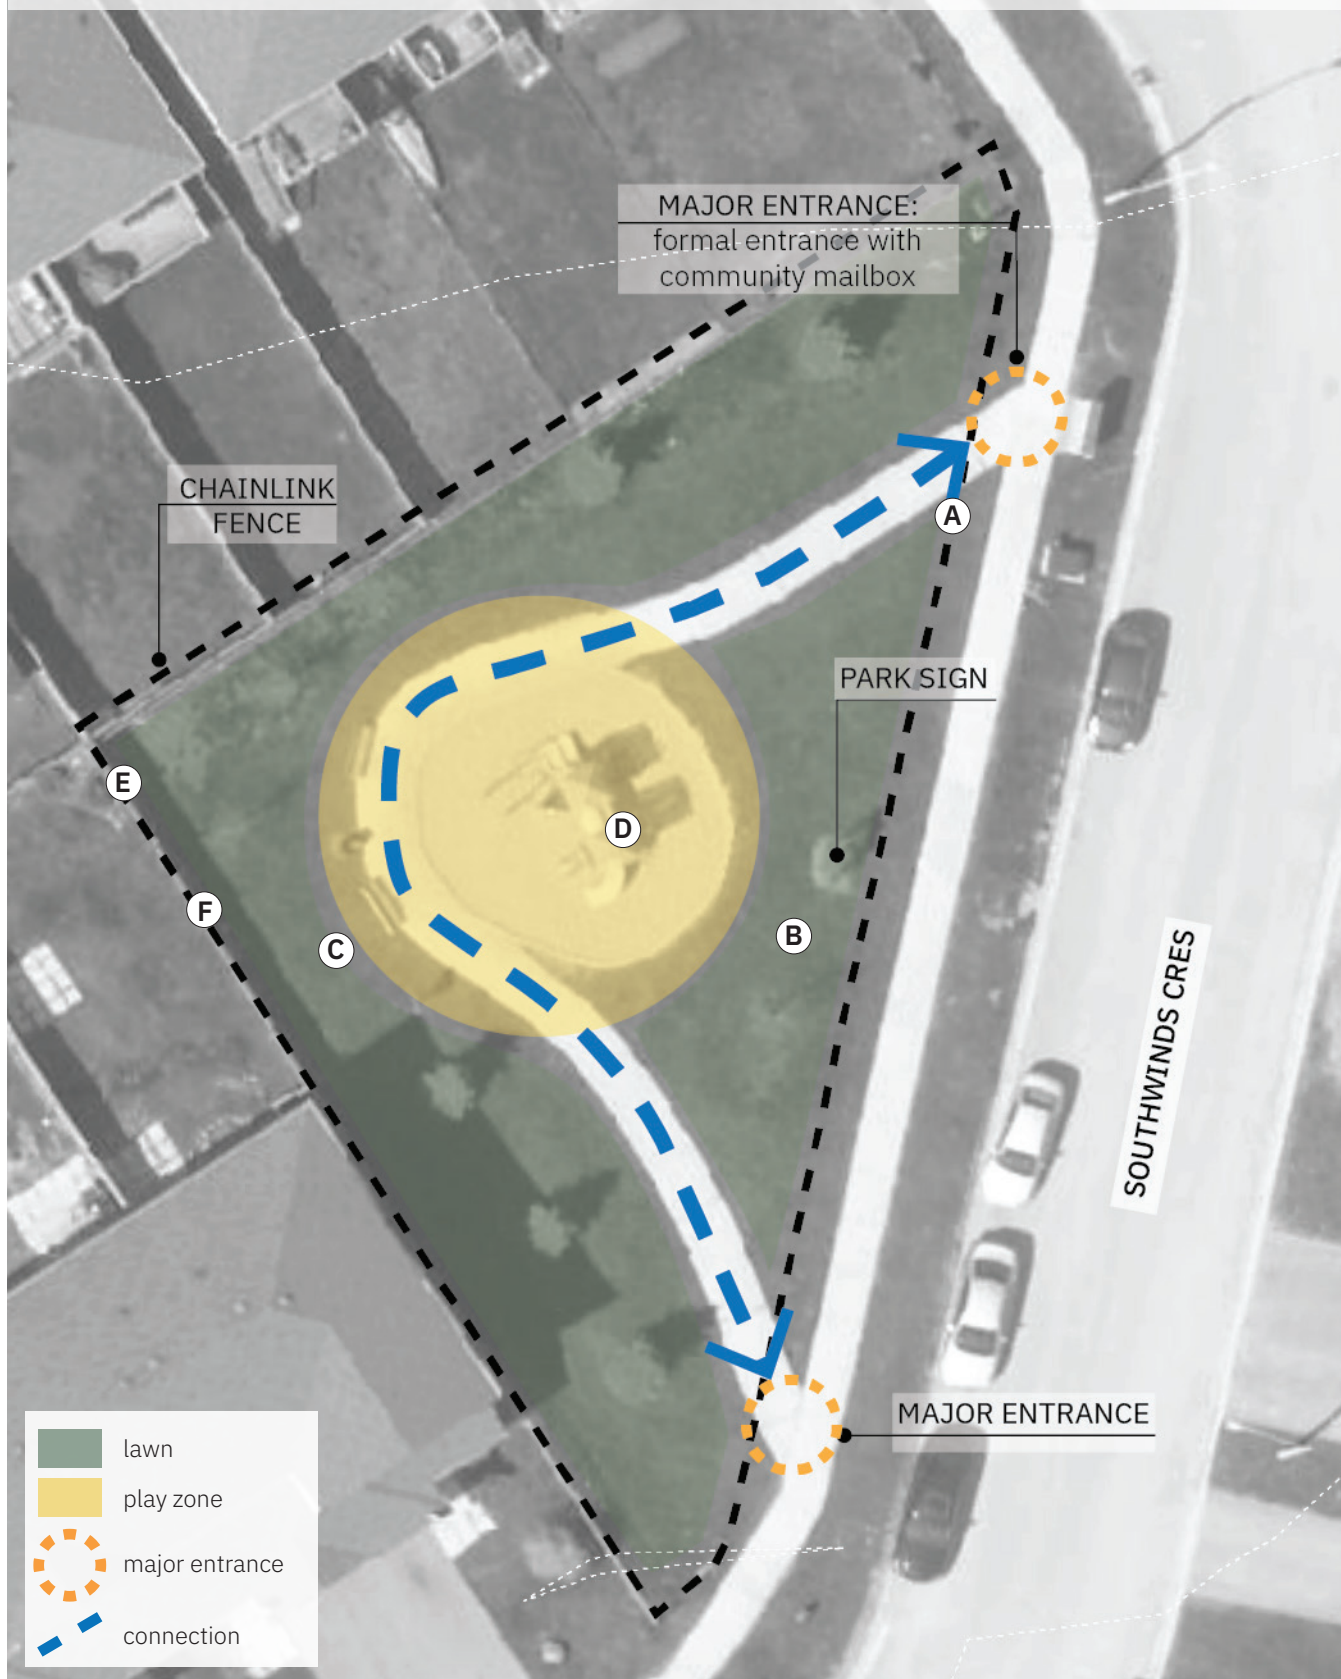
Figure AB.2: Bob Merkley Park Existing Conditions

address	139 Southwinds Cres	topography	mostly flat
size	0.17 ac / 0.07 ha	hydrology	ponding in NW corner

one small climber- 3 slides
play surfacing

sand with curb to retain - adequate zone with curb to retain
fence(s)

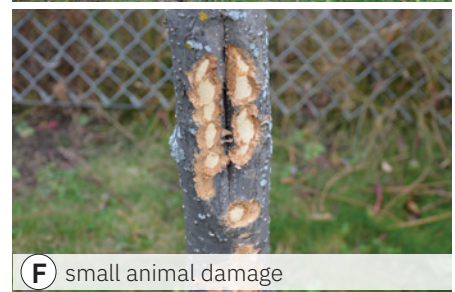
**F** small animal damage

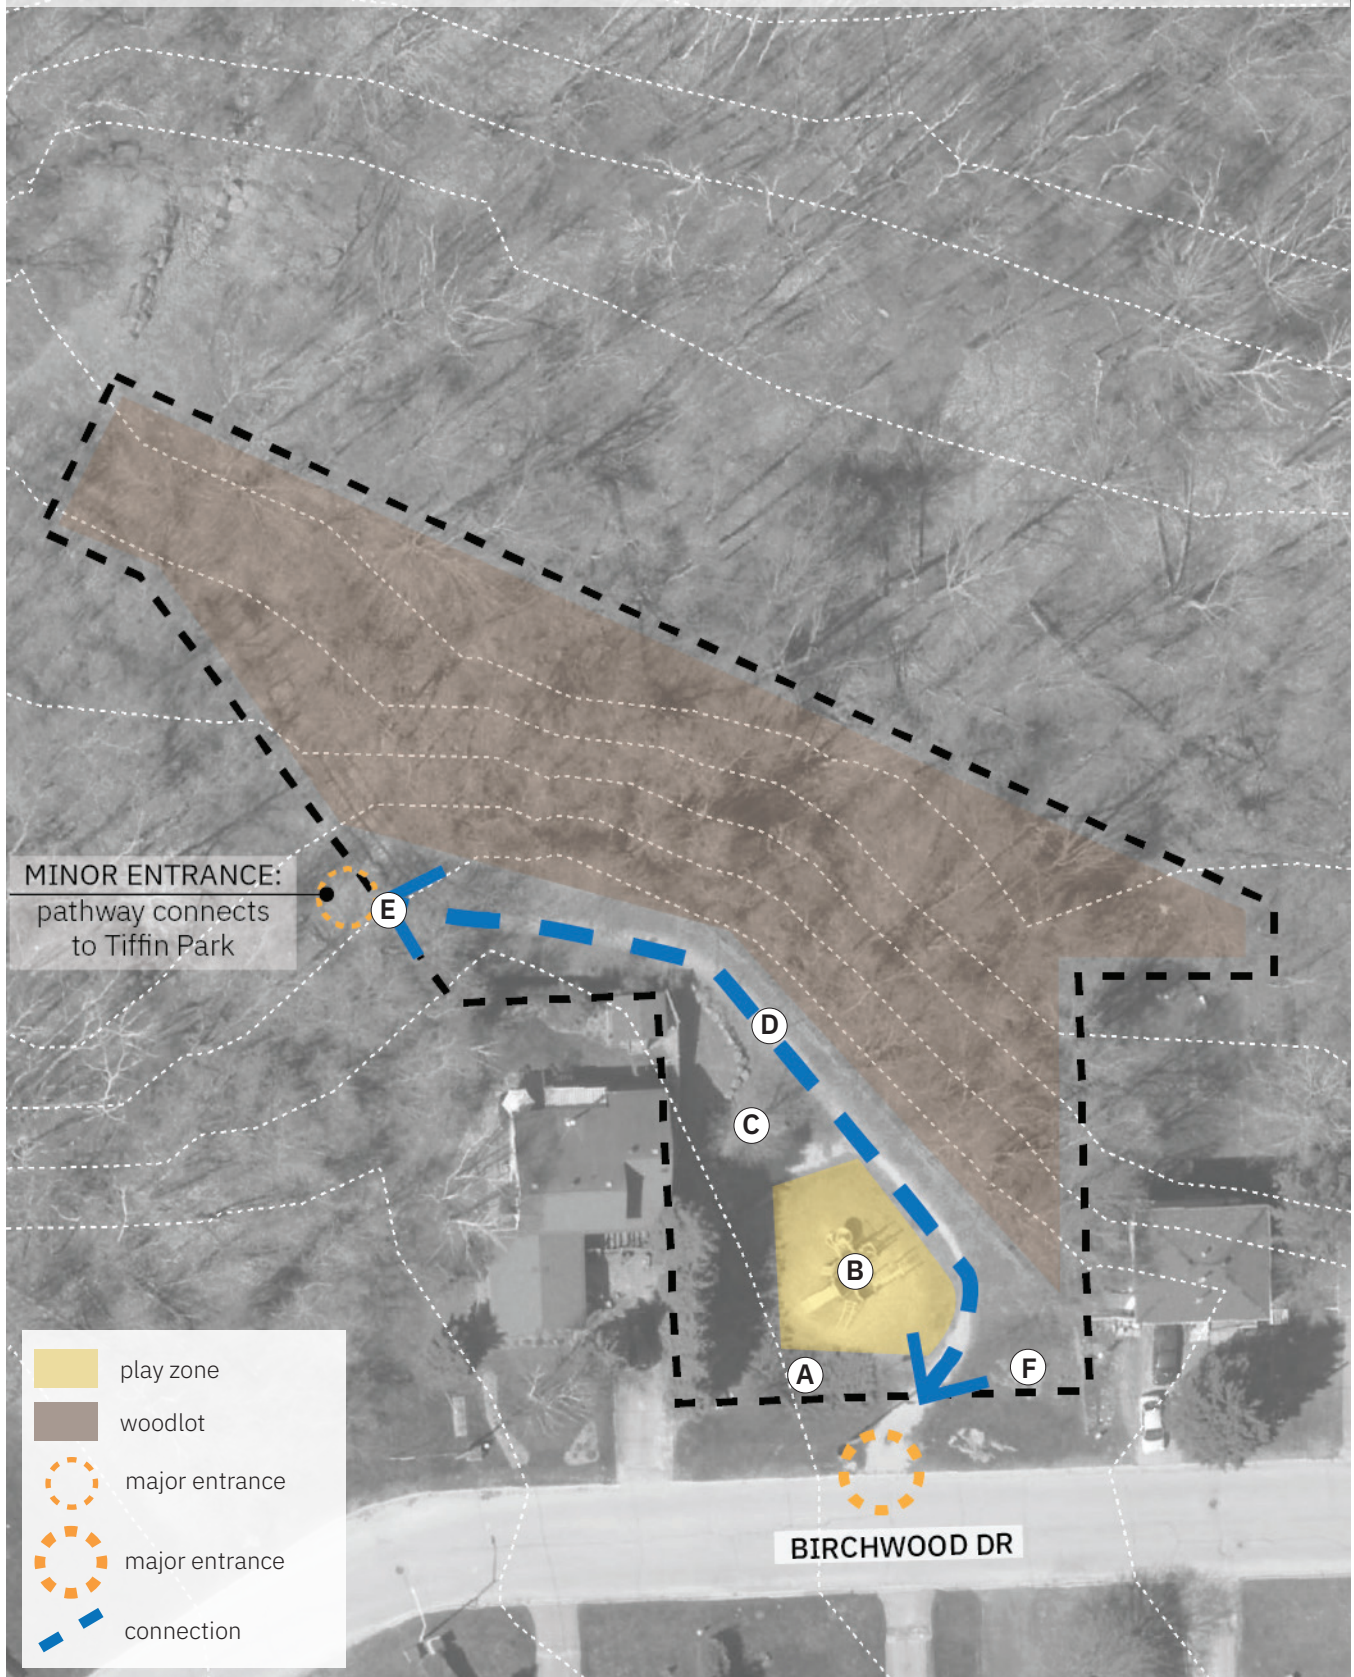
Figure AB.4: Quota Park Existing Conditions

play structure(s)	<span style="color: yellow;">■</span>	junior play- 2 slides
play surfacing	<span style="color: red;">■</span>	sand- inadequate safety zone
furnishing(s)	<span style="color: red;">■</span> <span style="color: green;">■</span>	park bench (2) park sign
stair	<span style="color: green;">■</span>	wooden stairs down to Tiffin Park connection
vegetation	<span style="color: green;">■</span> <span style="color: green;">■</span> <span style="color: yellow;">■</span>	woodlot ornamental planting at park sign coniferous plant bed
pathway(s)	<span style="color: yellow;">■</span>	granular pathway from roadway to wooden stairs
fence	<span style="color: green;">■</span>	chain link fence at top of slope

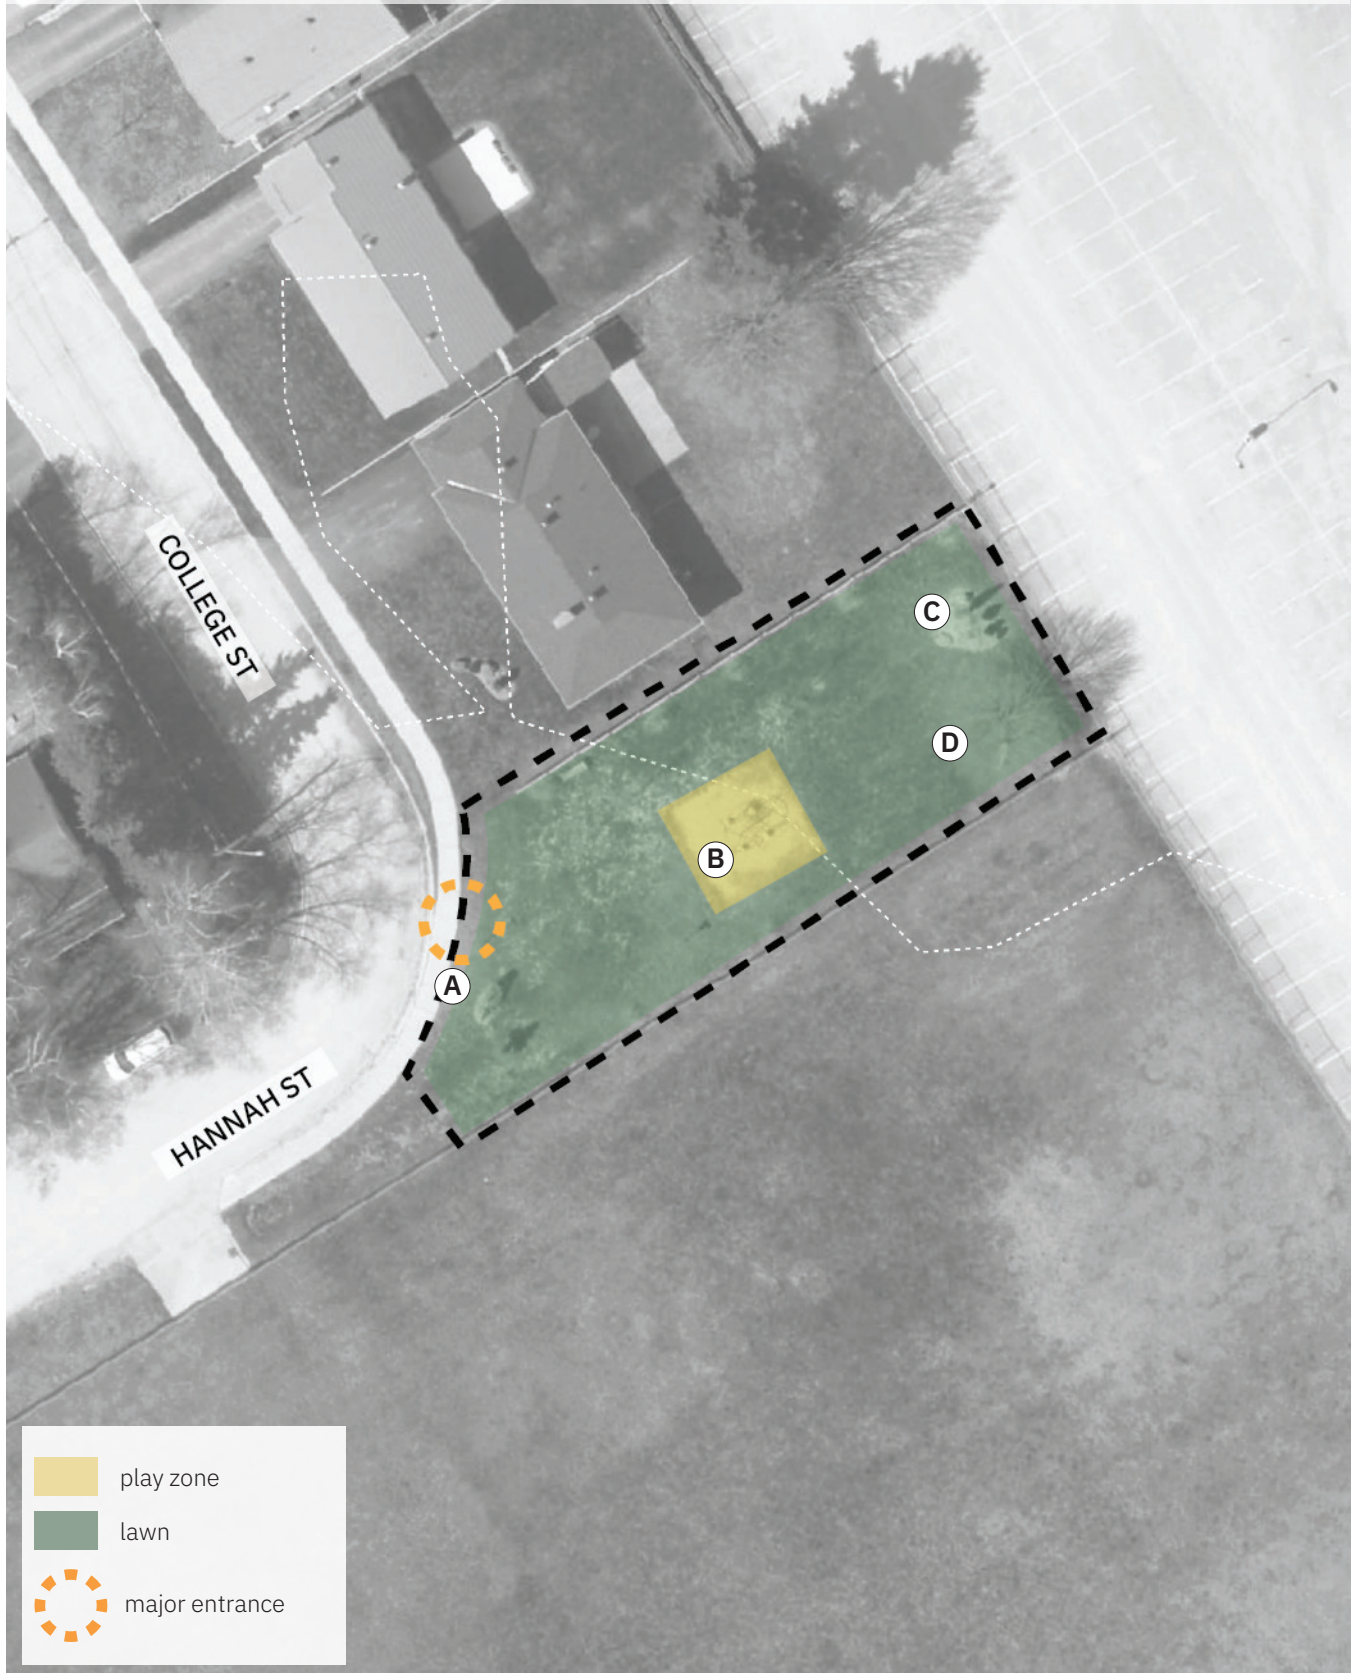
Figure AB.8: Regent Park Existing Conditions

play structure(s)	<span style="color: yellow;">■</span>	junior play- 4 twists
play surfacing	<span style="color: red;">■</span>	sand- inadequate safety zone
furnishing(s)	<span style="color: green;">■</span> <span style="color: green;">■</span>	wood/concrete benches (2) park sign
vegetation	<span style="color: green;">■</span> <span style="color: green;">■</span> <span style="color: green;">■</span>	open lawn display planting bed ornamental planting at park sign
fence	<span style="color: green;">■</span> <span style="color: green;">■</span>	chain link fence on two sides (industrial) wood fence along residential side

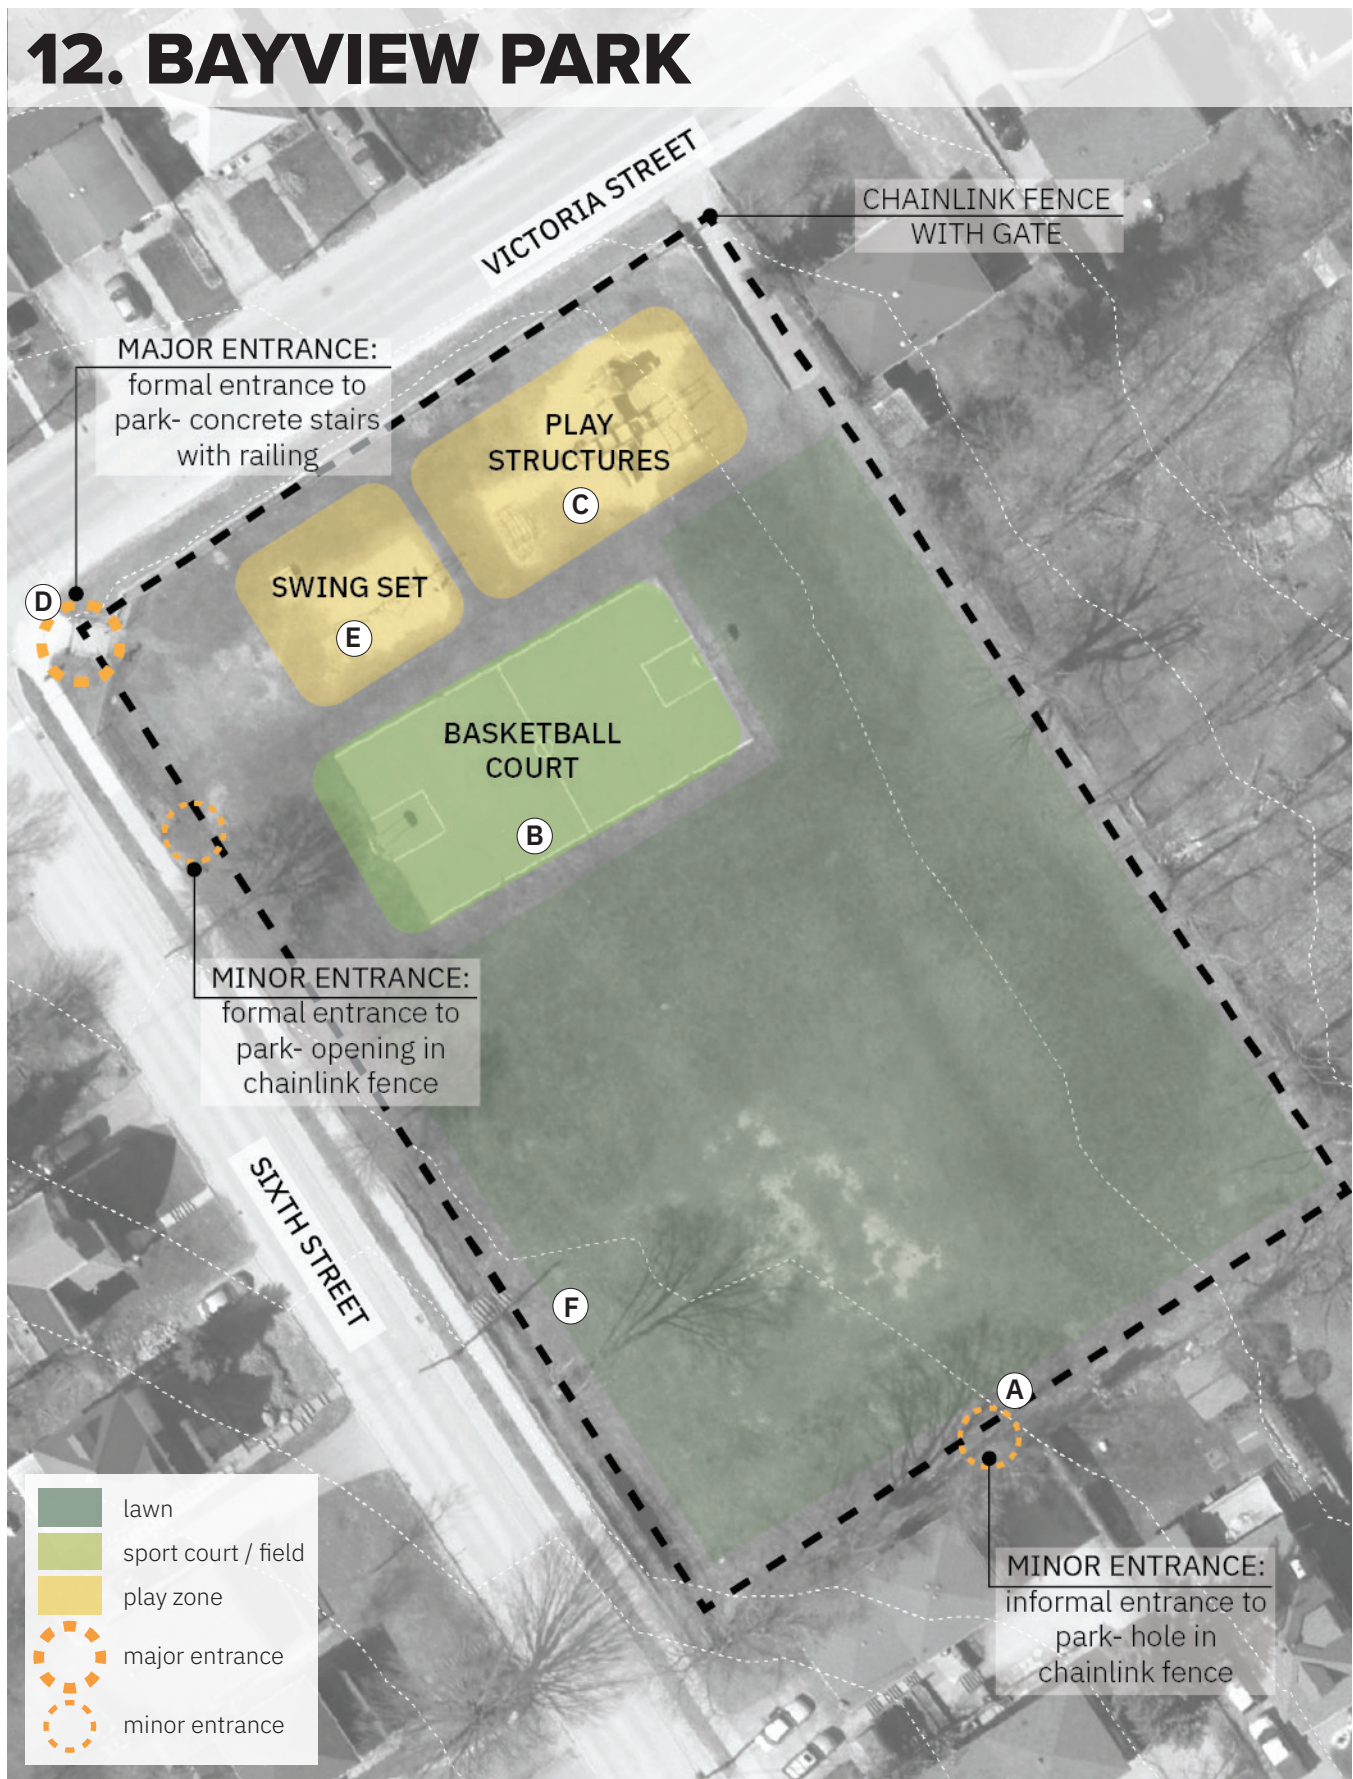
Figure AB.13: Bayview Park Existing Conditions

play structure(s)	<div style="display: flex; flex-direction: column; gap: 5px;"> <div><span style="color: yellow;">■</span> one large climber- 3 slides</div> <div><span style="color: yellow;">■</span> one small climber- elephant</div> <div><span style="color: red;">■</span> double swing set with 2 baby, 1 regular and 3 missing swings</div> </div>
play surfacing	<span style="color: red;">■</span> sand - inadequate zone
fence(s)	<span style="color: green;">■</span> chainlink around park
sports field + type	<span style="color: yellow;">■</span> asphalt basketball court with green paint and white linework
stairs	<div style="display: flex; flex-direction: column; gap: 5px;"> <div><span style="color: green;">■</span> concrete stairs into the park (with railing)</div> <div><span style="color: yellow;">■</span> stairs along SW retaining wall (leads into chainlink fence)</div> </div>
furnishing(s)	<span style="color: red;">■</span> picnic table

retaining wall(s)	<div style="display: flex; flex-direction: column; gap: 5px;"> <div><span style="color: yellow;">■</span> south west interior of the park</div> <div><span style="color: red;">■</span> north exterior of the park</div> </div>
vegetation	<div style="display: flex; flex-direction: column; gap: 5px;"> <div><span style="color: yellow;">■</span> open lawn</div> <div><span style="color: green;">■</span> 4 newly planted trees</div> </div>

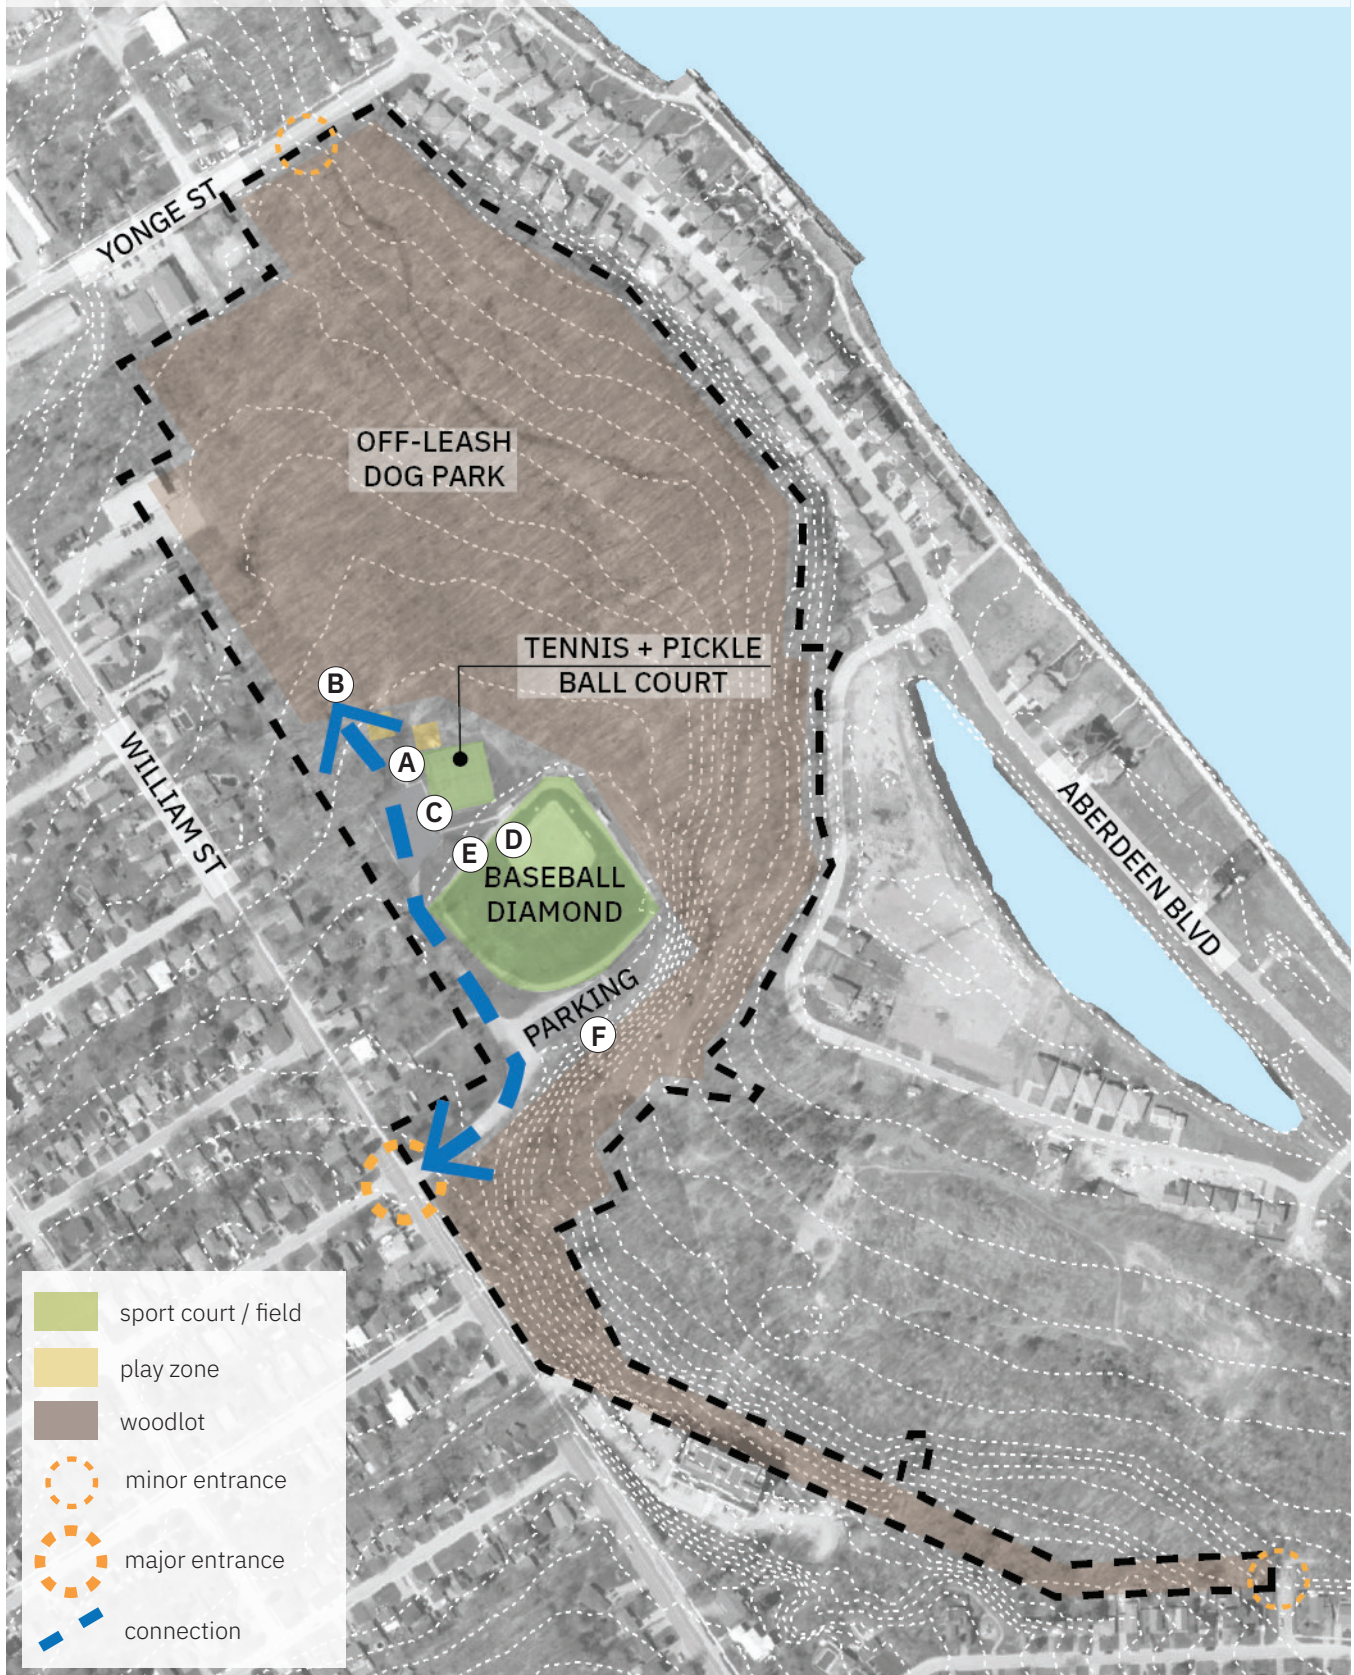
Figure AB.15: Tiffin Park Existing Conditions

play structure(s)	■ junior play- 2 slides ■ double bay swing
play surfacing	■ sand- inadequate safety zone
furnishing(s)	■ park sign ■ picnic table ■ bleachers
sports field + type	■ one tennis court ■ eight pickleball courts ■ baseball diamond with scoreboard
lighting	■ lighting for tennis/pickleball ■ lighting for baseball diamond
stair	■ unit paving stairs from parking to baseball diamond
vegetation	■ woodlot with dog off leash ■ ornamental planting at park sign ■ coniferous plant bed
pathway(s)	■ unit paving from steps to parking lot ■ dirt pathway in woodlot
fence	■ chain link fence around tennis/pickleball ■ chain link fence around baseball diamond
structure(s)	■ washroom facilities
parking	■ one gravel lot ■ one asphalt lot

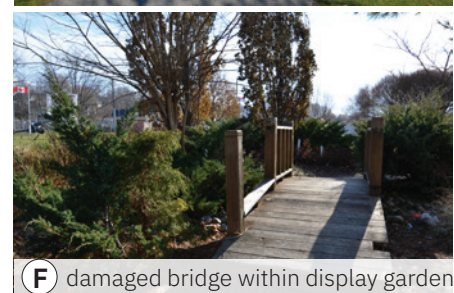
F damaged bridge within display garden
