**2286261 Ontario Limited**  
C/O Quality Inn & Conference Centre  
924 King Street, Midland, ON L4R 0B8

Subject: **Subgrade Inspections**  
**924 King Street, Midland**  
Englobe reference: 02504787.001

Re : Sub grade inspection for foundation evaluation

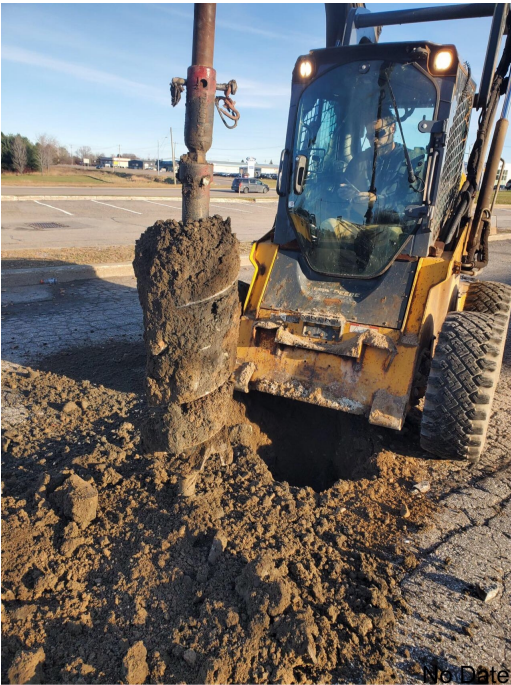
Augured drill holes.

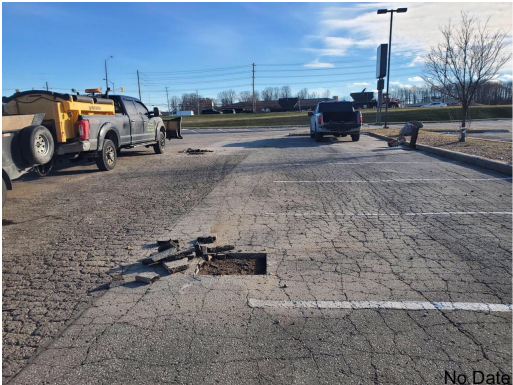
Proposed location of new McDonald's

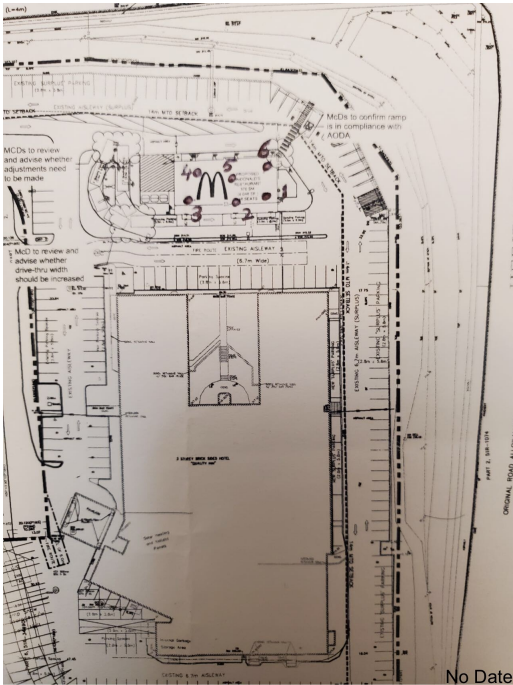
Bore holes location alongside proposed building.

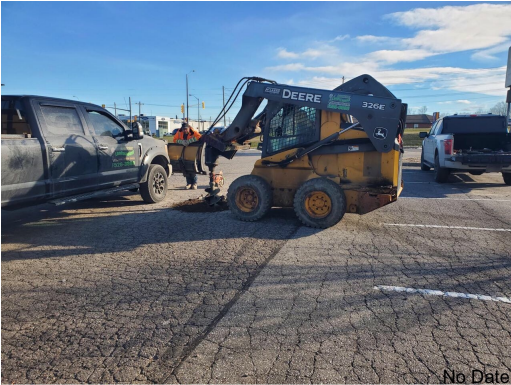
Augured drilling in progress

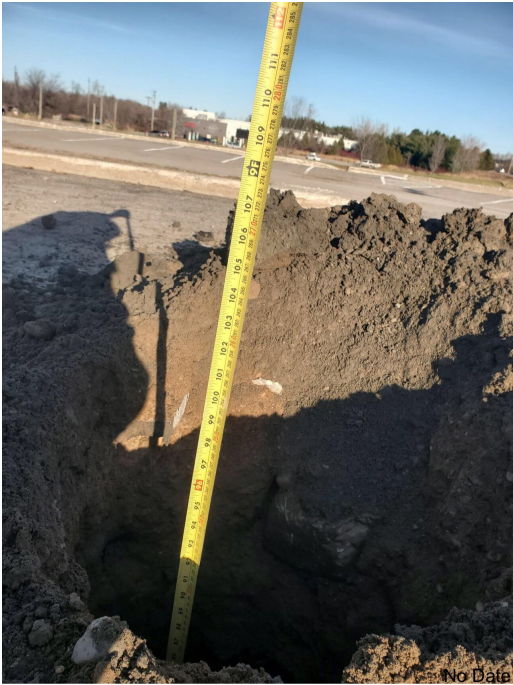
Depth of drilled holes

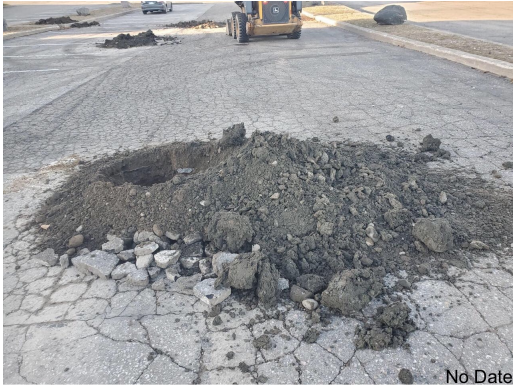
The native subgrade soil encountered in the augured holes consisted of brownish gray to gray '*Clayey Silt till*', *trace Sand and Gravel*. The soil was in 'Damp to Moist' condition and exhibited 'Stiff' consistency.

Native materials cutting
