# Traffic Data Analysis

Fourth Street

Southbound and Northbound

Town of Midland

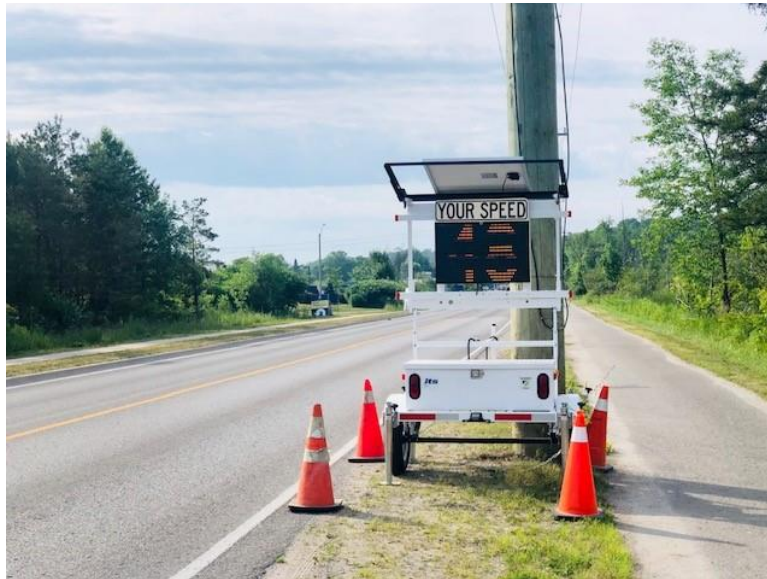
**Figure 1. Traffic Trailer**

The traffic trailer used was model ATS-3 as shown in Figure 1. The traffic trailer is set to show the speed of the approaching vehicle and display short messages depending on the speed. The traffic trailer uses radar to detect vehicles and collect data. The data is then grouped into one-hour intervals.

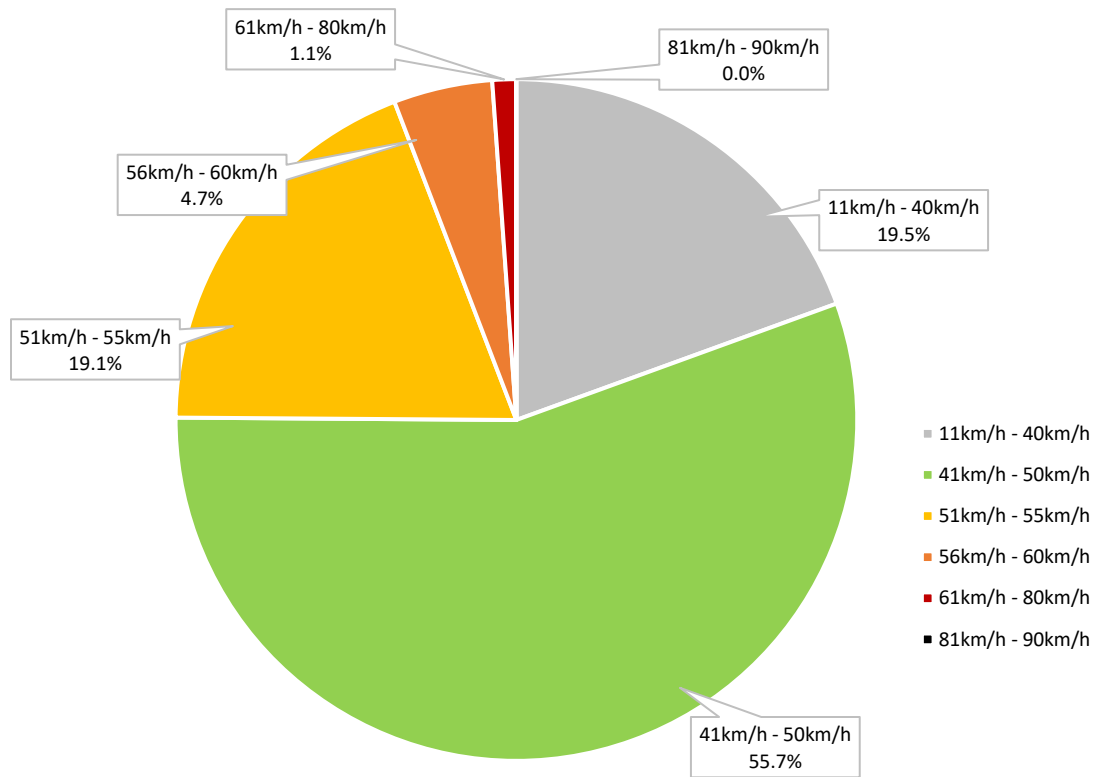
**Figure 2. Fourth St. Southbound**

Figure 2 shows that 19.5% of vehicles were travelling below the posted speed limit, 55.7% of vehicles were travelling between 41 – 50 km/h, and 24.9% of vehicles were travelling above 51km/h. Considering the accepted speed limit is 10km/h over the posted speed limit, a total of 75.2% of vehicles were travelling within the accepted speed limit in the southbound direction.

Figure 2 and 3 below show the speed summary for the southbound traffic.

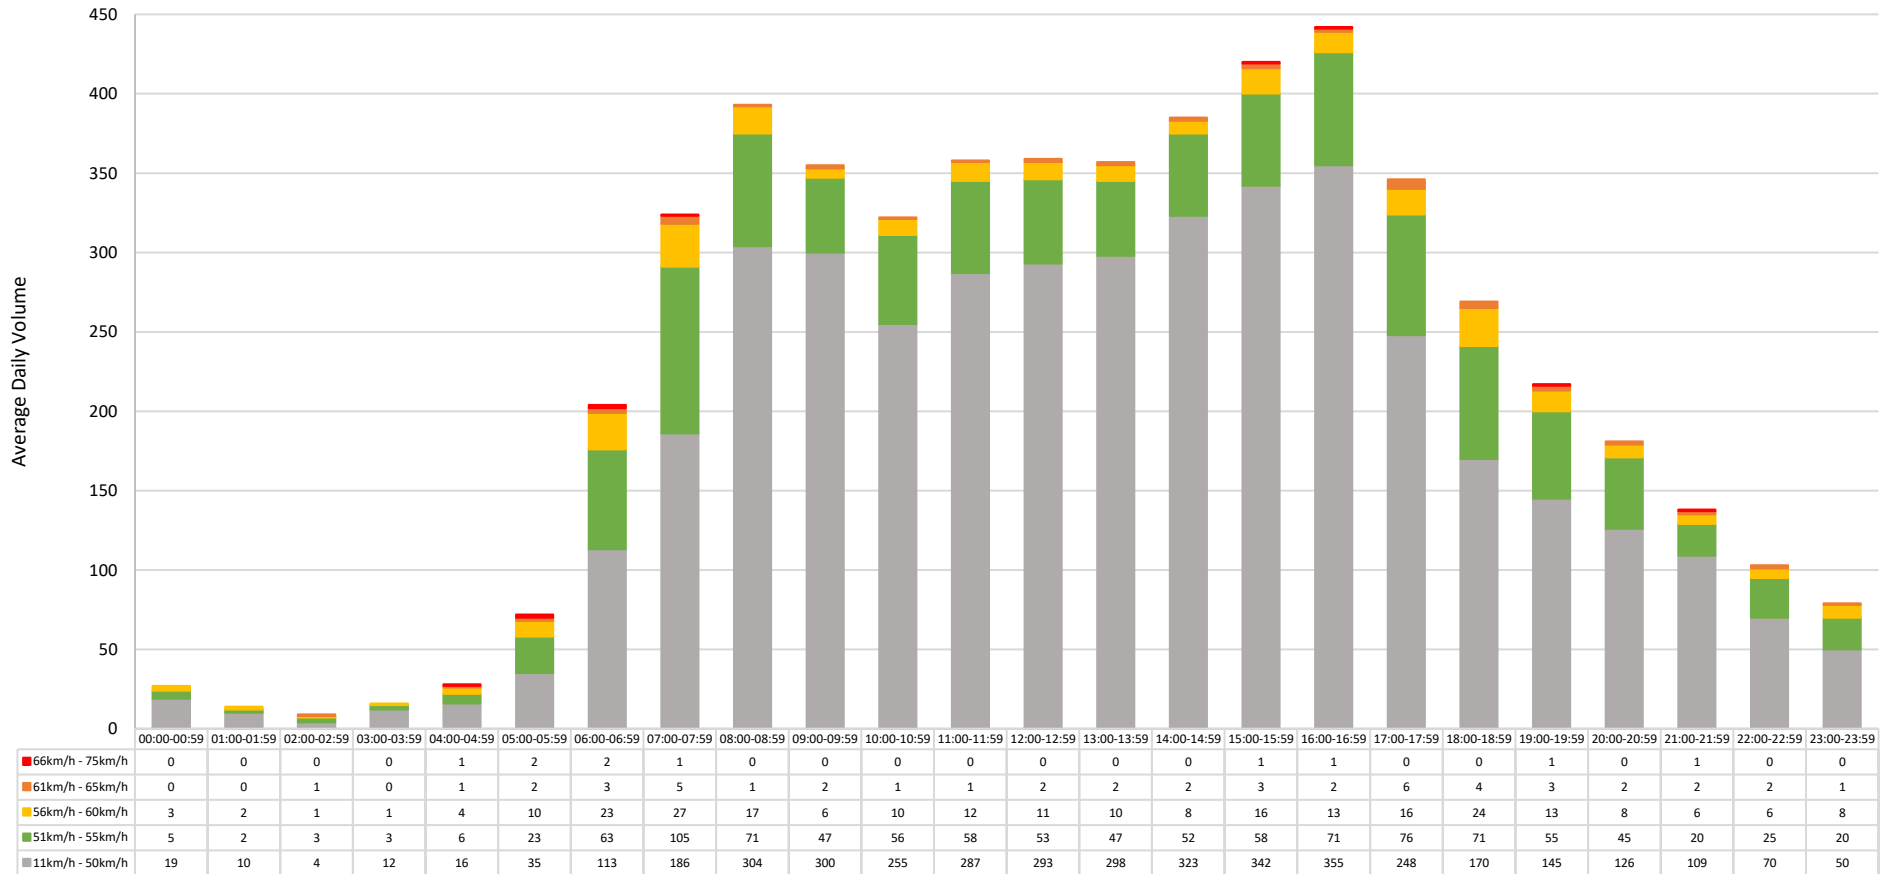
**Figure 3. Speed by Hour Analysis for Southbound**

Figure 3 is the speed by hour graph used to determine the time where most speeding occurs. This graph indicates that speeding remained relatively consistent throughout the collection period and speeding peaked between 7am to 8am and 5pm to 6pm. Based on the low volume of speeding that occurred, there are no speeding concerns in the southbound direction.

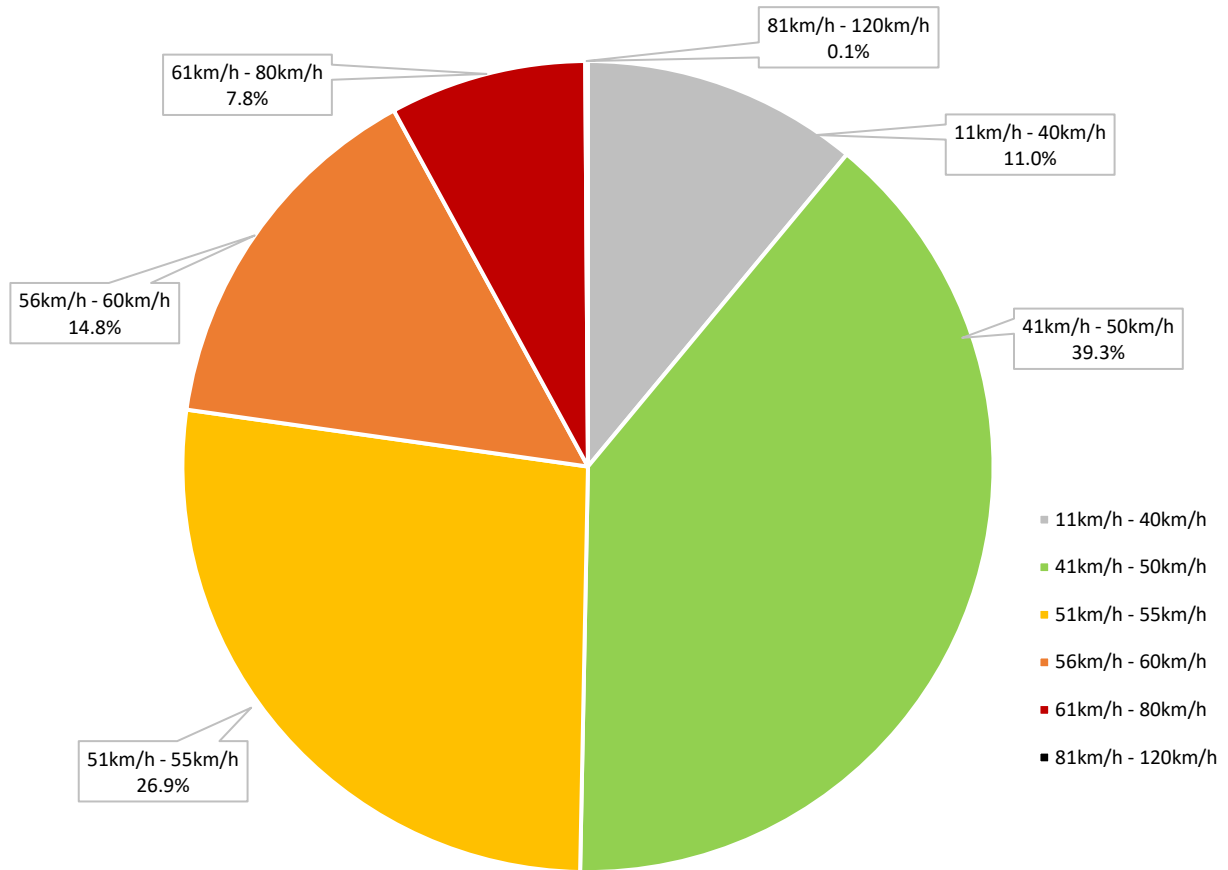
**Figure 4. Fourth St. Northbound**

Figure 4 shows that 50% of the vehicles were travelling below the posted speed limit, 42% of vehicles were travelling between 51-60km/h, and 8% of vehicles were travelling above 60km/h. Considering the accepted speed limit is 10km/h over the posted speed limit, a total of 92% of vehicles were driving within the accepted speed limit.

Figure 4 to 6 are the speed summary for the northbound traffic.

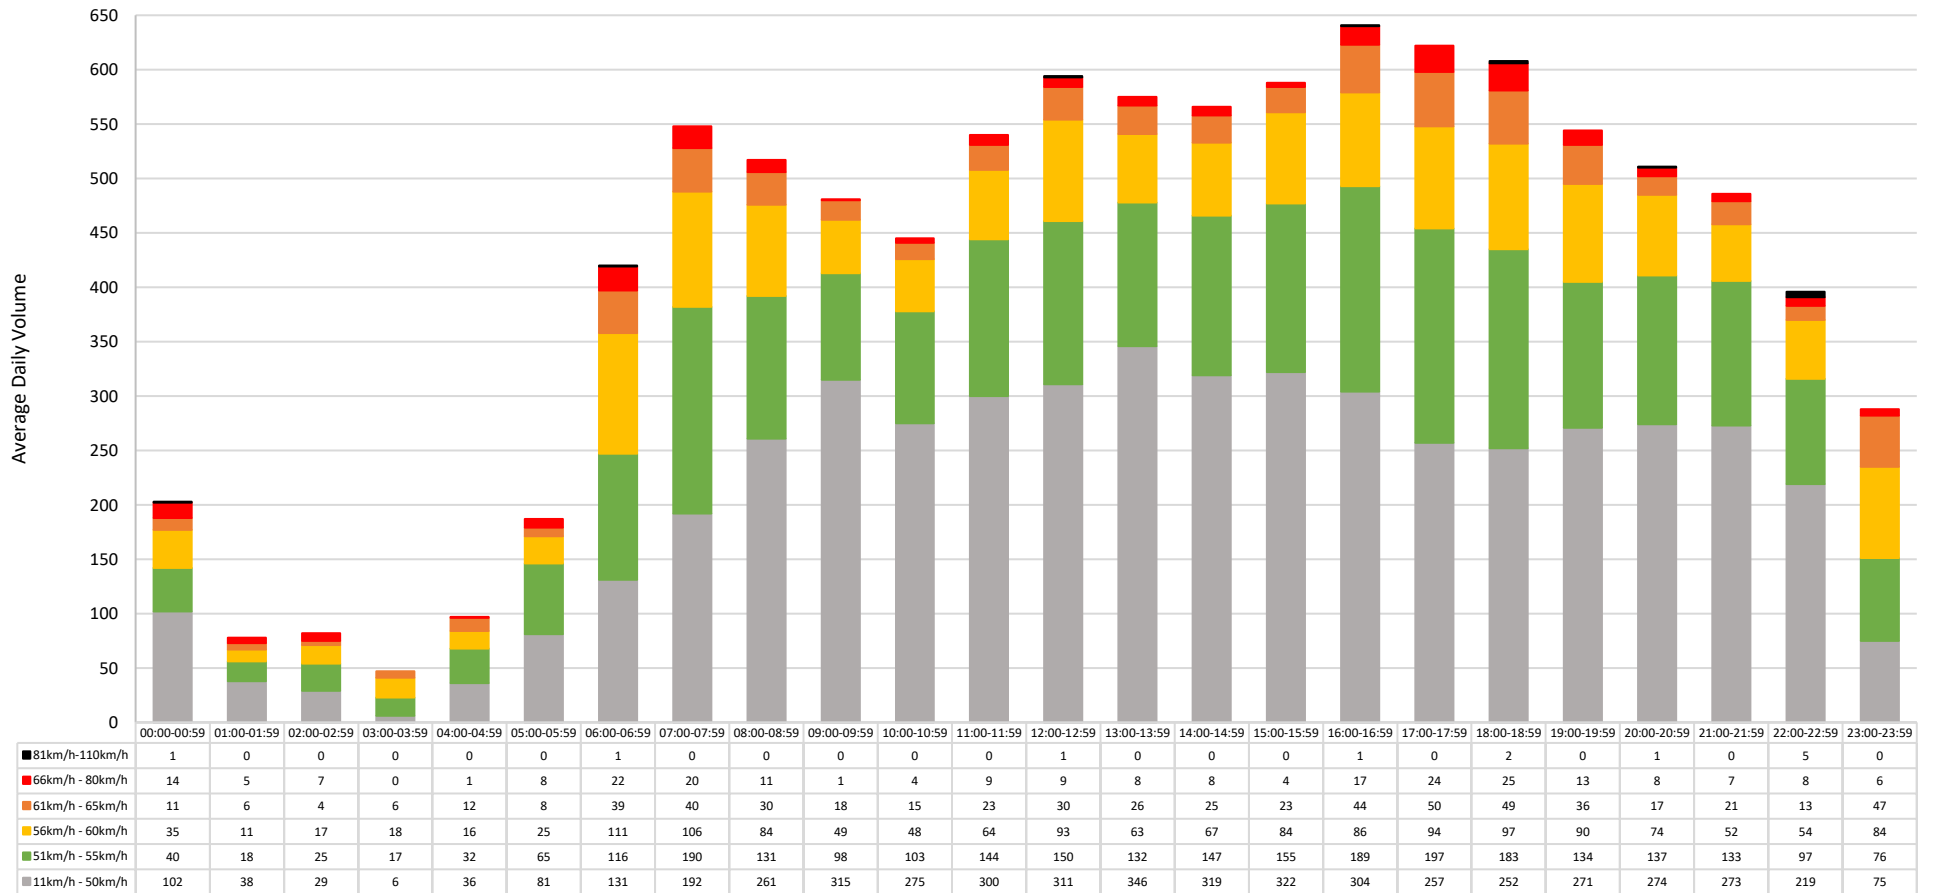
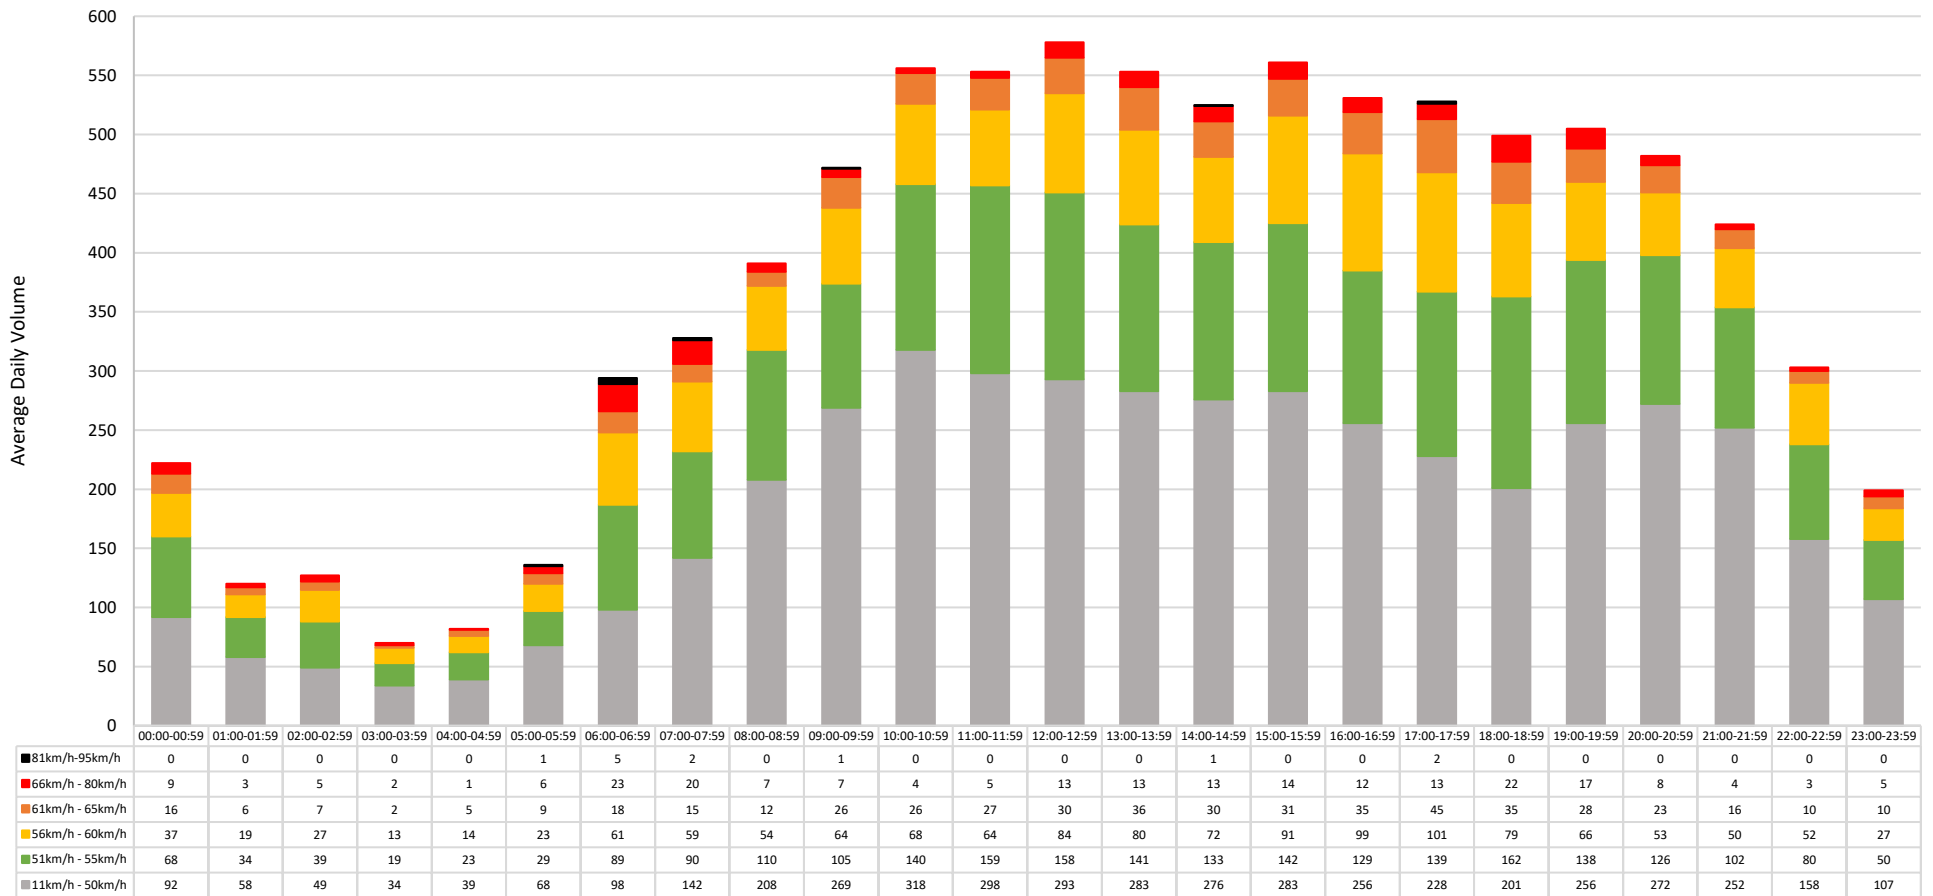
Figure 5. Speed by Hour Analysis for Northbound (July 25<sup>th</sup> to July 26<sup>th</sup>, 2019)

**Figure 6. Speed by Hour Analysis for Northbound (July 27<sup>th</sup> to July 28<sup>th</sup>, 2019)**

Figure 5 (weekday) and Figure 6 (weekend) above are the speed by hour graphs used to determine the time where most speeding occurs. The graphs indicate that on a weekday, speeding mostly occurred during the typical morning and evening commute times, which are 6:00am to

9:00am and 3:00pm to 6:00pm respectively. The data also shows that there is another peak at noon and around midnight. The graphs indicate that on a weekend, speeding mostly occurs between 6am and 8am and remains relatively consistent between 12pm and 8pm, peaking in the evening between 6pm and 7pm.

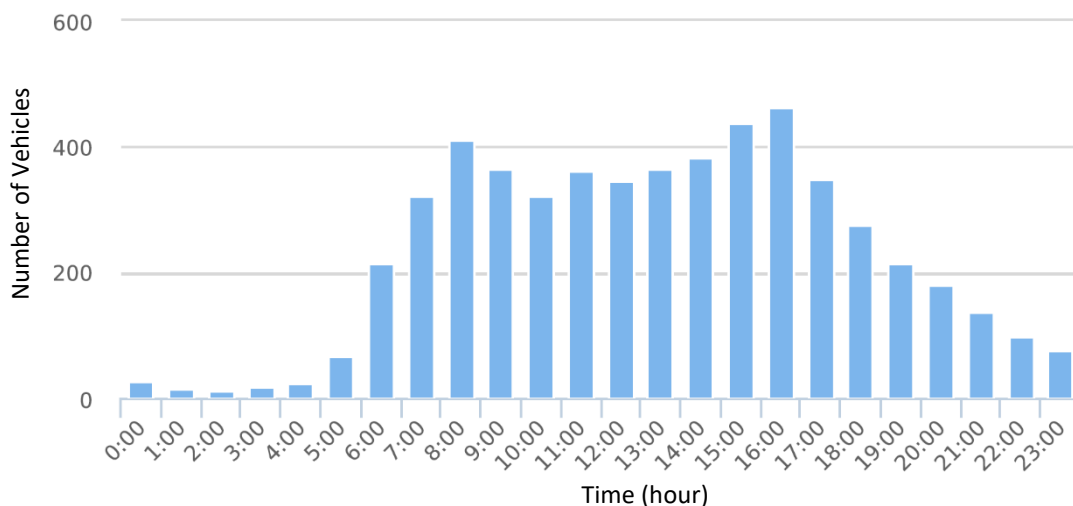
**Figure 7. Average Volume by Hour from July 23<sup>rd</sup> to July 24<sup>th</sup> (Southbound)**

The data collected for two full days (July 23<sup>rd</sup> to July 24<sup>th</sup>) is used to analyze the average traffic volume at different times of a day (Figure 7). From the graph, Fourth Street has peak traffic during the typical morning and evening commute times.

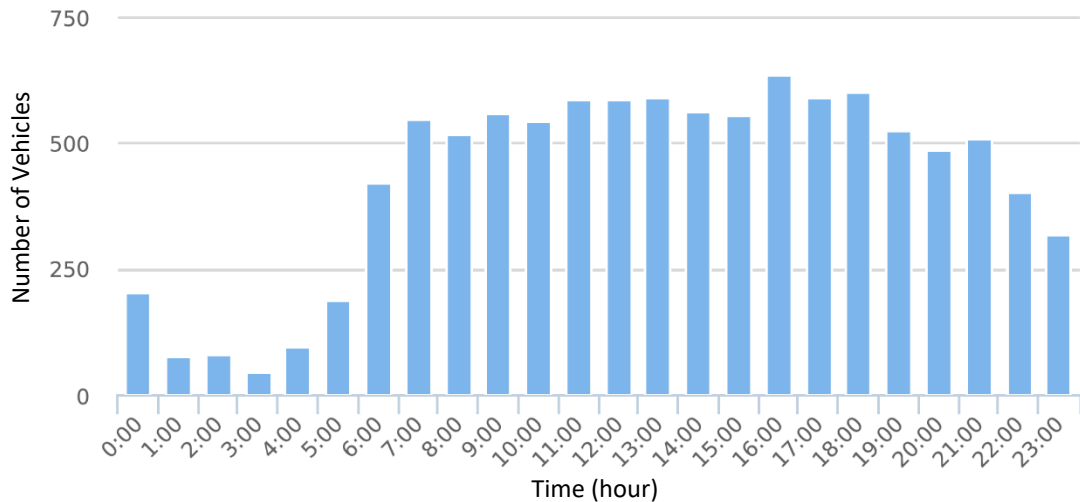
Figure 8. Volume by Hour on July 26<sup>th</sup> (Northbound)

The data collected on July 26<sup>th</sup> is used to analyze the average traffic volume at different times of a day on a weekday (Figure 8). From the graph, Fourth Street has peak traffic during the typical morning and evening commute times and around noon.

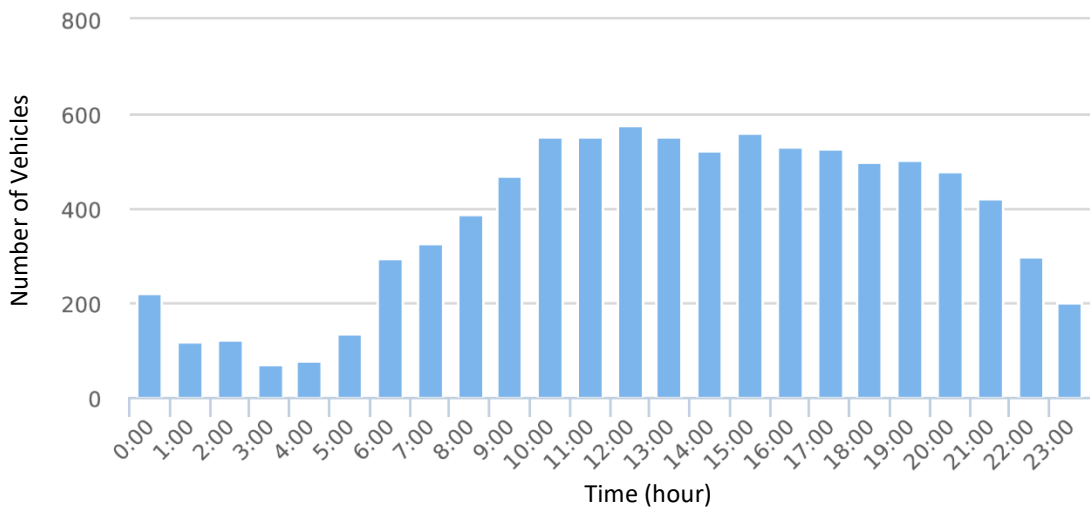
Figure 9. Average Volume by Hour on July 27<sup>th</sup> to July 28<sup>th</sup> (Northbound)

The data collected from July 27<sup>th</sup> to July 28<sup>th</sup> (weekends) are used to analyze the average traffic volume at different times of the day as shown in Figure 9. From the graph, the traffic on the weekend in the northbound direction has a peak volume around noon.
