Traffic Data Analysis

Bayview Drive

Town of Midland

Engineering Department

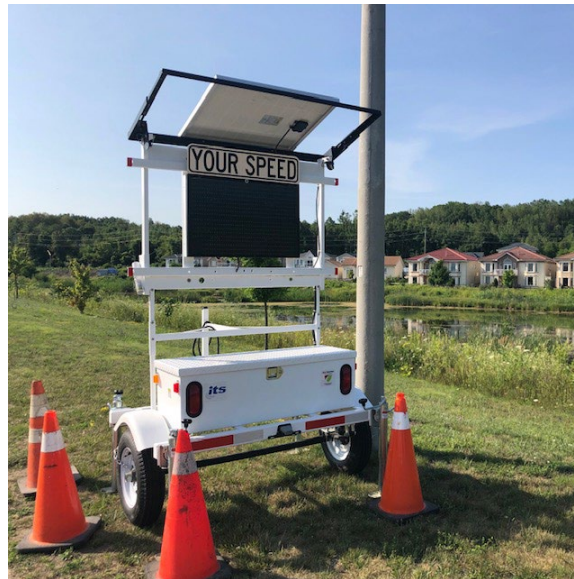
Figure 1. Traffic Trailer

The traffic trailer used was model ATS-3 as shown in Figure 1. The traffic trailer is set to show the speed of the approaching vehicle and display short messages depending on the speed. The data is collected and grouped into one-hour intervals.

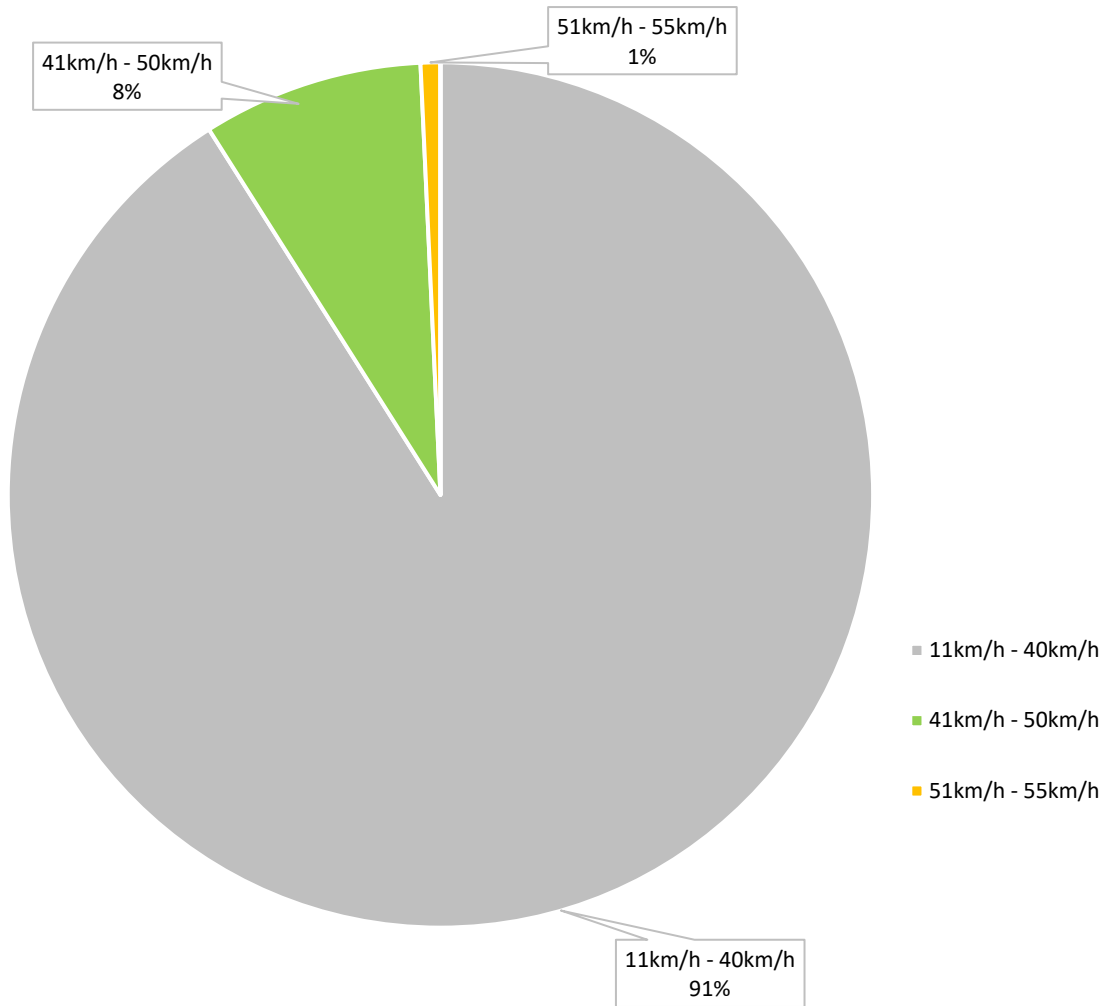
Figure 2. Bayview Dr. Southbound

Figure 2 shows that 99% of vehicles were travelling below the posted speed limit and 1% of vehicles were travelling above 50km/h. Considering the accepted speed limit is 10km/h over the posted speed limit, all vehicles were travelling within the accepted speed limit in the southbound direction.

Figure 2 and 3 below show the speed summary for the southbound traffic.

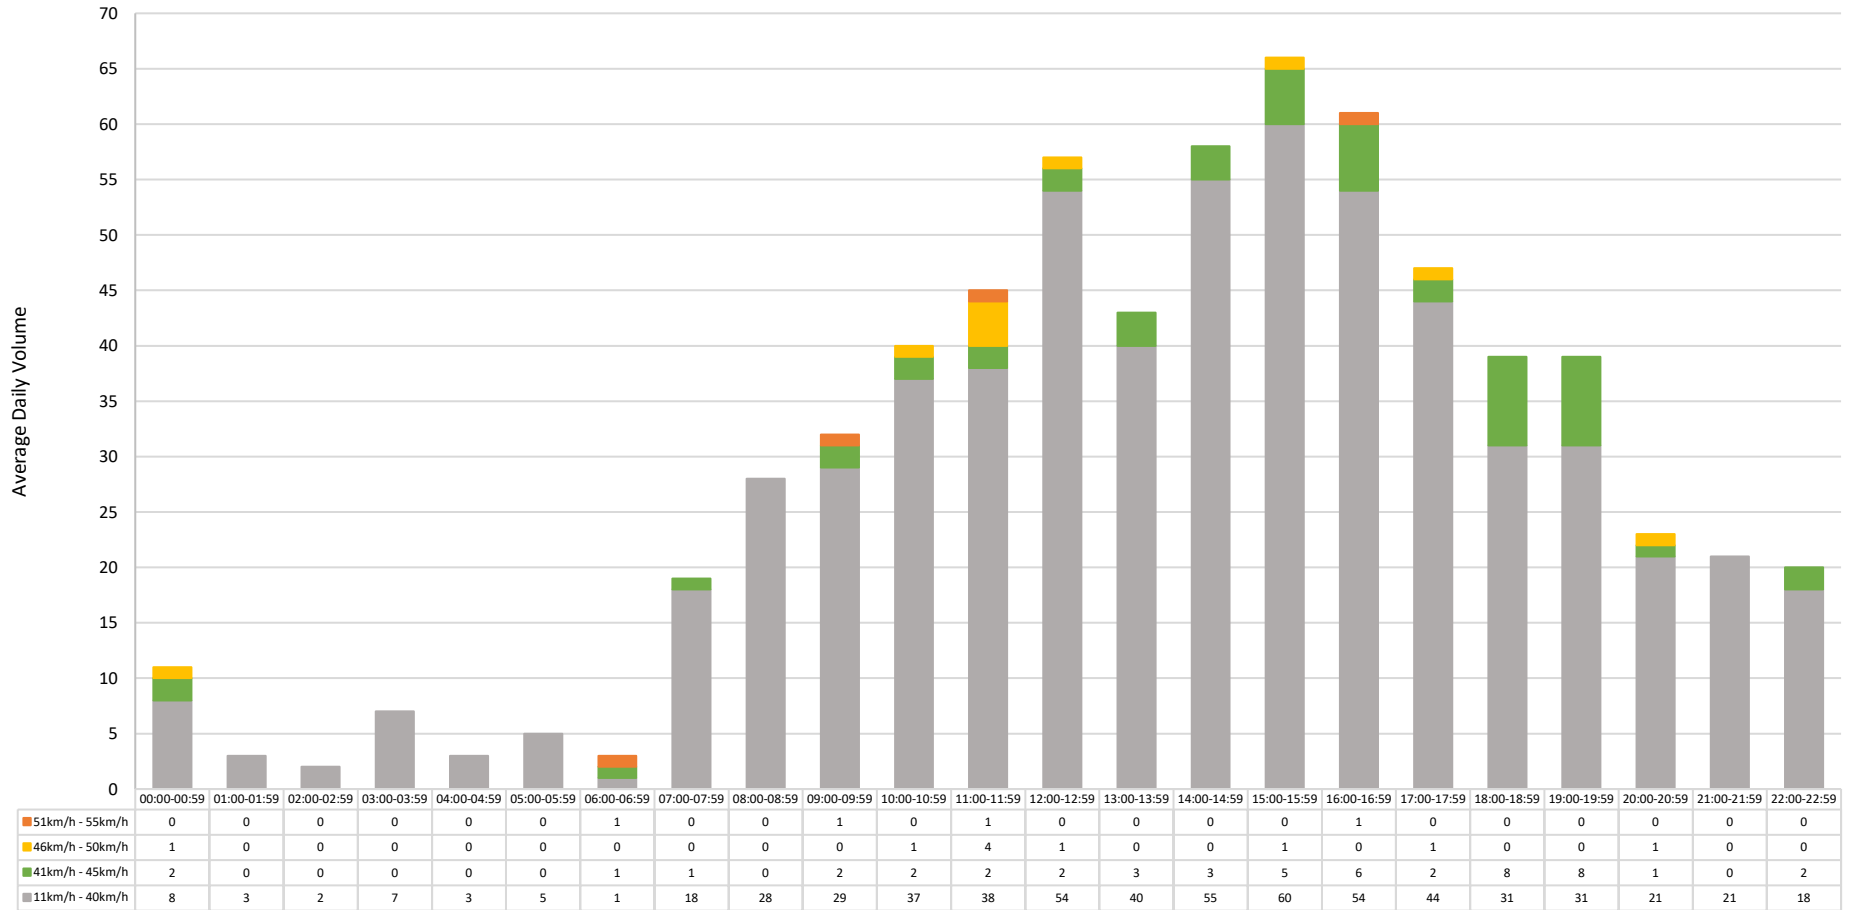
Figure 3. Speed by Hour Analysis for Southbound

Figure 3 is the speed by hour graph used to determine the time where most speeding occurs. This graph highlights that although speeding peaked from 11:00am to 12:00pm, there are no speeding concerns throughout the collection period.

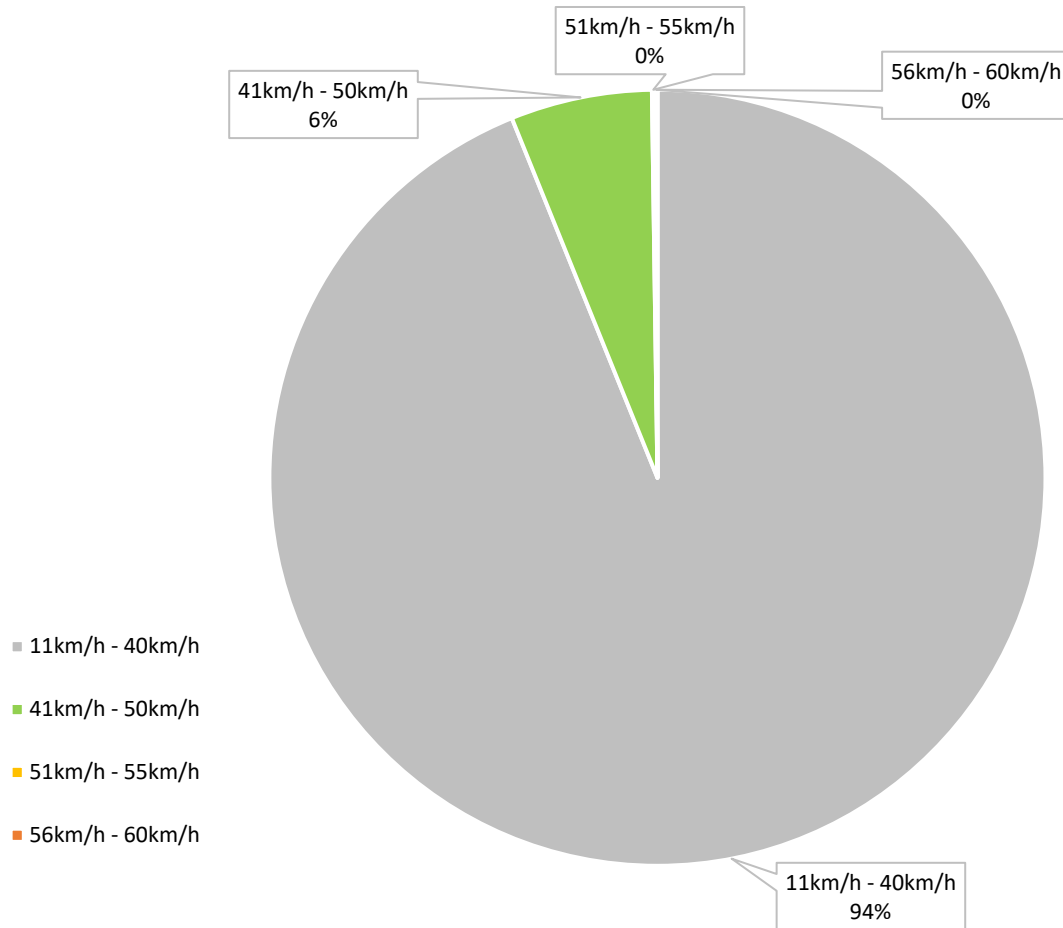
Figure 4. Bayview Dr. Northbound

Figure 4 shows that all vehicles were travelling below the posted speed limit.

Figure 4 to 6 below is the speed summary for the northbound traffic.

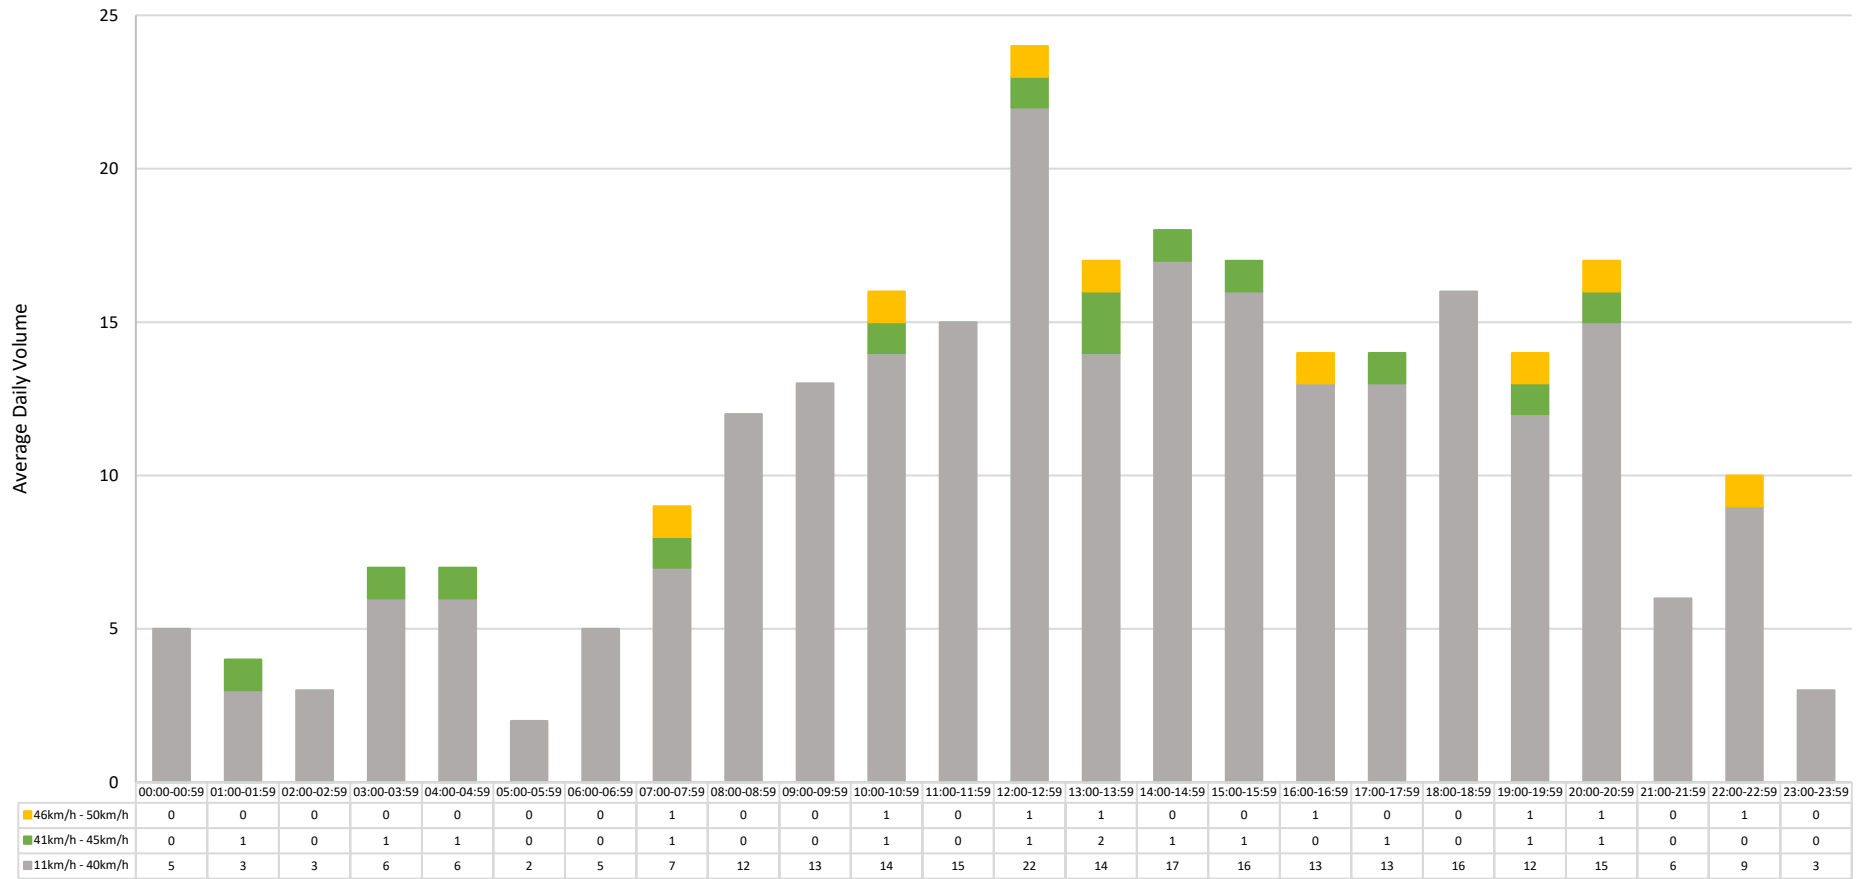
Figure 5. Speed by Hour Analysis for Northbound (August 10th to August 11th, 2019)

Figure 5 (weekend) and Figure 6 (weekday) above are the speed by hour graphs used to determine the time where most speeding occurs. The graphs highlight that there are no speeding concerns throughout the collection period.

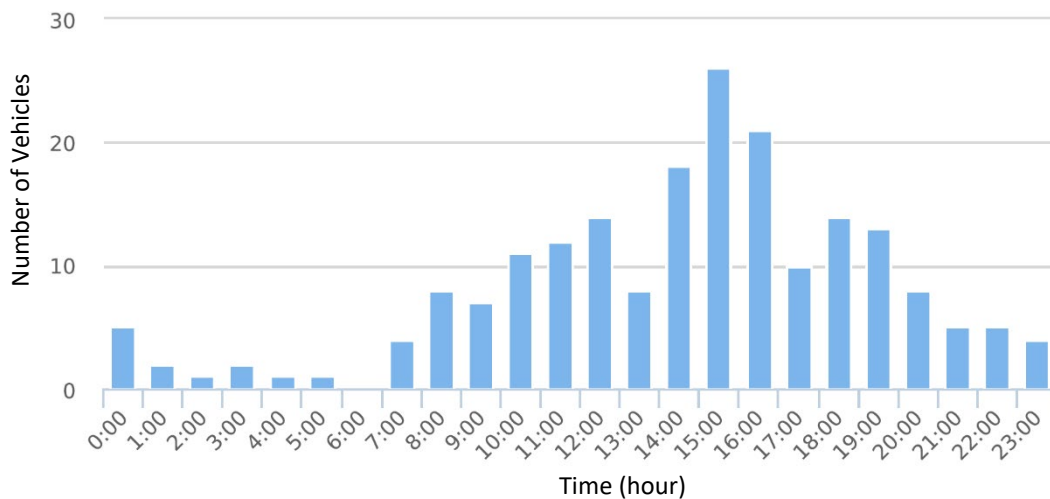
Figure 7. Average Volume by Hour on August 7th to August 8th (Southbound)

The data collected for two full days (August 7th to August 8th) is used to analyze the average traffic volume at different times of a day (Figure 7). From the graph, Bayview Drive has peak traffic during the typical evening commute time, which is 3:00pm to 6:00pm, and especially from 3:00pm to 4:00pm.

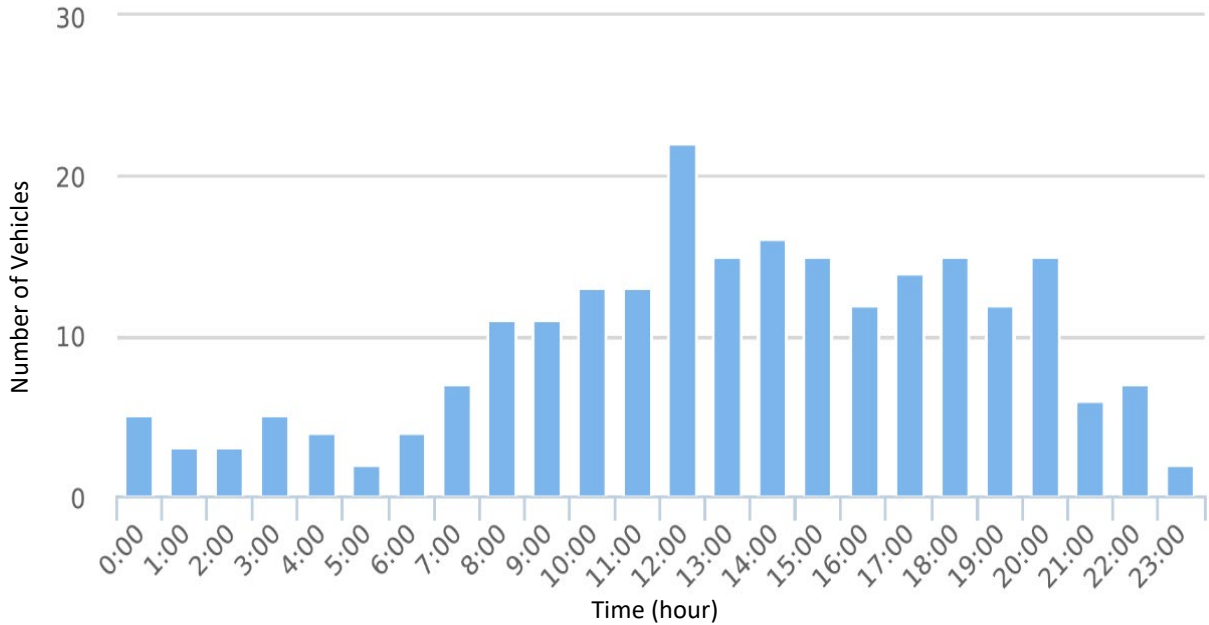
Figure 8. Average Volume by Hour from August 10th to August 11th (Northbound)

The data collected from August 10th to August 11th (weekend) and on Aug 12th (weekday) are used to analyze the average traffic volume at different times of the day as shown in Figure 8 and Figure 9 respectively. The peak traffic occurred during noon hour on the weekend in the northbound direction. The peak traffic on a weekday is at the typical evening commute time.
