# Traffic Data Analysis

Cook Drive.

Town of Midland

Engineering Department

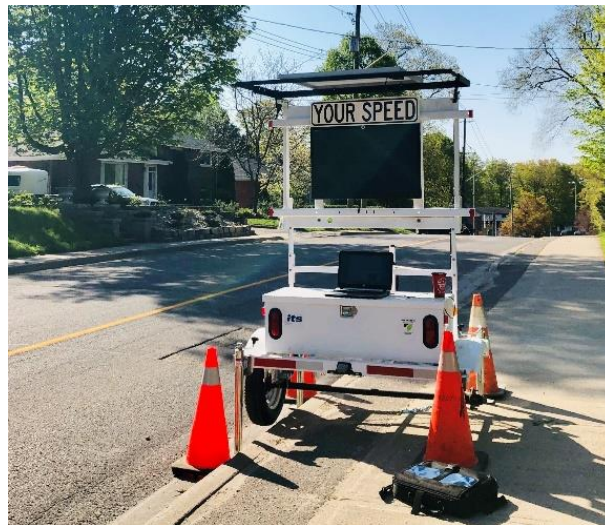
**Figure 1. Traffic Trailer**

The traffic trailer used was a model ATS-3 as shown in Figure 1. The traffic trailer is set to show the speed of the approaching vehicle and display short messages depending on the speed. The data is collected and grouped into one-hour intervals.

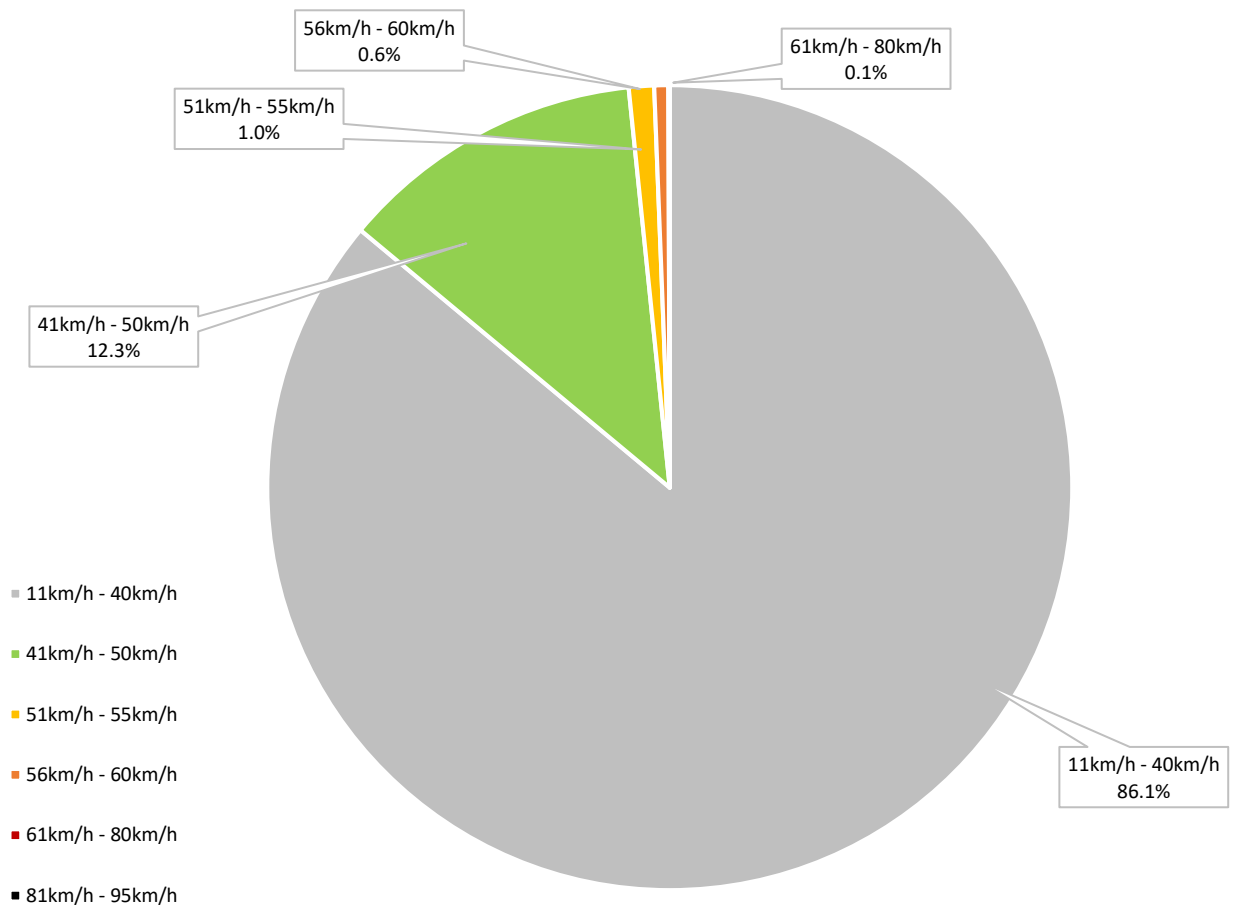
**Figure 2. Cook Dr. Eastbound Speed Breakdown**

Figure 2 shows that 98.4% of vehicles were travelling below the posted speed limit and 0.7% of vehicles were travelling between 51-60 km/h. Considering the accepted speed limit is 10km/h over the posted speed limit, we find that a total of 99.9% of vehicles were travelling within the accepted speed limit in the eastbound direction.

Figure 2 and 3 below show the speed summary for the eastbound traffic.

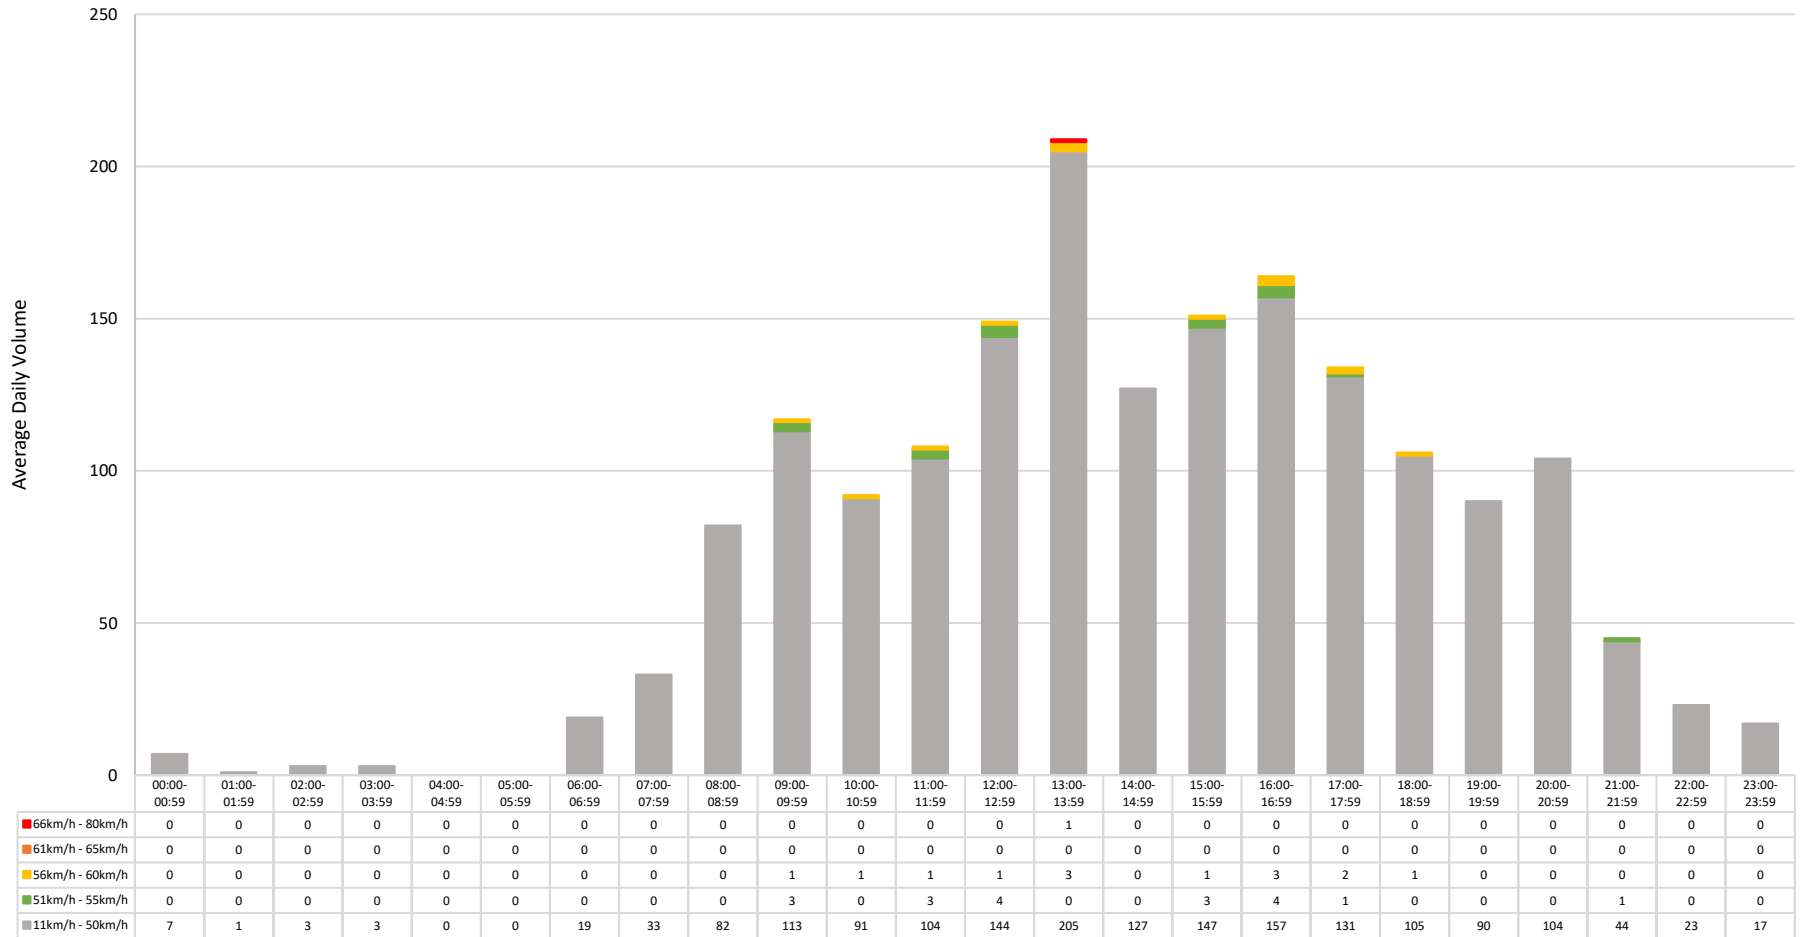
**Figure 3. Speed by Hour Analysis for Eastbound**

Figure 3 is the speed by hour graph used to determine the time where most speeding occurs. This graph highlights that there are no speeding concerns at any point throughout the collection period.

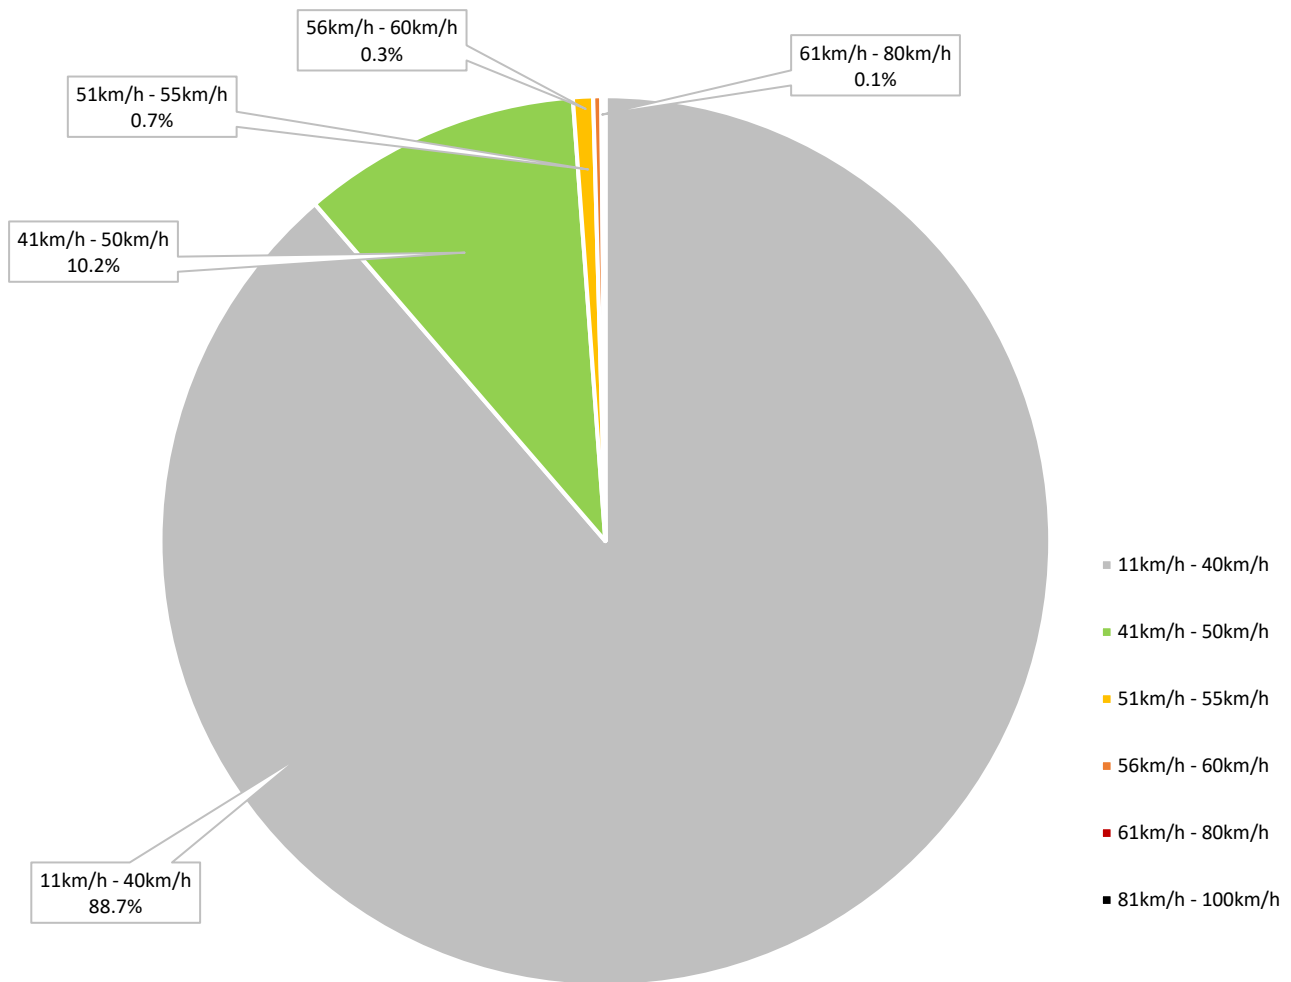
**Figure 4. Cook Dr. Westbound**

Figure 4 shows that 98.9% of the vehicles were travelling below the posted speed limit and 1% of vehicles were travelling between 51-60 km/h. Considering the accepted speed limit is 10km/h over the posted speed limit, a total of 99.9% of vehicles were travelling within the accepted speed limit.

Figure 4 and 5 below is the speed summary for the westbound traffic.

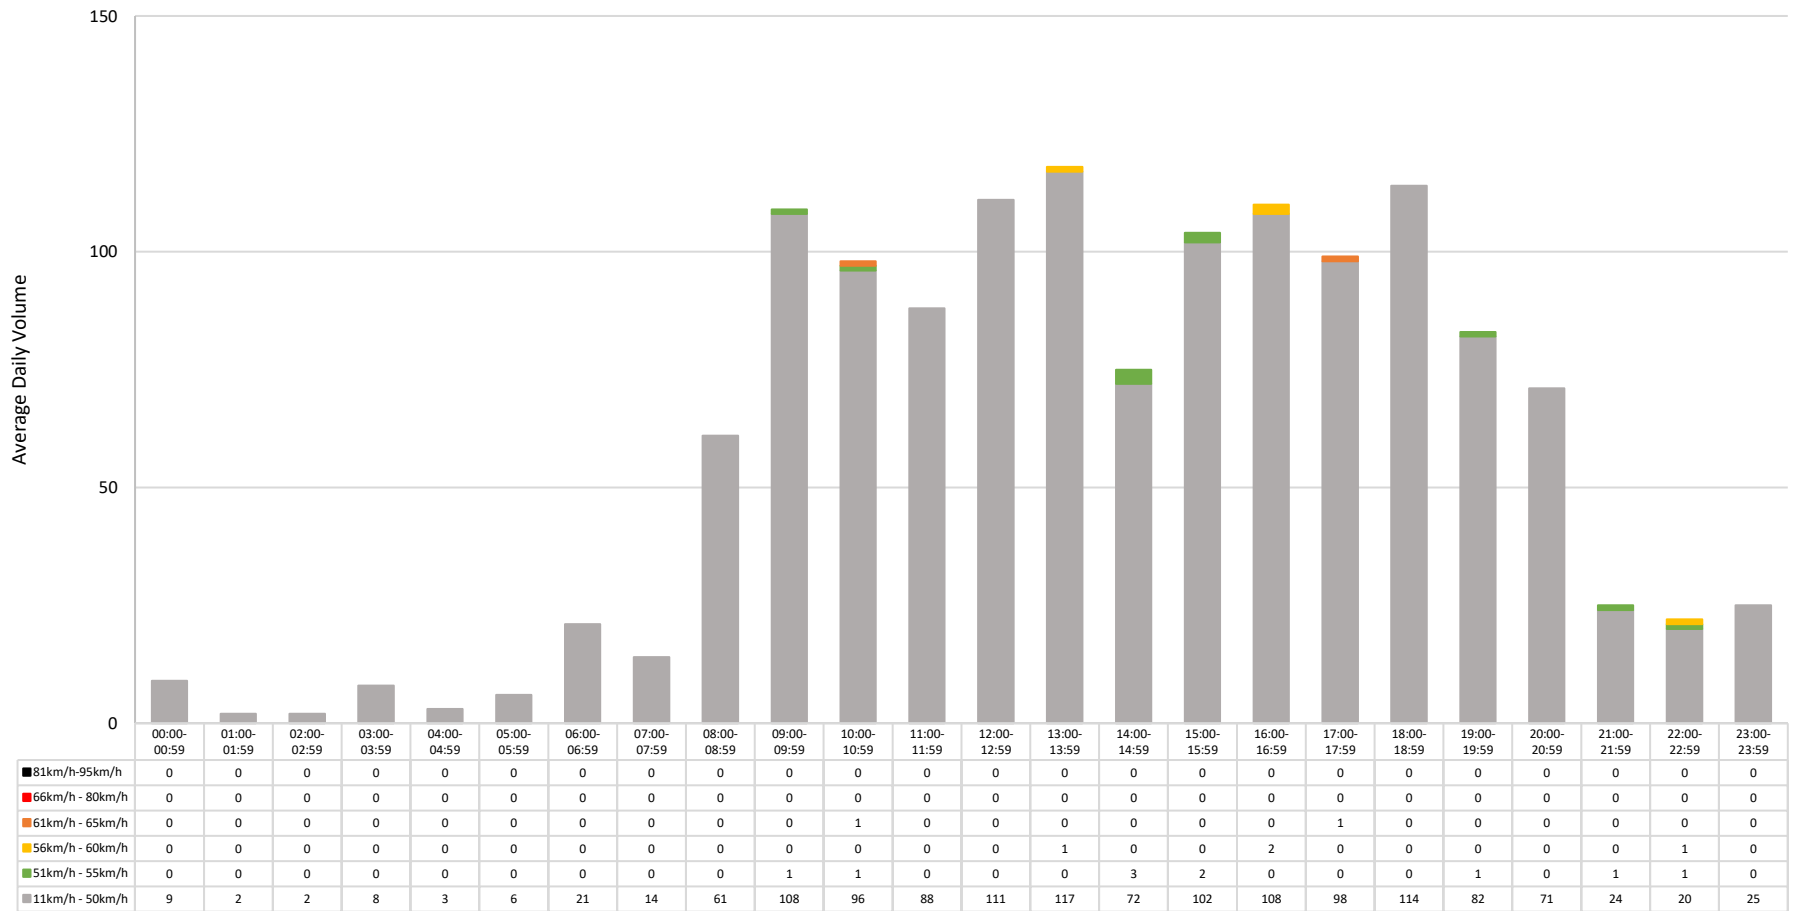
Figure 5. Speed by Hour Analysis for Westbound

Figure 5

above is the speed by hour graph used to determine the time where most speeding occurs. The graph highlights that there are no speeding concerns at any point throughout the collection period

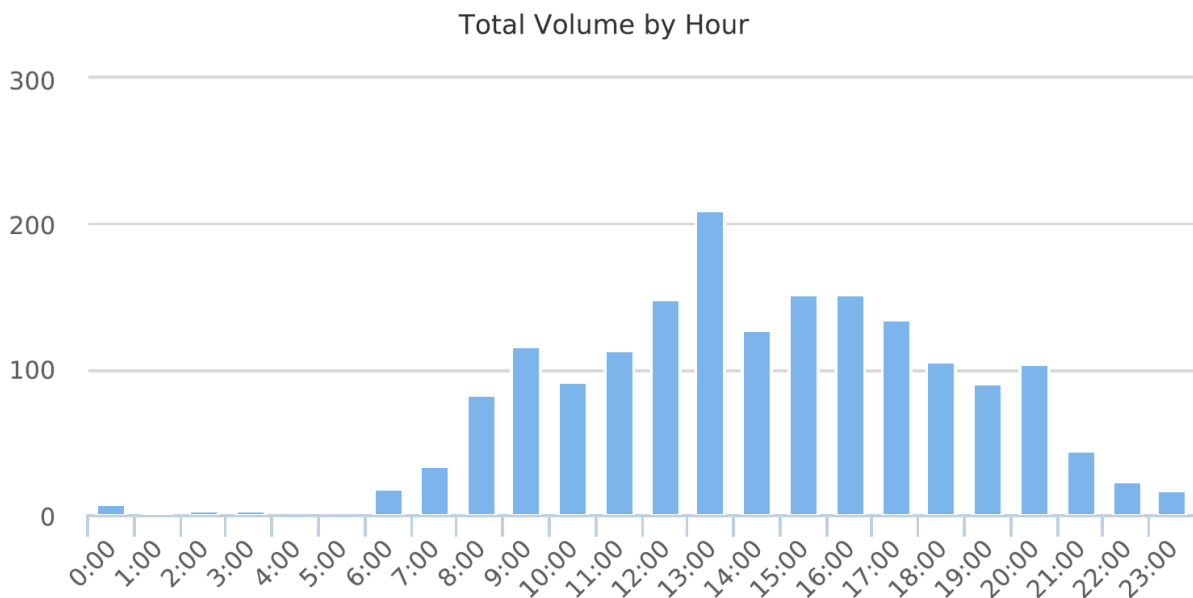
Figure 6. Average Volume by Hour (Eastbound)

The data collected from August 27<sup>th</sup> to August 29<sup>th</sup> is used to analyze the average traffic volume at different times of day (Figure 6). From the graph, Cook Drive has peak traffic around lunch hour, otherwise following a normal curve.

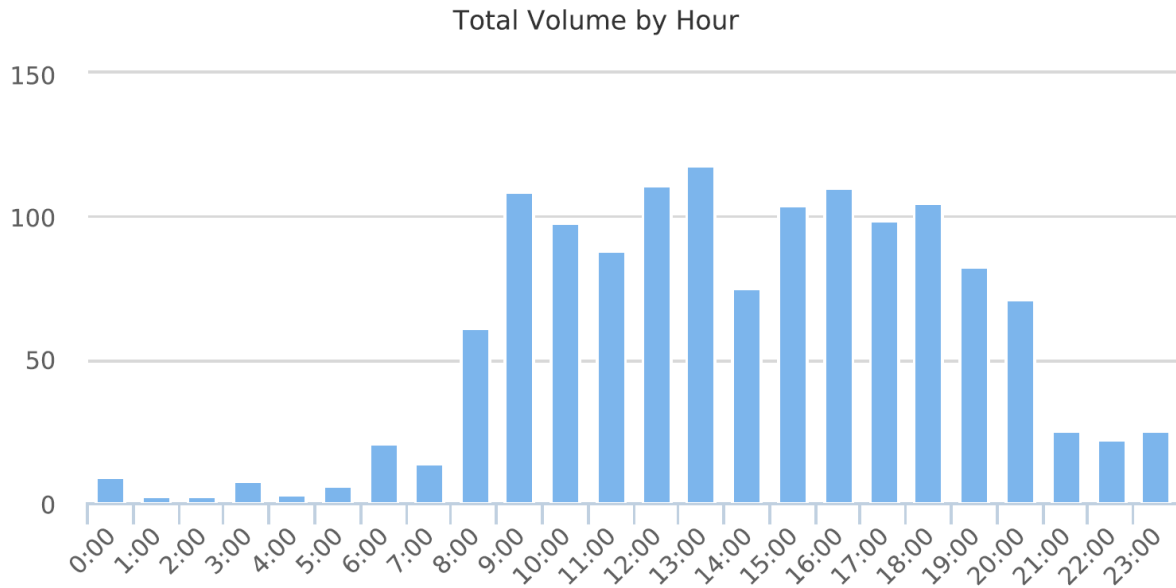
**Figure 7. Average Volume by Hour (Westbound)**

The data collected from August 30<sup>th</sup> to September 2<sup>nd</sup> is used to analyze the average traffic volume at different times of day (Figure 7). From the graph, Cook Drive has relatively steady traffic volumes from 8:00am to 8:00pm.
