Traffic Data Analysis

Fifth Street

Town of Midland

Engineering Department

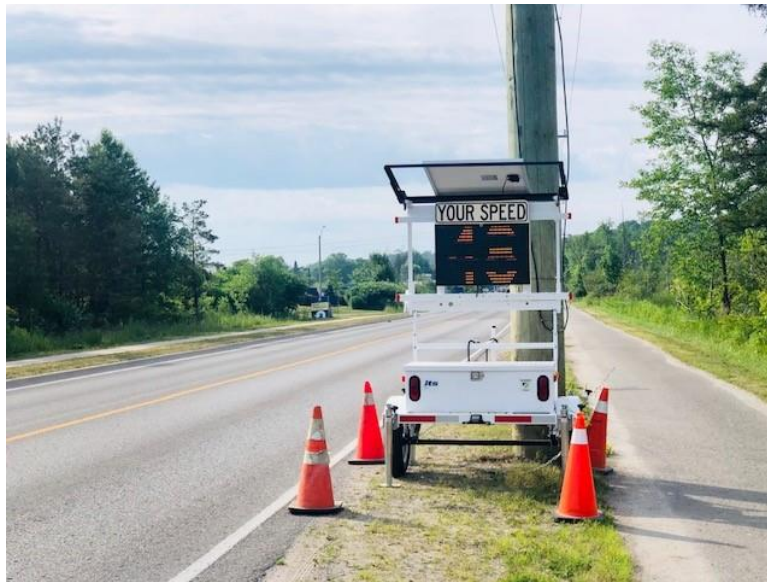
Figure 1. Traffic Trailer

The traffic trailer used was model ATS-3 as shown in Figure 1. The traffic trailer is set to show the speed of the approaching vehicle and display short messages depending on the speed. The data is collected and grouped data into one-hour intervals.

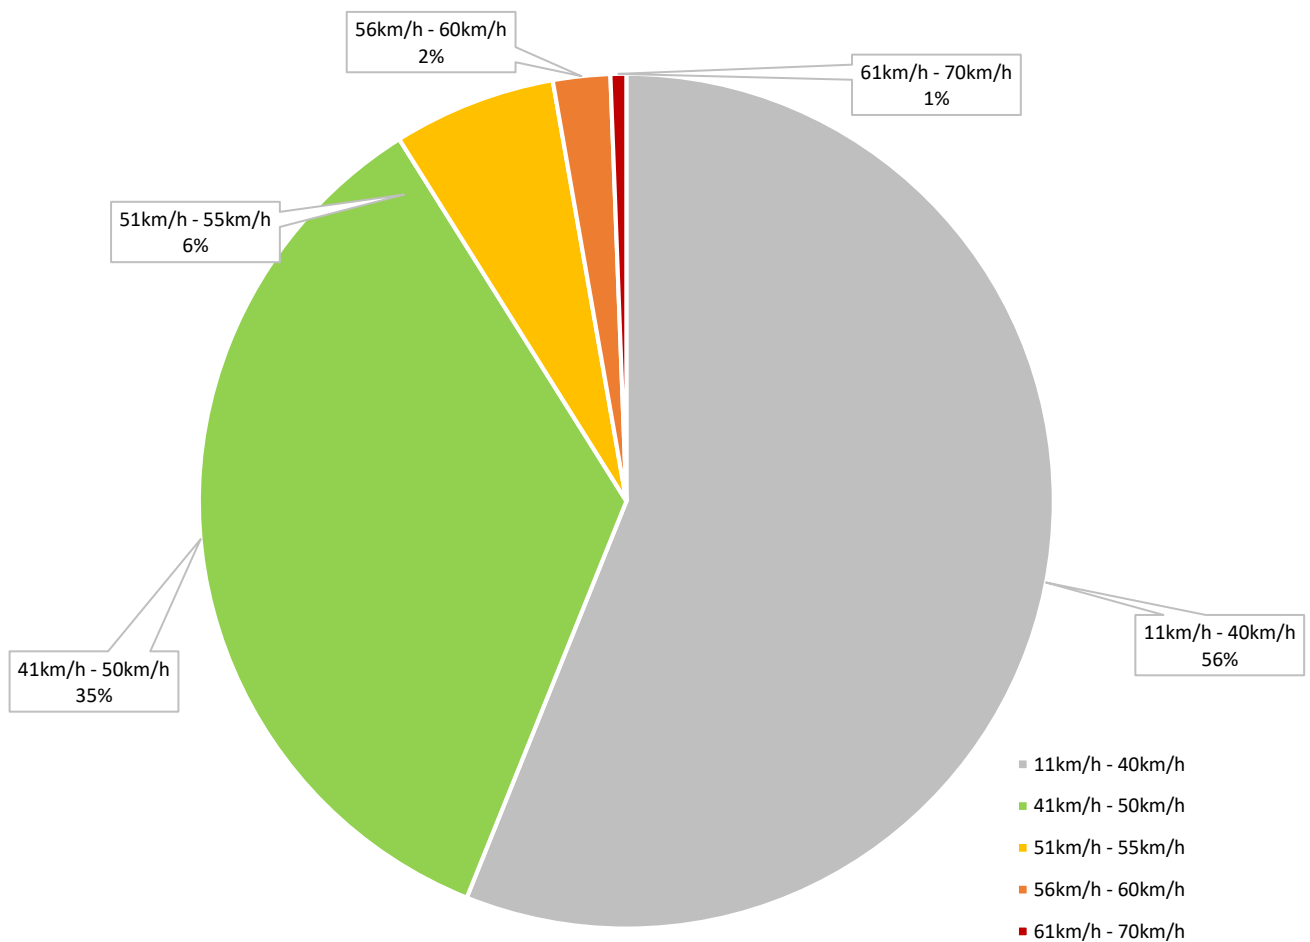
Figure 2. Fifth St. Northbound

Figure 2 shows that 91% of vehicles were travelling below the posted speed limit and 8% of vehicles were travelling between 51-60 km/h. Considering the accepted speed limit is 10km/h over the posted speed limit, a total of 99% of vehicles were travelling within the accepted speed limit in the northbound direction.

Figure 2 and 3 below show the speed summary for the northbound traffic.

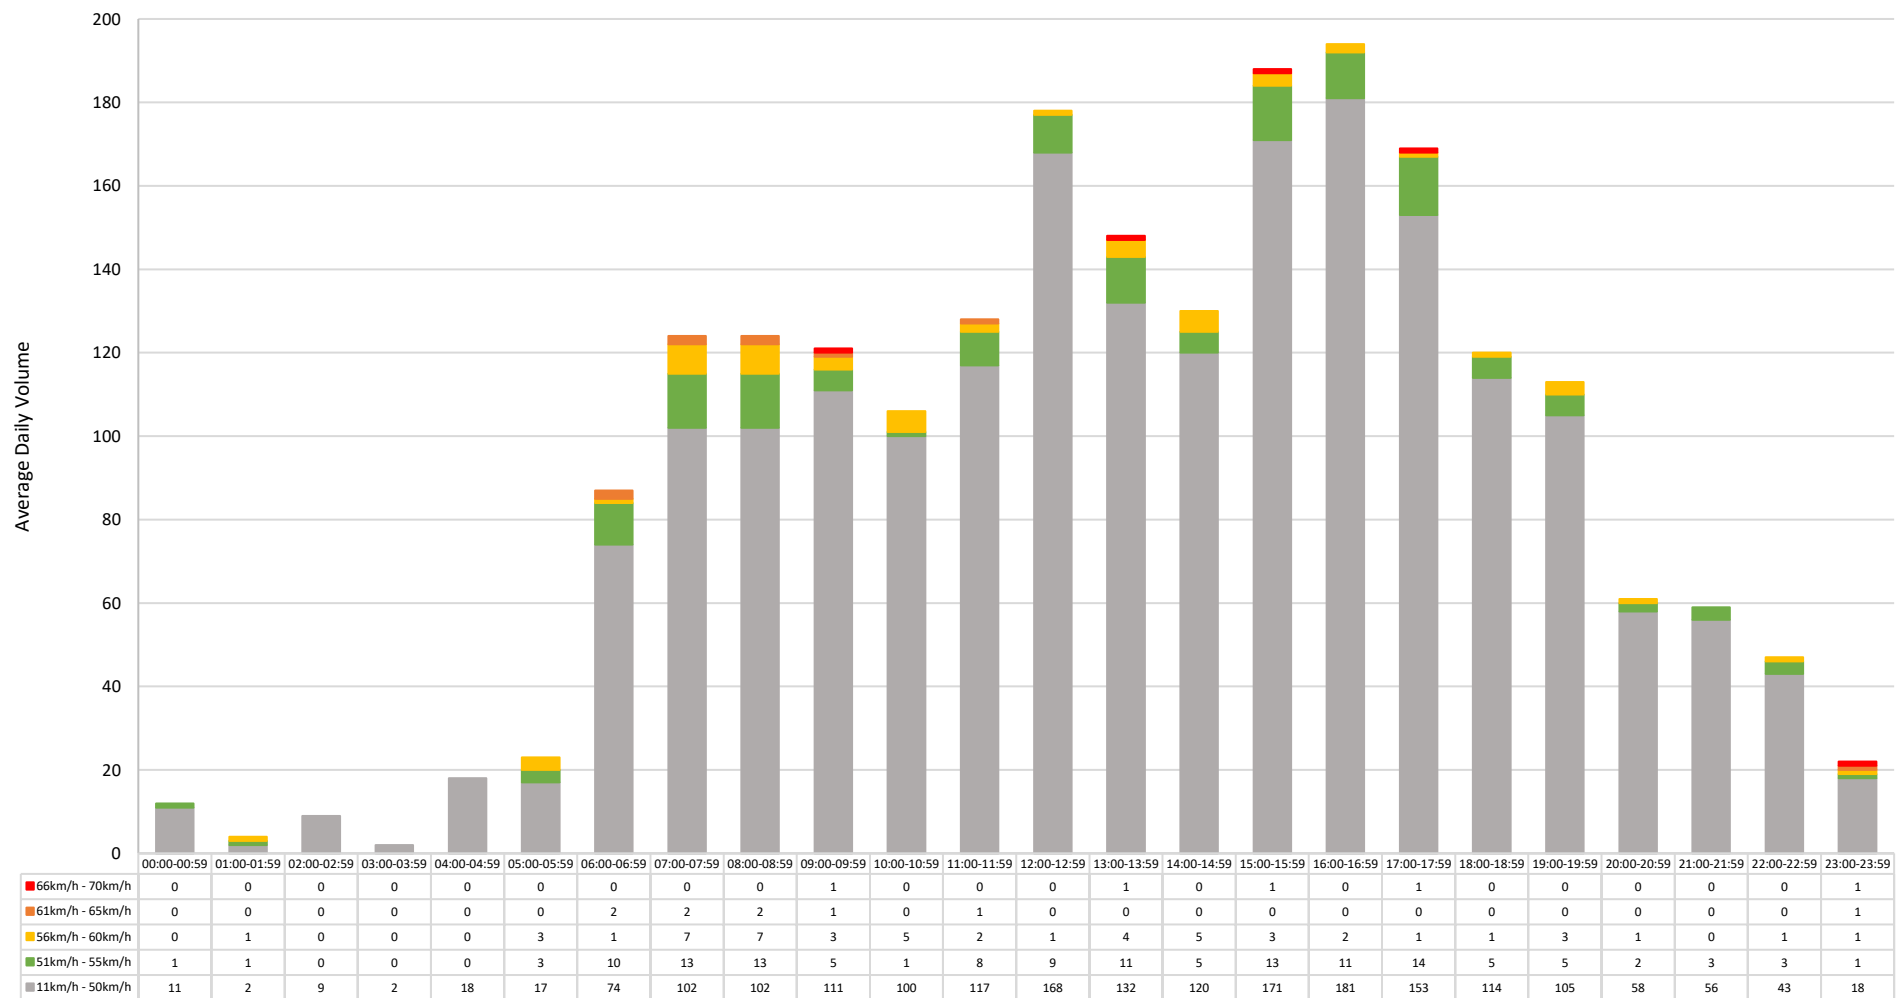
Figure 3. Speed by Hour Analysis for Northbound

Figure 3 is the speed by hour graph used to determine the time where most speeding occurs. This graph highlights that although speeding peaked from 6:00am to 10:00pm, there are no speeding concerns throughout the collection period for the northbound direction.

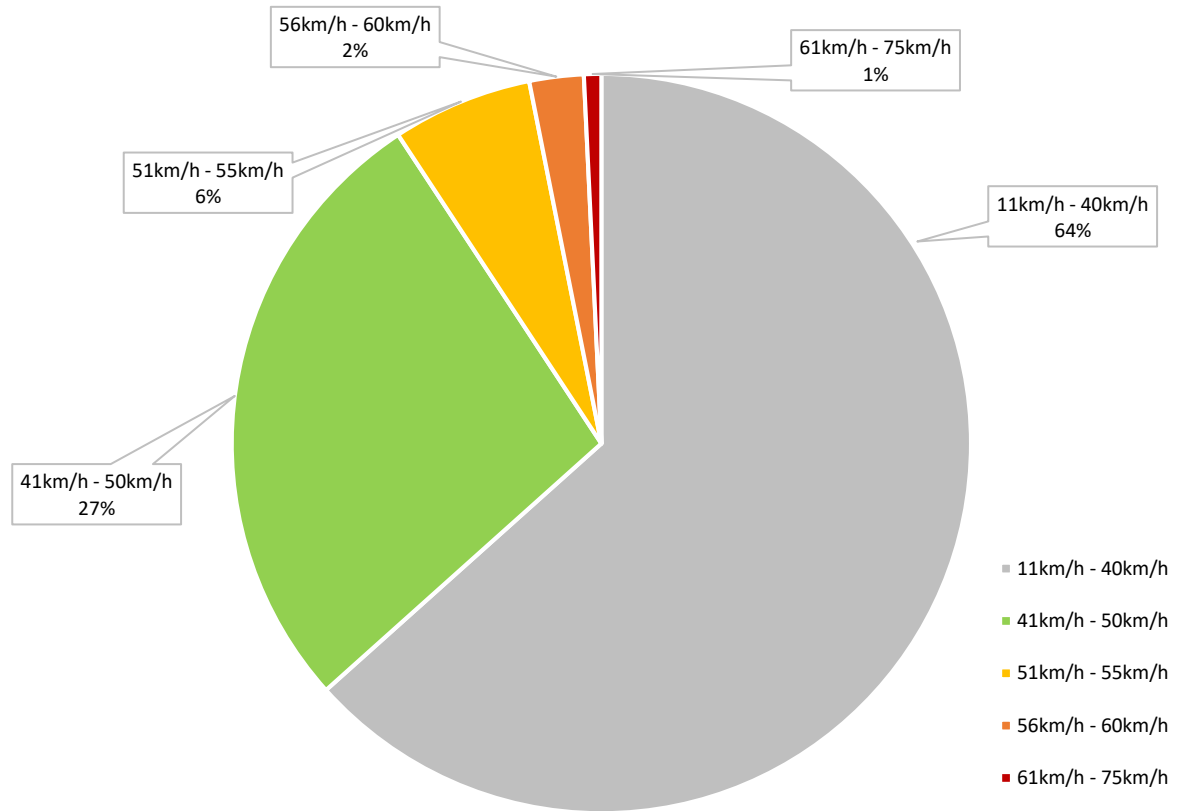
Figure 4. Fifth St. Southbound

Figure 4 shows that 91% of the vehicles were travelling below the posted speed limit and 8% of vehicles were travelling between 51-60 km/h. Considering the accepted speed limit is 10km/h over the posted speed limit, a total of 99% of vehicles were travelling within the accepted speed limit.

Figure 4 to 6 are the speed summary for the southbound traffic.

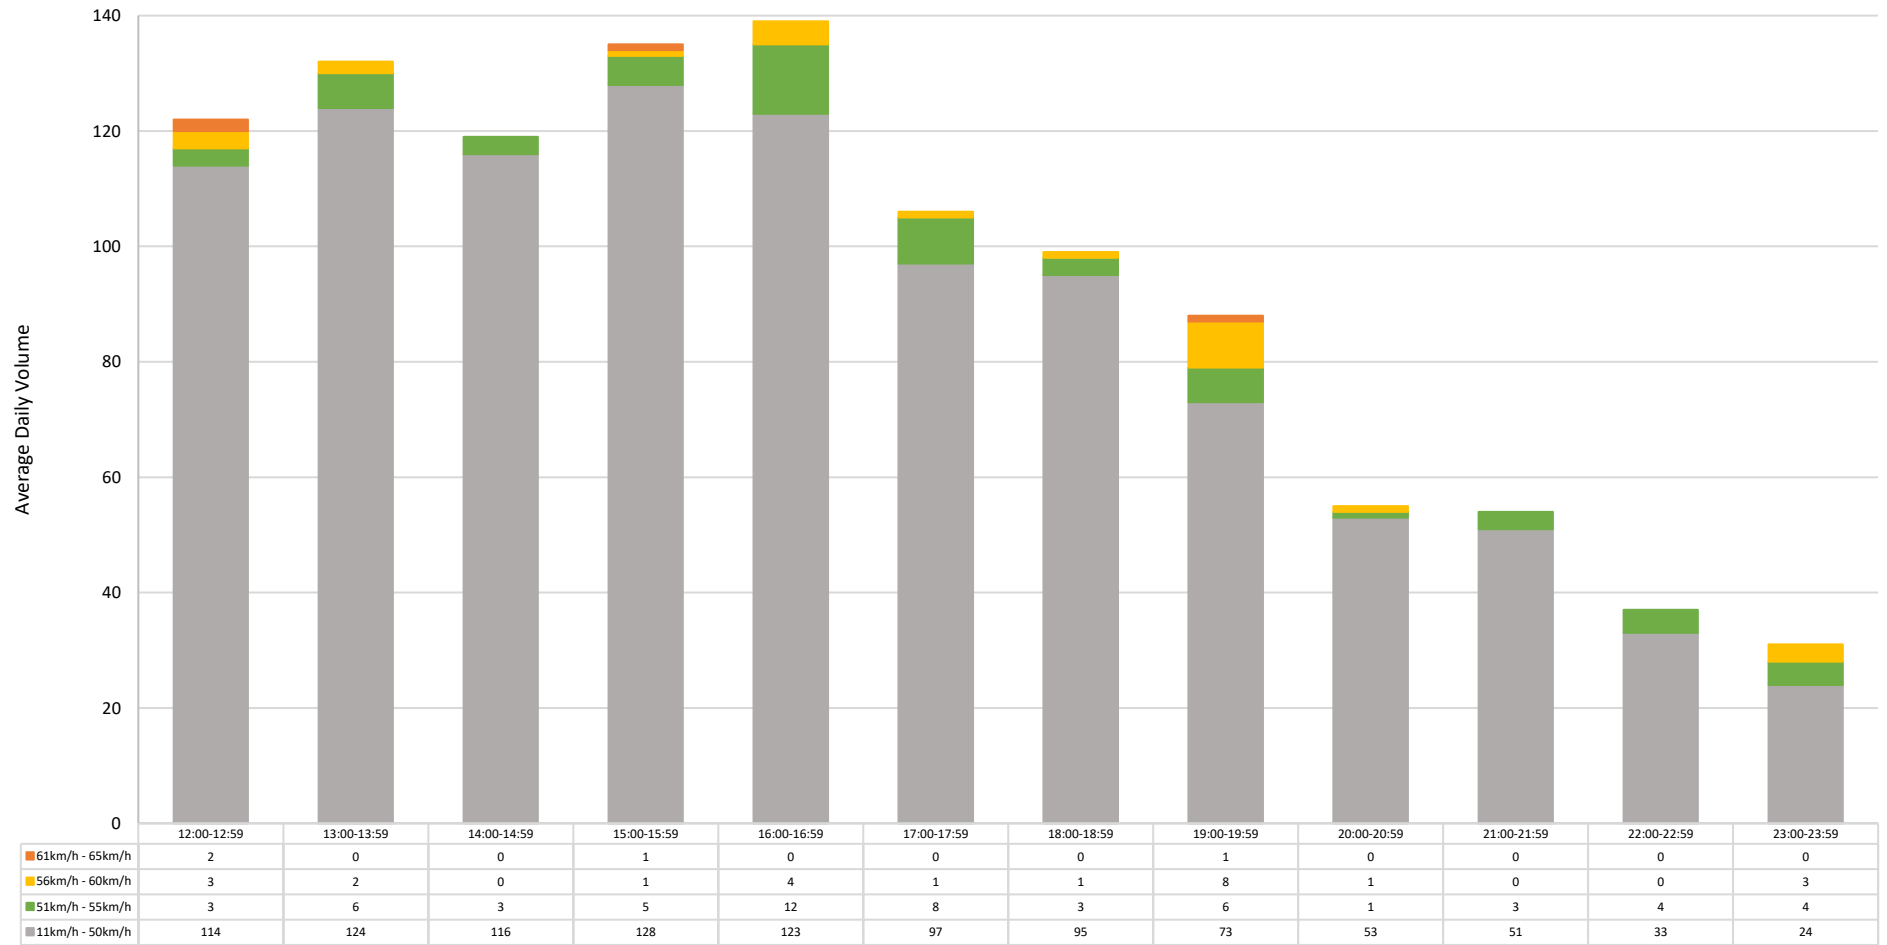
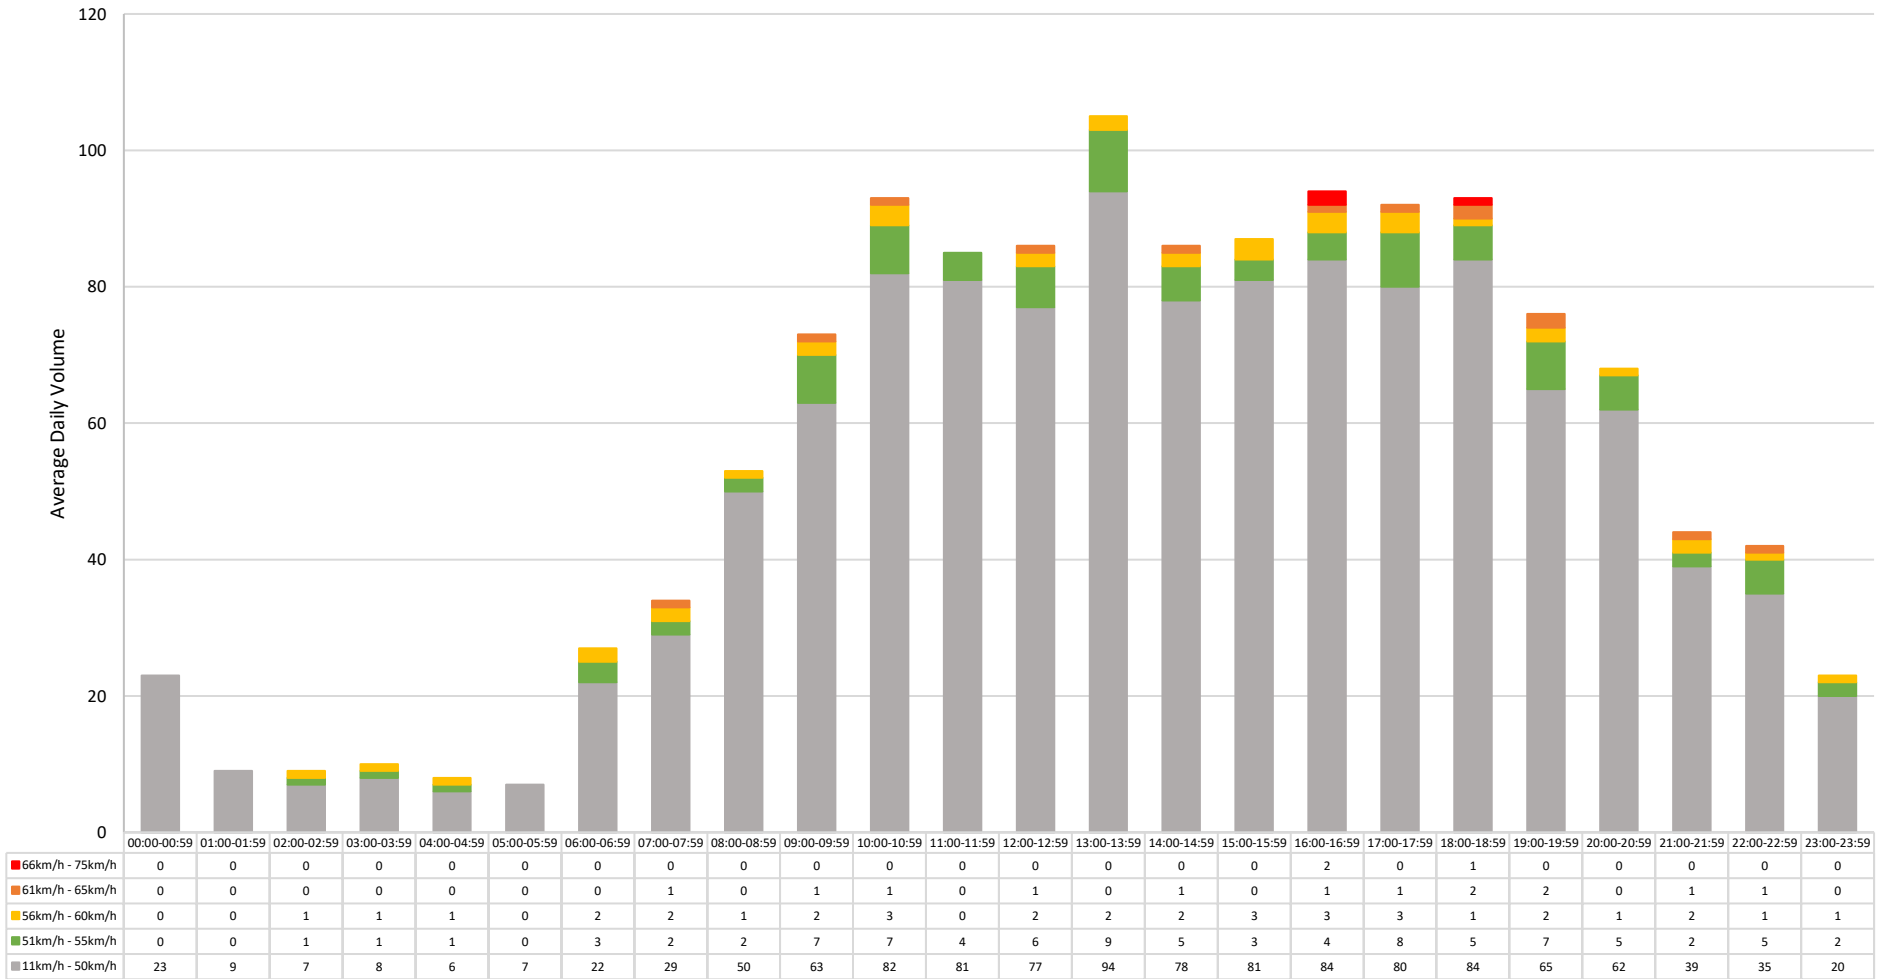
Figure 5. Speed by Hour Analysis for Southbound (Aug 16th, 2019)

Figure 6. Speed by Hour Analysis for Southbound (Aug 17th to Aug 18th, 2019)

Figure 5 and 6 are the speed by hour graph used to determine the time where most speeding occurs. The graphs highlight that there were more vehicles speeding in the afternoon on the weekend (Aug 17th to Aug 18th) than on a weekday. It should be noted that due to the time of day the trailer was relocated to the southbound direction it was unable to collect data during the morning of August 16th. Based on the low volume of speeding that occurred, there are no speeding concerns in the southbound direction.

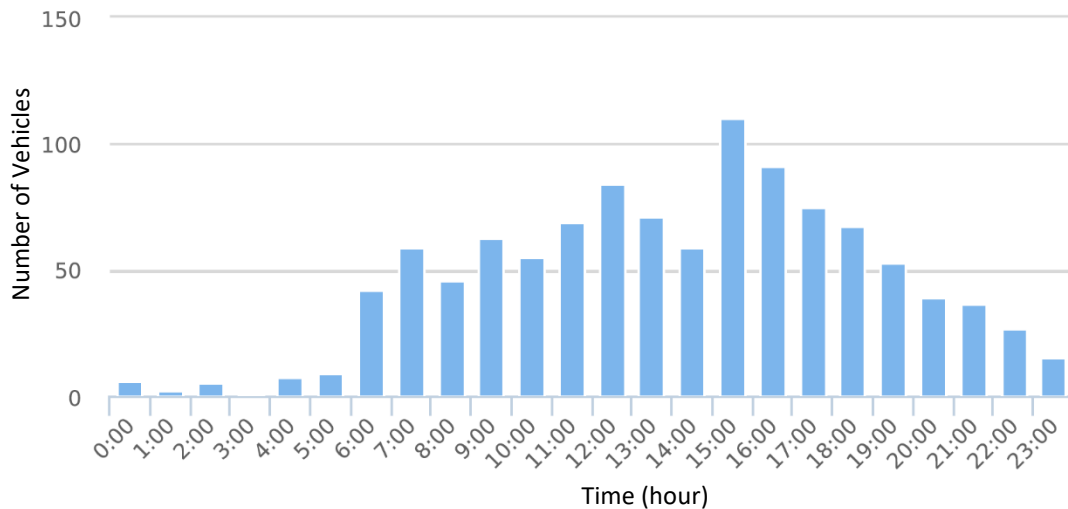
Figure 7. Average Volume by Hour from Aug 14th (Northbound)

The data collected for the full day (Aug 14th) is used to analyze the average traffic volume at different times of a day (Figure 7). From the graph, Fifth Street has peak traffic during the typical evening commute time.

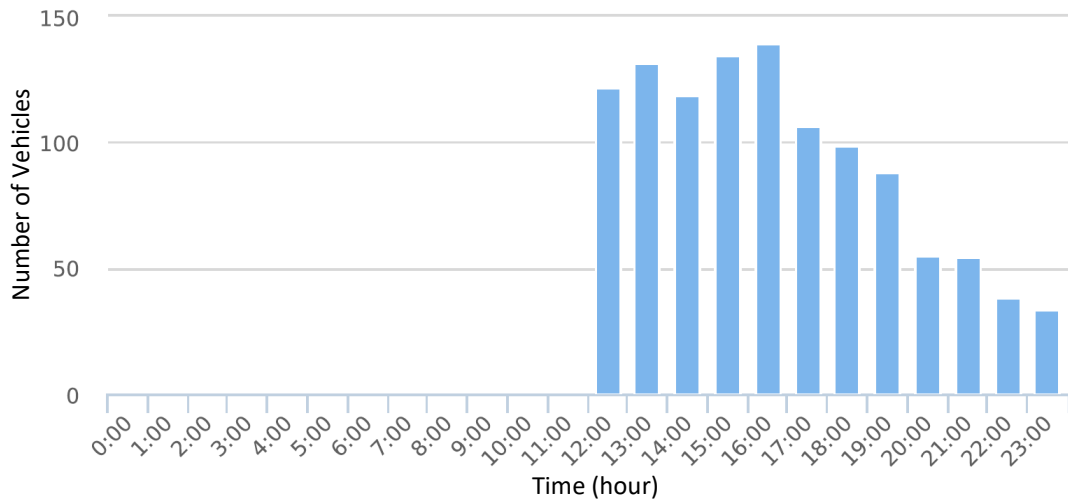
Figure 8. Volume by Hour on Aug 16th (Southbound)

The data collected on August 16th is used to analyze the average traffic volume at different times of a day (Figure 8). From the data collected, Fifth Street had peak traffic during the typical evening commute time on the weekday in the southbound direction. Again, it should be noted that due to the time of date that the trailer was relocated to the southbound direction it was unable to collect data for the morning on August 16th.

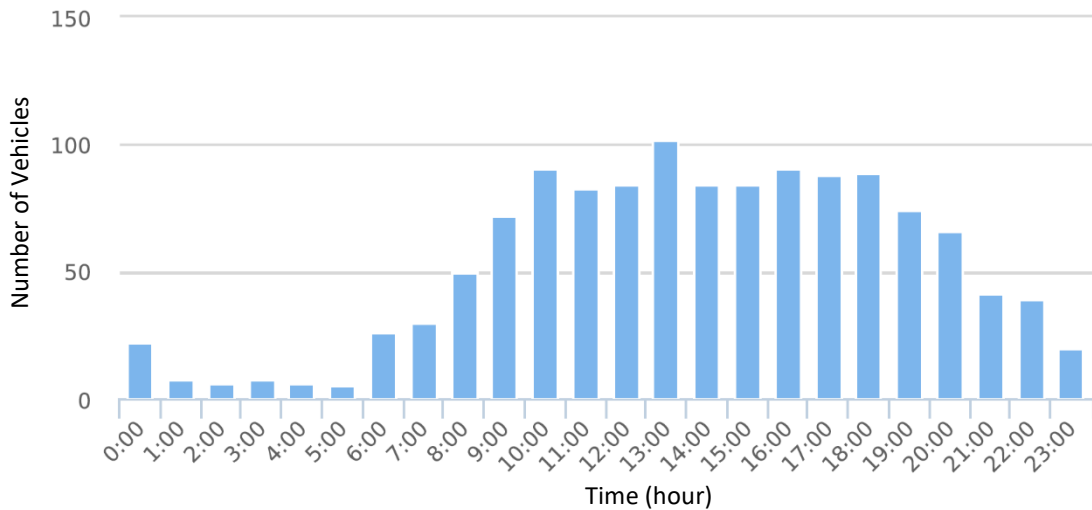
Figure 9. Average Volume by Hour on August 17th to August 18th (Southbound)

The data collected from August 17th to August 18th (weekend) is used to analyze the average traffic volume at different times of the day as shown in Figure 9. From the graph, the traffic on the weekend in the southbound direction has a peak volume between 1pm and 2pm.
