# Traffic Data Analysis

Victoria St.

Town of Midland

Engineering Department

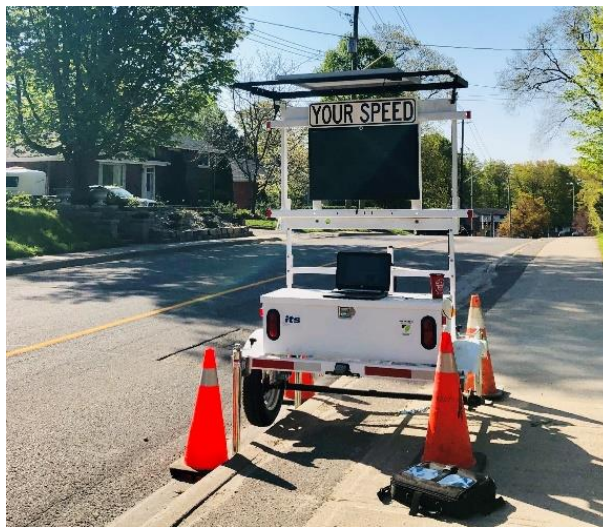
**Figure 1. Traffic Trailer**

The traffic trailer used was a model ATS-3 as shown in Figure 1. The traffic trailer is set to show the speed of approaching vehicles and display short messages depending on the speed. The traffic trailer uses radar to detect vehicles and collect data and grouped data into one-hour intervals.

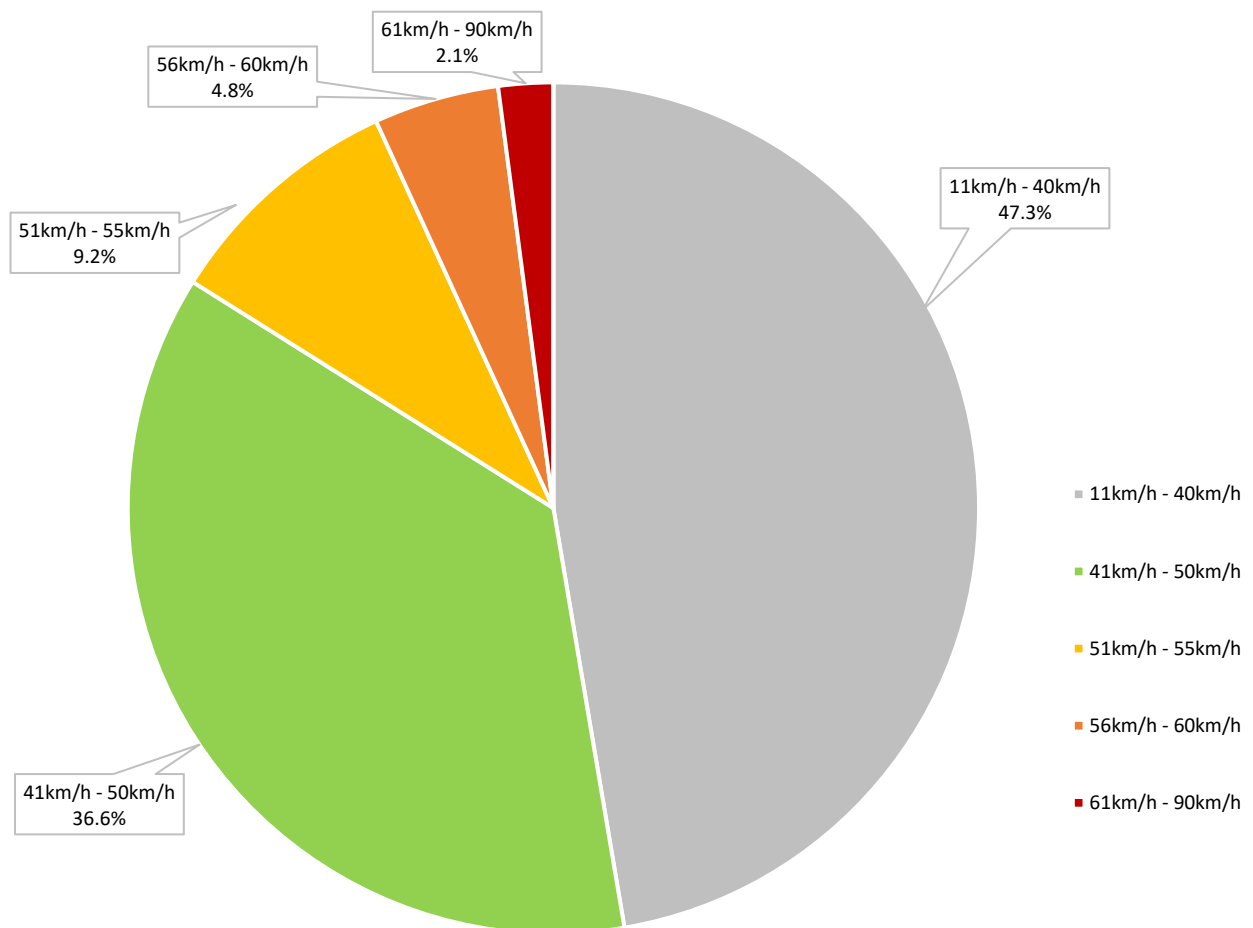
**Figure 2. Victoria St. Eastbound Speed Breakdown**

From Figures 2 and 3, we can see that **83.9%** of vehicles were travelling below the posted speed limit, **14%** of vehicles were travelling between 51-60 km/h, and **2.1%** of vehicles were travelling above 60km/h. As previously stated, it is generally accepted to travel 10km/h over the posted speed limit. With that said, we find that a total of **97.9%** of vehicles were travelling within the accepted speed limit in the Eastbound direction.

Figure 2 and 3 below show the speed summary for the **Eastbound traffic**.

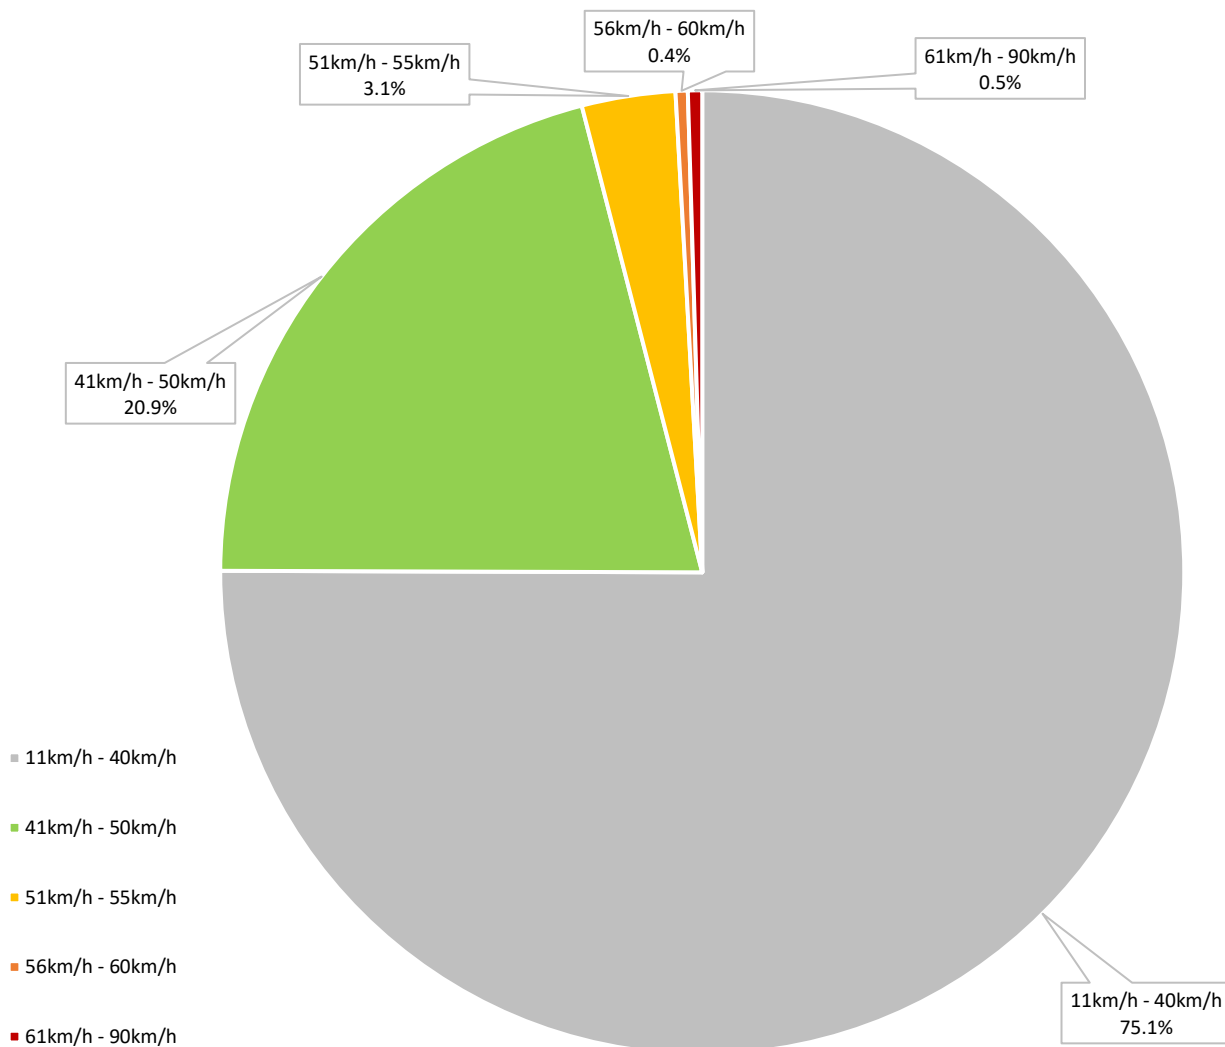
**Figure 4. Victoria St. Westbound**

From Figures 4 and 5 we can see that **96%** of the vehicles were travelling below the posted speed limit, **3.5%** of vehicles were travelling between 51-60 km/h, and **0.5%** of vehicles were travelling above 60km/h. When we consider the acceptable to travel 10km/h over the posted speed limit, we find that **99.5%** of vehicles were driving within the acceptable range. The overall average speed is lower in the Westbound direction compared to Eastbound. This is most likely due to the topography and vehicles are travelling uphill following a turn from Fourth Street and still accelerating.

Figure 4. and 5. show the speed summary for the **Westbound traffic**.

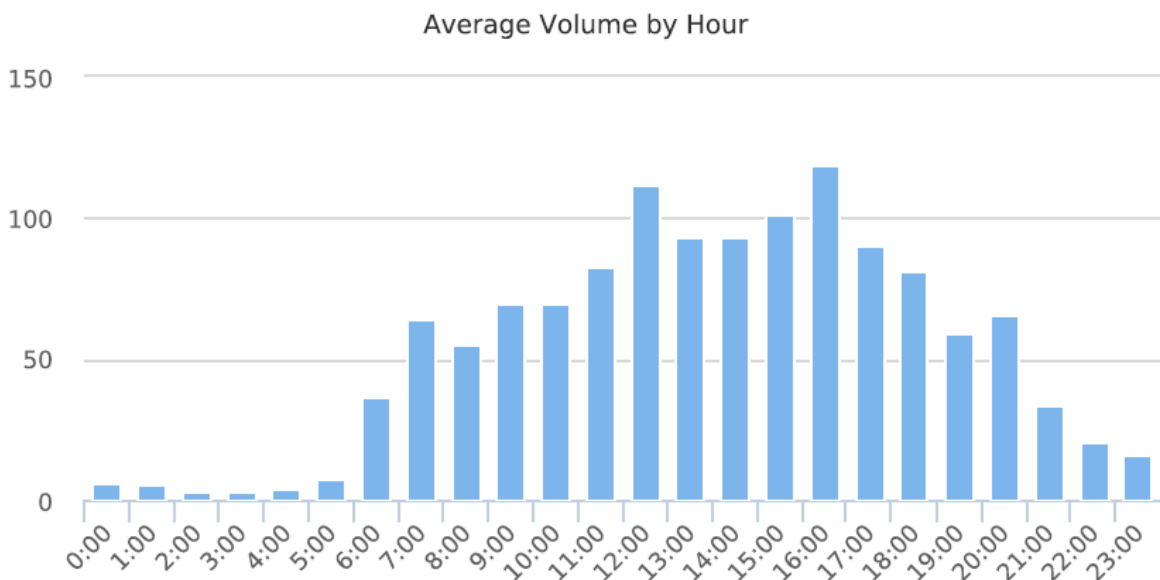
**Figure 6. Average Volume by Hour (Eastbound)**

The data collected from **August 20<sup>th</sup>** and **August 21<sup>st</sup>** is used to analyze the average traffic volume at different times of day (Figure 6). From the graph, Victoria St has peak traffic during the typical evening rush hour and noon.

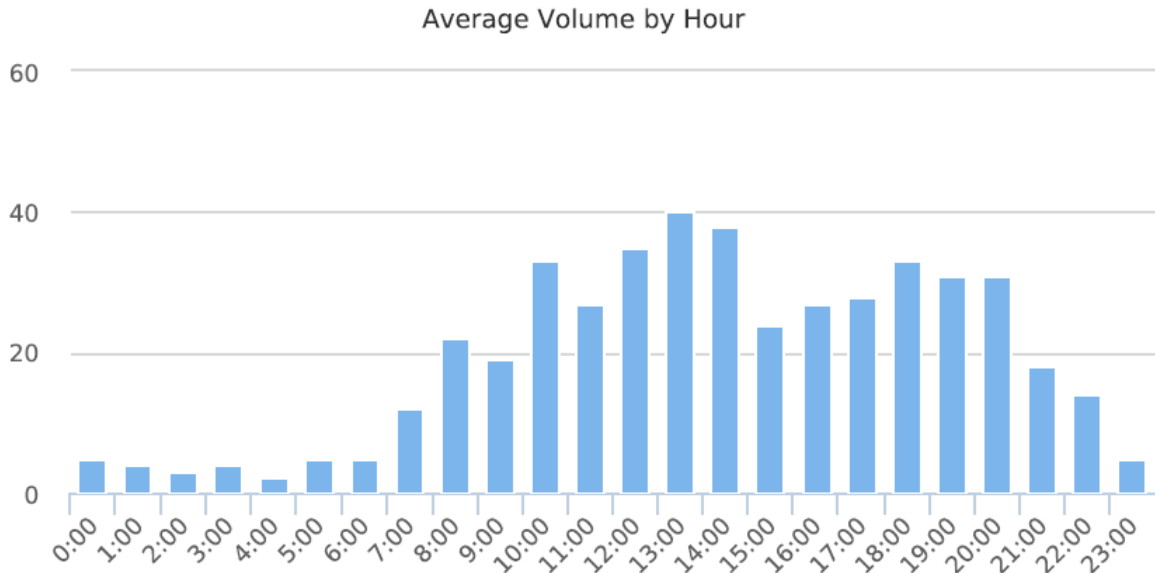
**Figure 7. Average Volume by Hour (Westbound)**

The data collected from **August 24<sup>th</sup>** to **August 25<sup>th</sup>** is used to analyze the average traffic volume at different times of day (Figure 7). From the graph, Victoria St. Has peak traffic just after noon and in the evening around 8pm.
