Traffic Data Analysis

William St.

Northbound and Southbound

Town of Midland
Engineering Department

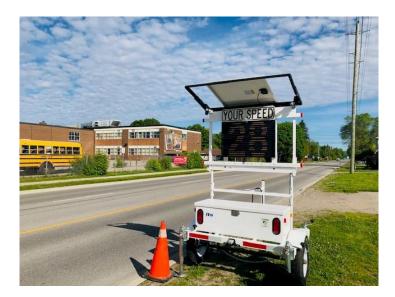
Figure 1. Traffic Trailer

The traffic trailer used was model ATS-3 as shown in the Figure 1. The traffic trailer is set to display the speed of the approaching vehicle and display short messages depending on the speed. The traffic trailer uses radar to detect vehicles and group collected data into 1-hour intervals. The speed limit in this community safety zone changes at different time of a day according to school times. Therefore, the challenge was to change the settings on the trailer to correspond this schedule.

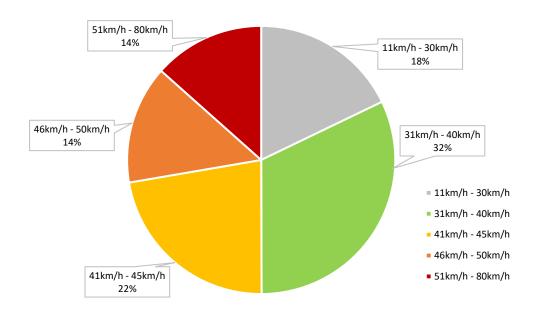
Figure 2. William St. Northbound (speed limit: 40km/h)

Figure 2 below shows that 50% of vehicles were travelling below the school times speed limit, 36% of vehicles were travelling between 41-50 km/h, and 14% of vehicles were travelling above 50km/h. When we consider the accepted speed limit is 10km/h over the school times speed limit, we find that a total of 86% of vehicles were travelling within the accepted speed limit.

Figure 2 and 3 below are the speed summary for the northbound traffic.

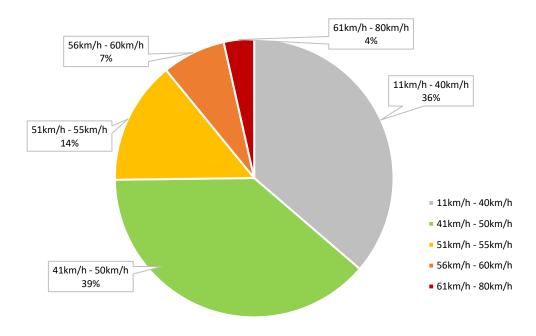
Figure 3. William St. Northbound (speed limit: 50km/h)

Figure 3 below shows that 75% of vehicles were travelling below the posted speed limit, 21% of vehicles were travelling between 51-60 km/h, and 4% of vehicles were travelling above 60km/h. When we consider the accepted speed limit is 10km/h over the posted speed limit, we find that a total of 96% of vehicles were travelling within the accepted speed limit.

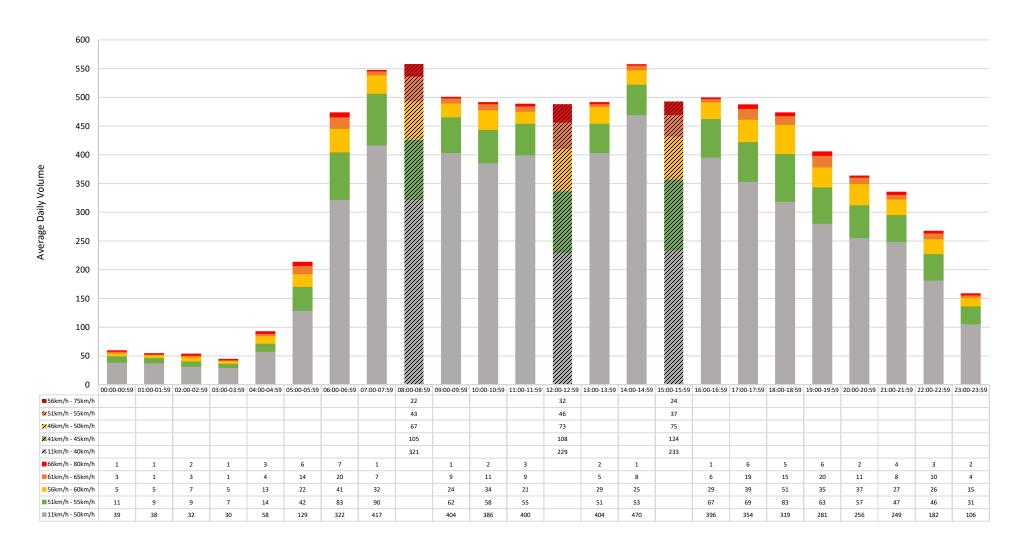
Figure 4. Speed by Hour Analysis for Northbound (weekday)

Figure 4 is the speed by hour graph in the northbound direction from June 17th to June 20th (weekday).

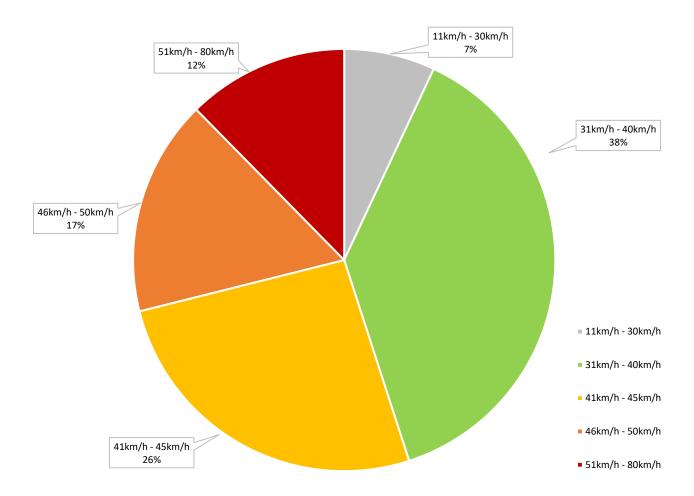
Figure 5. William St. Southbound (speed limit: 40km/h)

Figure 5 above shows that 45% of vehicles were travelling below the school times speed limit, 43% of vehicles were travelling between 41-50 km/h, and 12% of vehicles were travelling above 50km/h. When we consider the accepted speed limit is 10km/h over the school times speed limit, we find that a total of 88% of vehicles were travelling within the accepted speed limit.

Figure 5 and 6 below are the speed summary for the southbound traffic.

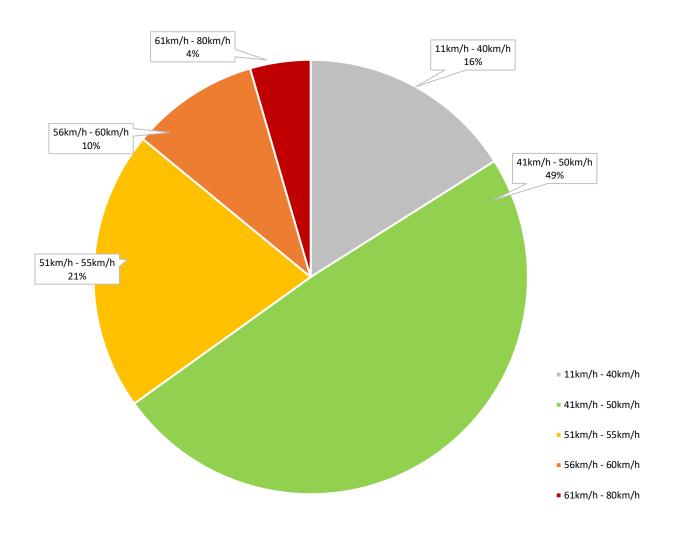
Figure 6. William St. Southbound (speed limit: 50km/h)

Figure 6 above shows that 65% of vehicles were travelling below the posted speed limit, 31% of vehicles were travelling between 51-60 km/h, and 4% of vehicles were travelling above 60km/h. When we consider the accepted speed limit is 10km/h over the posted speed limit, we find that a total of 96% of vehicles were travelling within the accepted speed limit.

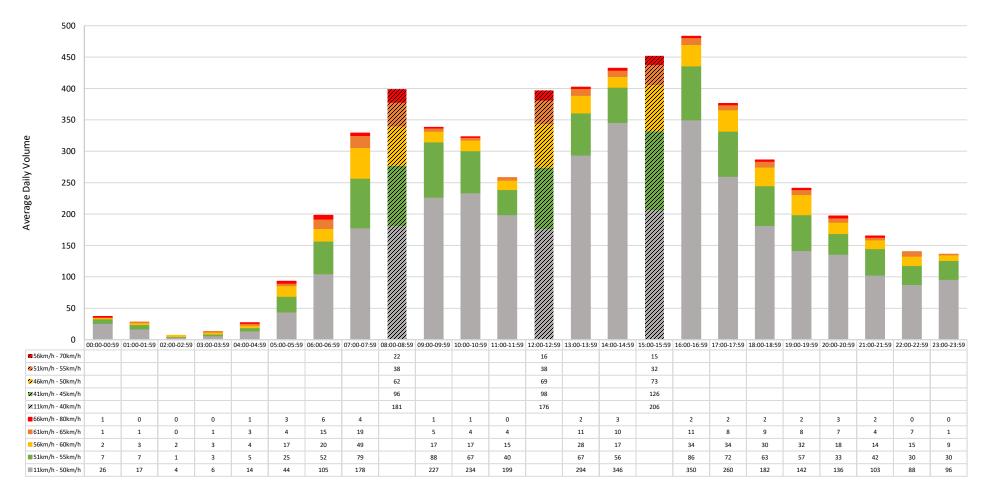
Figure 7. Speed by Hour Analysis for Southbound (weekday)

Figure 7 and 8 below are the speed by hour graph for weekdays (June 20^{th} – June 21^{st}) and the weekend (June 22^{nd} – June 23^{rd}) in the southbound direction.

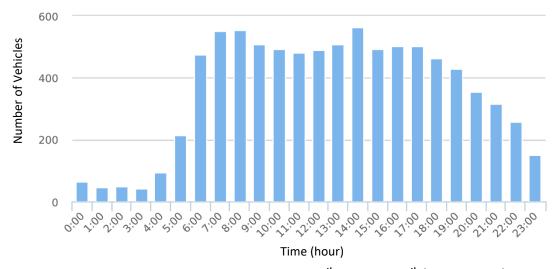
Figure 9. Average Volume by Hour on June 18th and June 19th (Northbound)

Figure 9 shows the average volume of vehicles travelling northbound of William St on June 18th and June 19th. It is noticed that the peak traffic occurs at typical morning and evening rush hours on a weekday in the northbound direction.

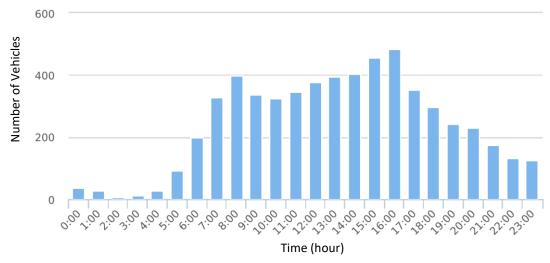
Figure 10. Volume by Hour on June 21st (Southbound)

The data collected on June 21st (Friday) is used to analyze the traffic volume by hour on a weekday in the southbound direction as shown in Figure 10. The school hours at the Sacred Heart Catholic School is from 08:45 to 15:00, and it appears that the peak traffic in the southbound direction occurs during when school starts and ends.

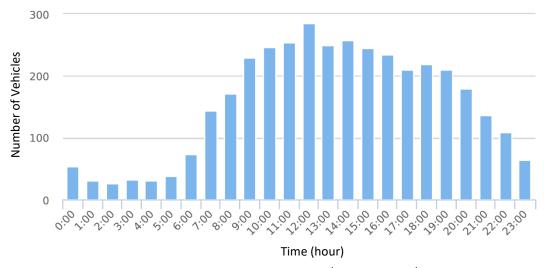
Figure 11. Average Volume by Hour on June 22nd and June 23rd (Southbound)

Figure 11 shows the average traffic volume on the weekend from June 22nd to June 23rd. It is noticed that the traffic volume pattern is quite different from a weekday. The volume of the traffic on the weekend continues to increase, peak around noon and decrease in the afternoon.
