Traffic Data Analysis

Harbourview Drive
Eastbound and Westbound

Town of Midland
Engineering Department

September 17, 2021

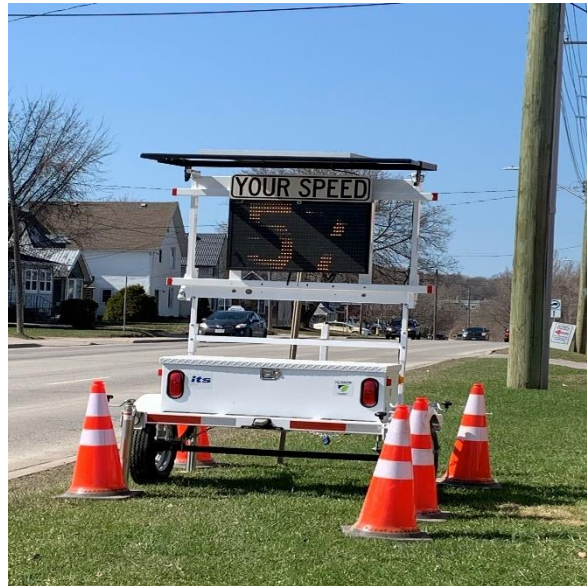
Figure 1- Traffic Trailer

The traffic trailer used was model ATS-3 as shown in Figure 1. The traffic trailer is set to not show the speed as the display was turned off for the duration of this location. The data is collected and grouped into one-hour intervals.

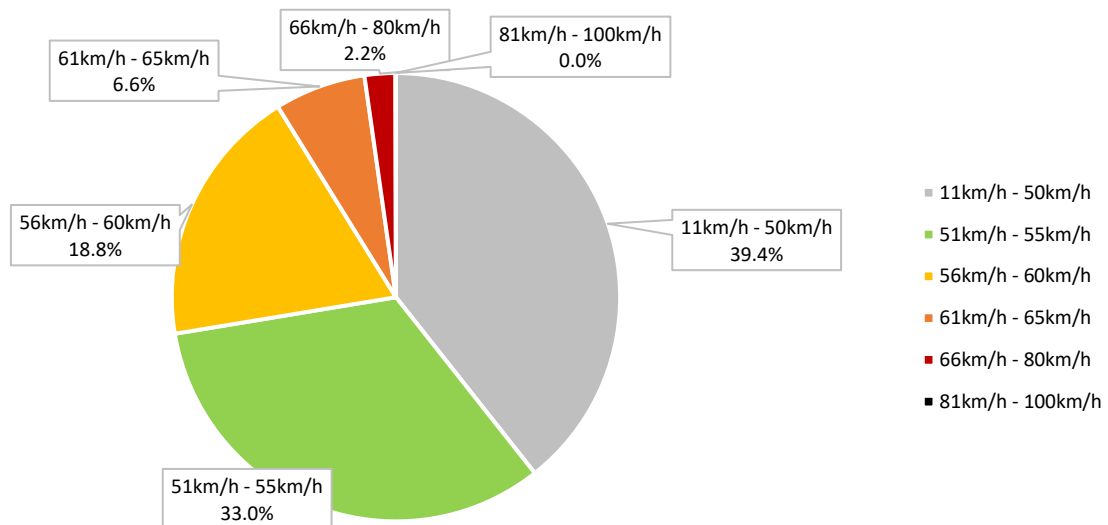
Figure 2- Harbourview Drive Eastbound

Figure 2 above shows that 39.4% of vehicles were travelling below the posted speed limit, 51.8% of vehicles were travelling between 51-60 km/h, and 8.8% of vehicles were travelling above 60km/h. Considering the accepted speed limit is 10km/h over the posted speed limit, a total of 91.2% of vehicles were travelling within the accepted speed limit in the eastbound direction.

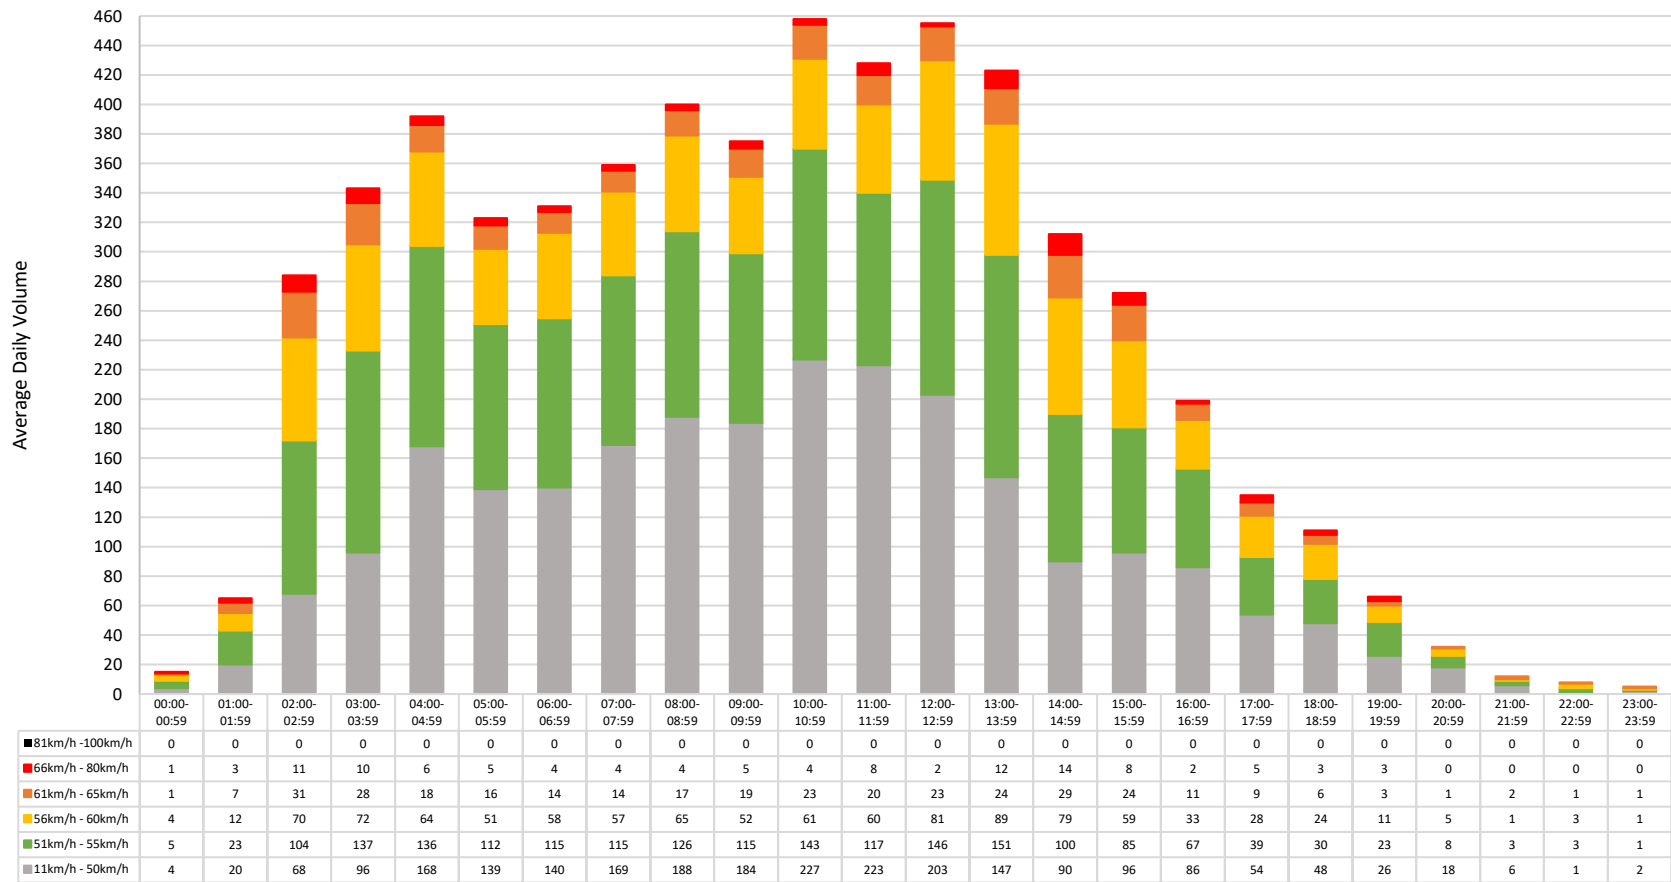
Figure 3- Speed by Hour Analysis for Eastbound Weekdays

Figure 3 above is the speed by hour graph used to determine the time where most speeding occurs on weekdays. The data shows that speeding formed a “u” shape as it increased in the morning and declined throughout the afternoon. It reached its peak from 10:00am to 1:00pm and begins to decline again. There was also an additional spike at 4:00am.

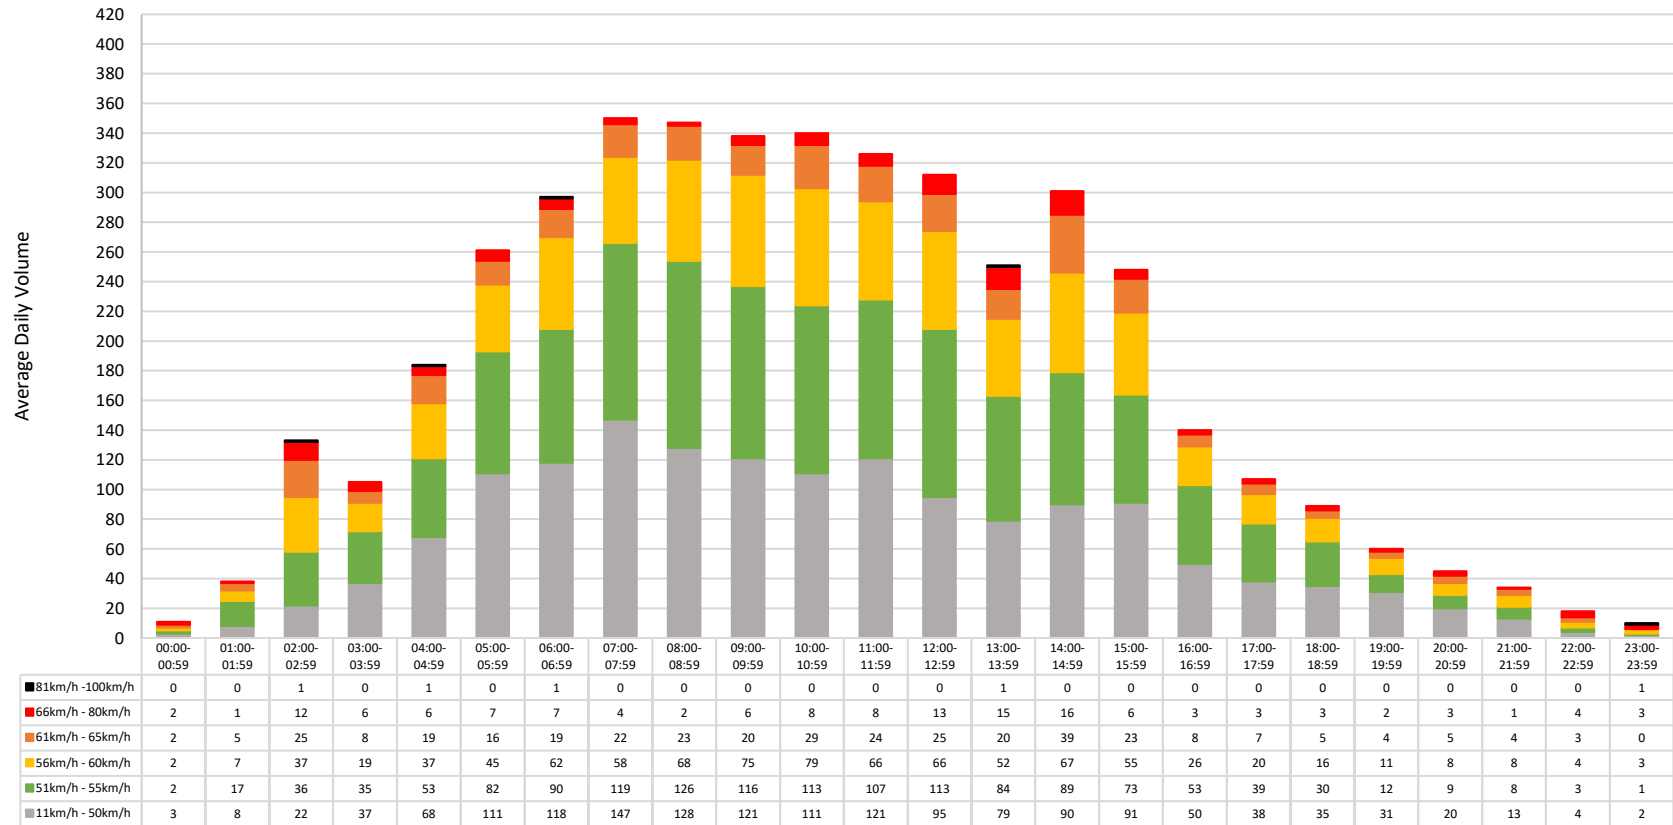
Figure 4 Speed by Hour Analysis for Eastbound Weekends

Figure 4 above is the speed by hour graph used to determine the time where most speeding occurs on the weekend. The data shows that speeding was low at night and began to increase around 5:00 am before beginning to decline again at 3:00pm. The speeding reached a peak from 7:00am until 10:00am.

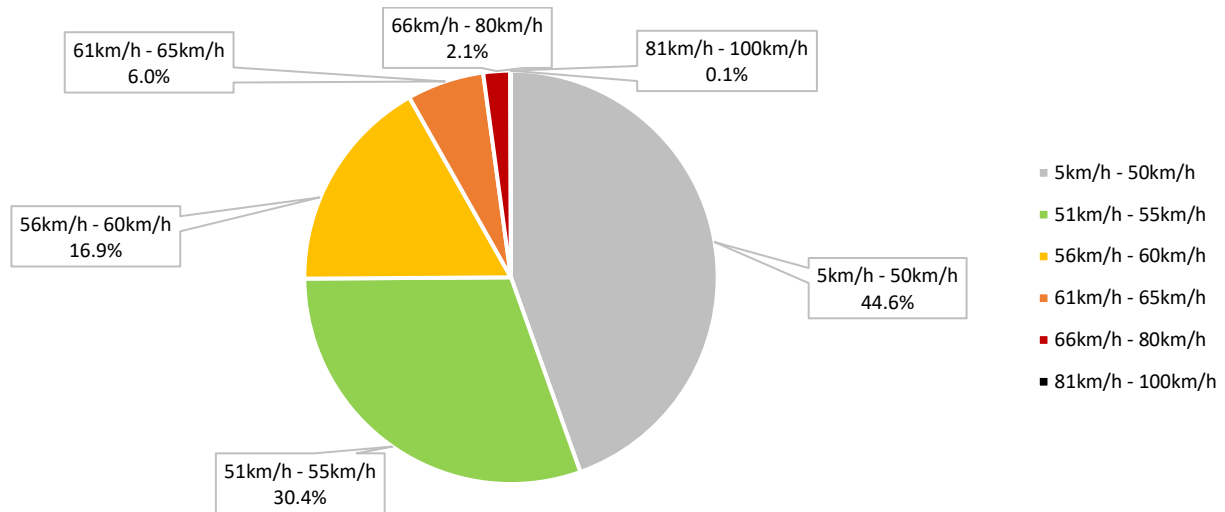
Figure 5- Harbourview Drive Westbound

Figure 5 above shows that 44.6% of vehicles were travelling below the posted speed limit, 47.3% of vehicles were travelling between 51-60 km/h, and 8.2% of vehicles were travelling above 60km/h. Considering the accepted speed limit is 10km/h over the posted speed limit, a total of 91.9% of vehicles were travelling within the accepted speed limit in the westbound direction.

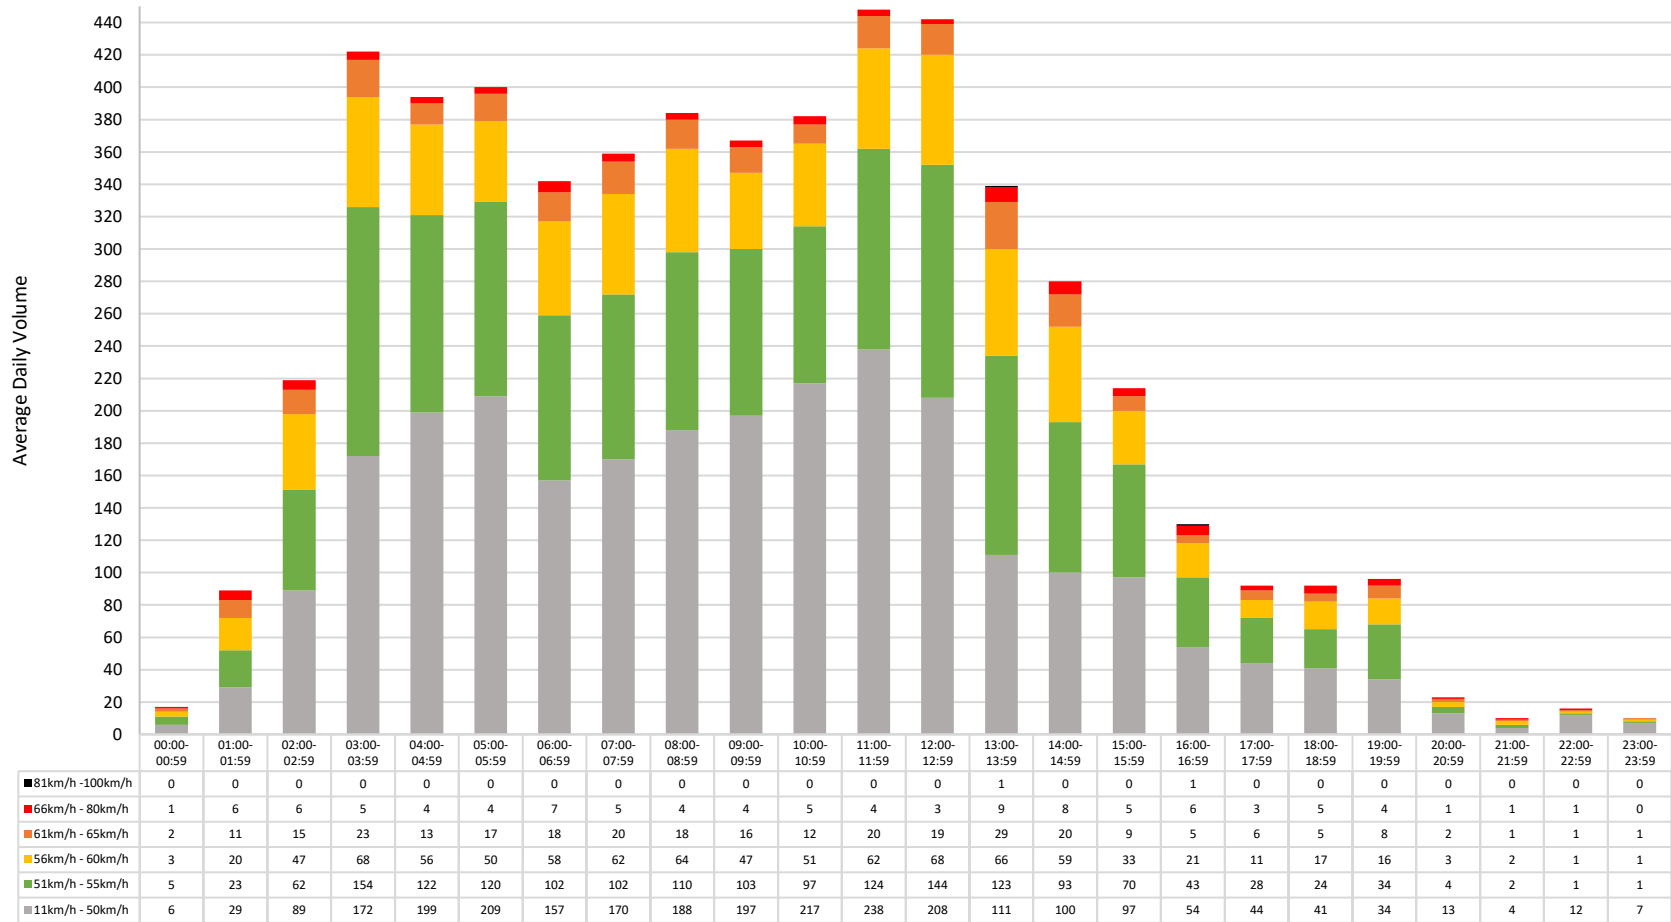
Figure 6- Speed by Hour Analysis for Westbound Weekdays

Figure 6 above is the speed by hour graph used to determine the time where most speeding occurs on weekdays. The data shows that speeding increased throughout the day until it reached its peak from 11:00am to 12:00pm and begins to decline again. There is an additional spike in speeding from 3:00am until 6:00am.

Figure 6 (weekday) and Figure 7 (weekend) above are the speed by hour graphs used to determine the time where most speeding occurs. The data shows that speeding was relatively consistent in the westbound and eastbound direction on weekdays and weekends having spikes from 6:00am to 10:00am.

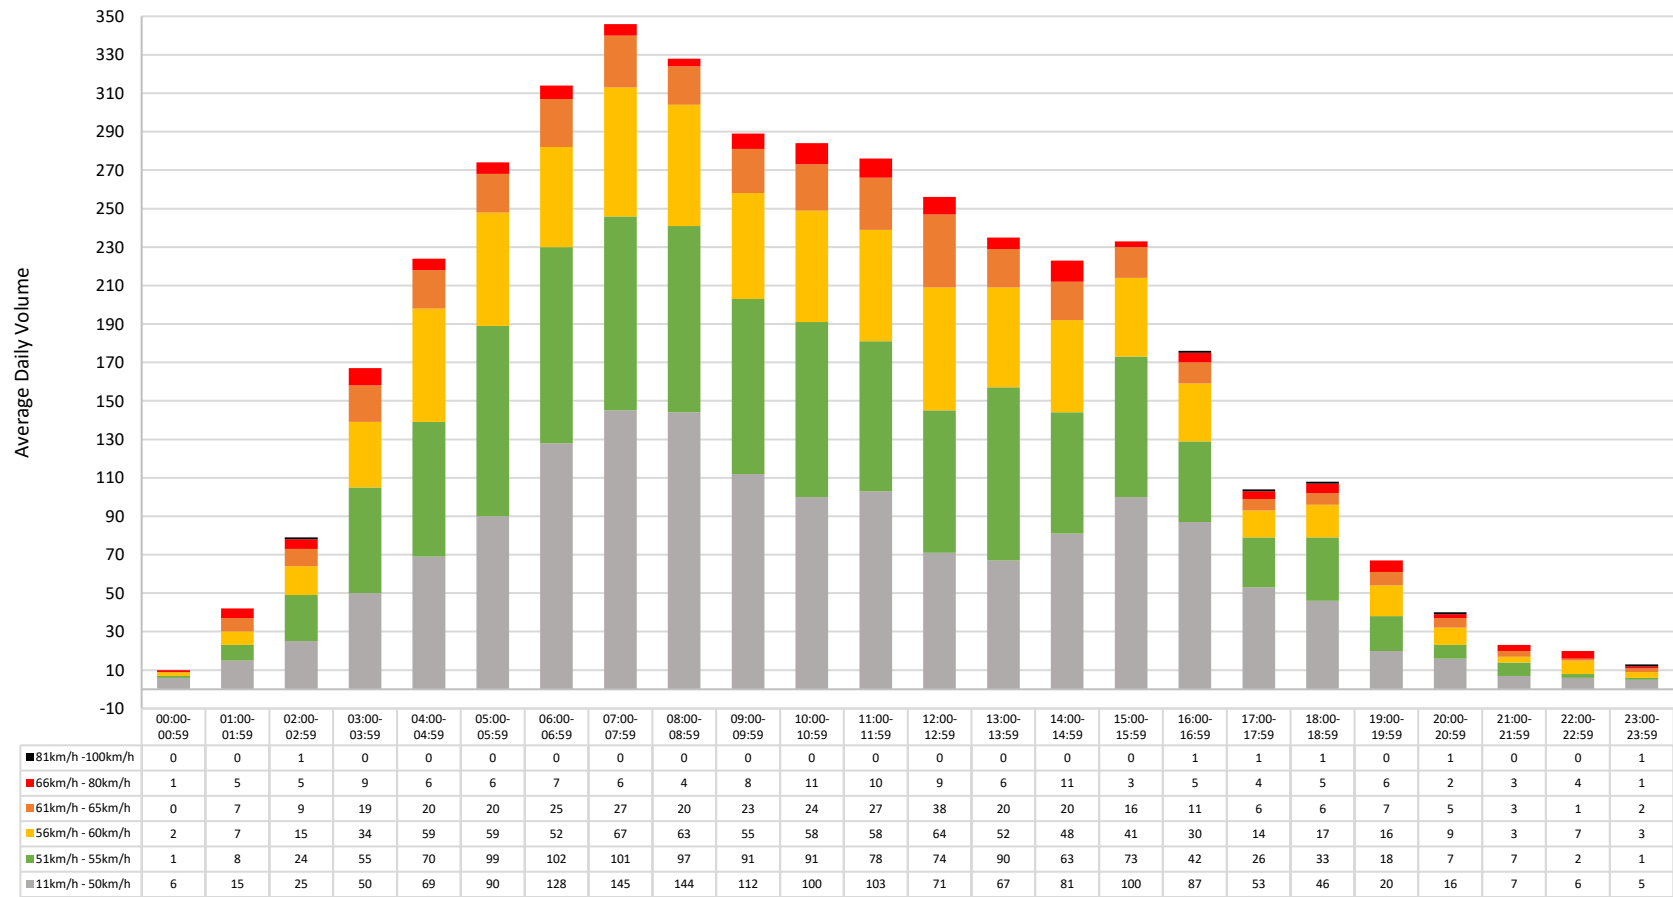
Figure 7- Speed by Hour Analysis for Westbound Weekends

Figure 7 above is the speed by hour graph used to determine the time where most speeding occurs on the weekend. The data shows that speeding was low at night and began to increase around 4:00 am before beginning to decline again at 8:00am. The speeding reached a peak from 7:00am until 8:00am.

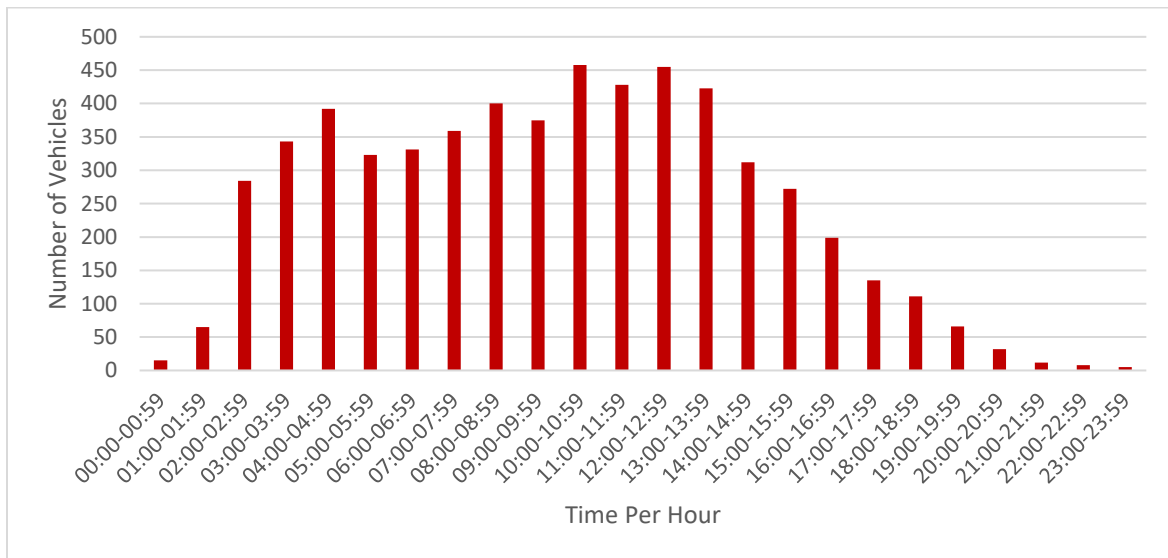
Figure 10 Average Volume per Hour from September 9th to September 10th and September 13th to September 14th (Eastbound)

As shown in Figure 10, on weekdays, peak traffic occurs from 10:00am to 1:00pm in the eastbound direction. Figure 11 shows that on weekends, the peak occurs between 8:00am and 12:00pm in the eastbound direction.

The data collected from September 9th to September 10th and September 13th to September 14th (weekdays) and September 11th to September 12th (weekend) are used to analyze the average traffic volume at different times of the day as shown in Figure 10 and Figure 11, respectively.

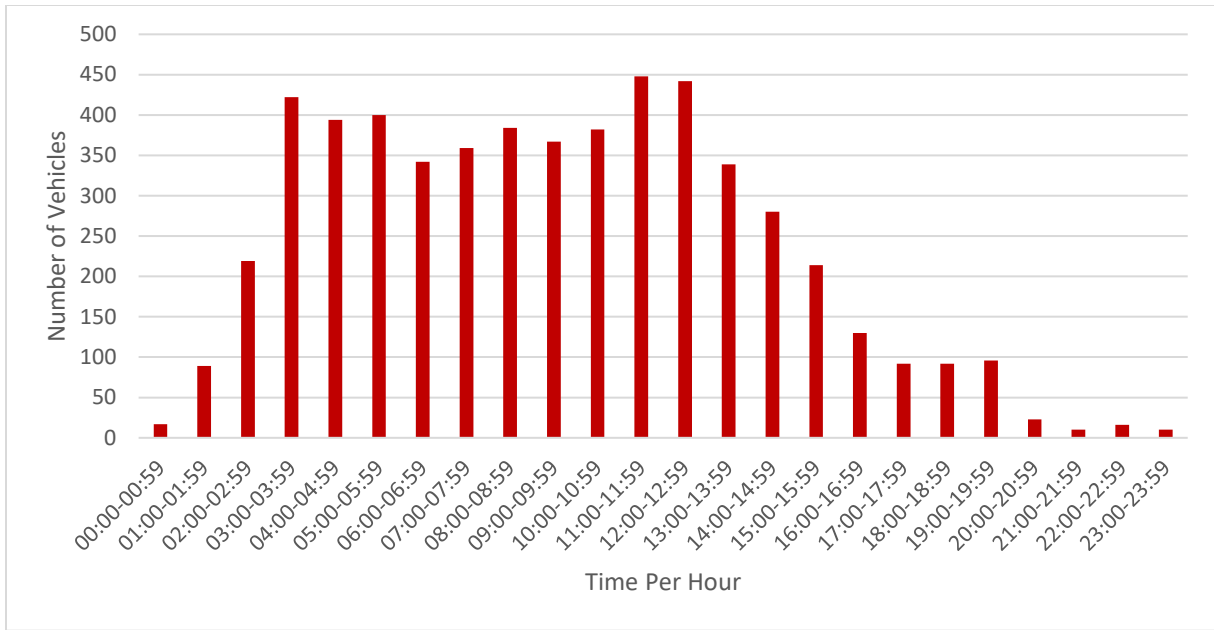
Figure 12- Average Volume by Hour from September 16th, 17th, 20th, 21st and 22nd (Westbound)

As shown in Figure 12, peak traffic occurs in the morning from 5:00am to 12:00am on the weekday in the westbound direction and there was a spike at 3:00am. On the weekend shown in Figure 13 a similar pattern was shown, there was a spike from 7:00am.

The data collected from September 16th, 17th, 20th, 21st and 22nd (weekdays) and September 18th and 19th (weekend) are used to analyze the average traffic volume at different times of the day as shown in Figure 12 and Figure 13, respectively.
