Traffic Data Analysis

Ottawa St.

Eastbound and Westbound

Town of Midland

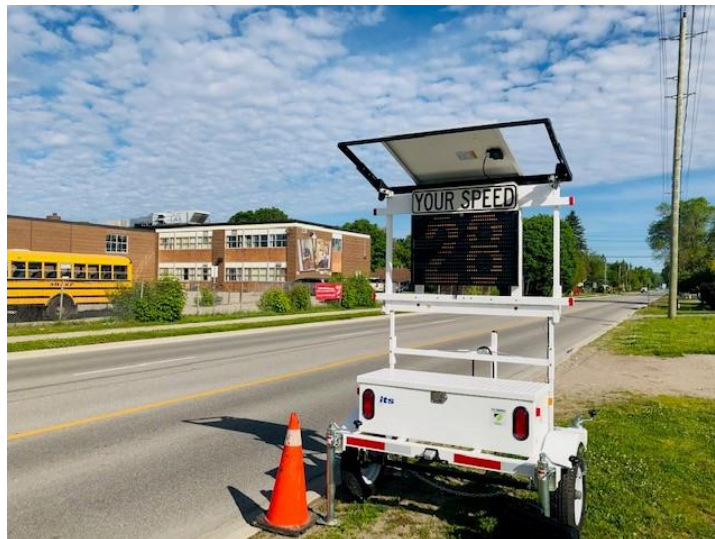
Figure 1. Traffic Trailer

The traffic trailer used was model ATS-3 as shown in the Figure 1. The traffic trailer is set to display the speed of the approaching vehicle and display short messages depending on the speed. The traffic trailer uses radar to detect vehicles and group collected data into 1-hour intervals. The speed limit in this community safety zone changes at different time of a day according to school times. Therefore, the challenge was to change the settings on the trailer to correspond this schedule.

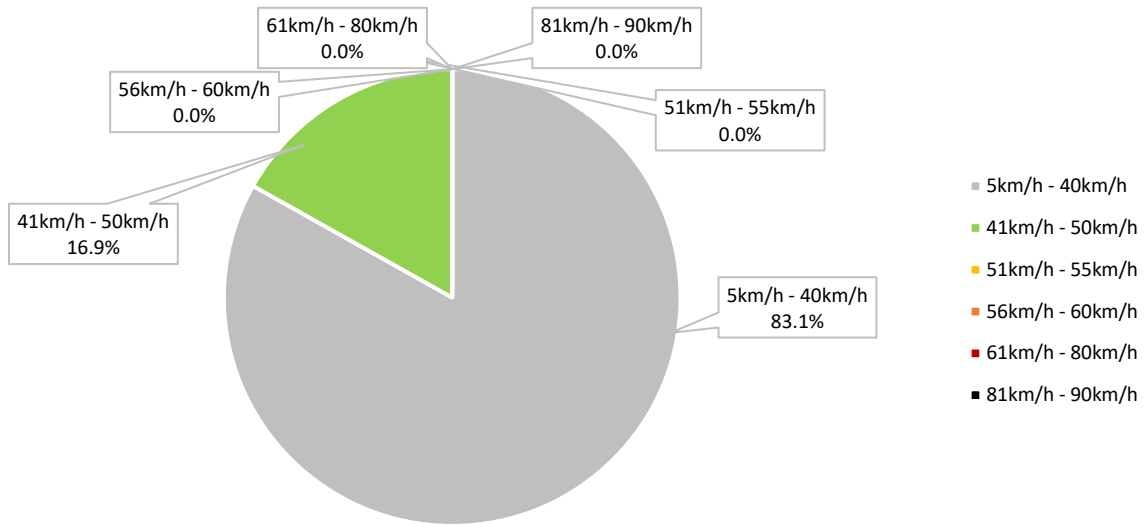
Figure 2. Ottawa St. Eastbound (speed limit: 40km/h)

Figure 2 represents when Ottawa St is 40km/hr for the community safety zone and shows that 83.1% of vehicles were travelling below the school times speed limit, 16.9% of vehicles were travelling between 41-50 km/h, and 0% of vehicles were travelling above 50km/h. When we consider the accepted speed limit is 10km/h over the school times speed limit, we find that a total of 100% of vehicles were travelling within the accepted speed limit.

Figures 2 and 3 below are the speed summary for the eastbound traffic.

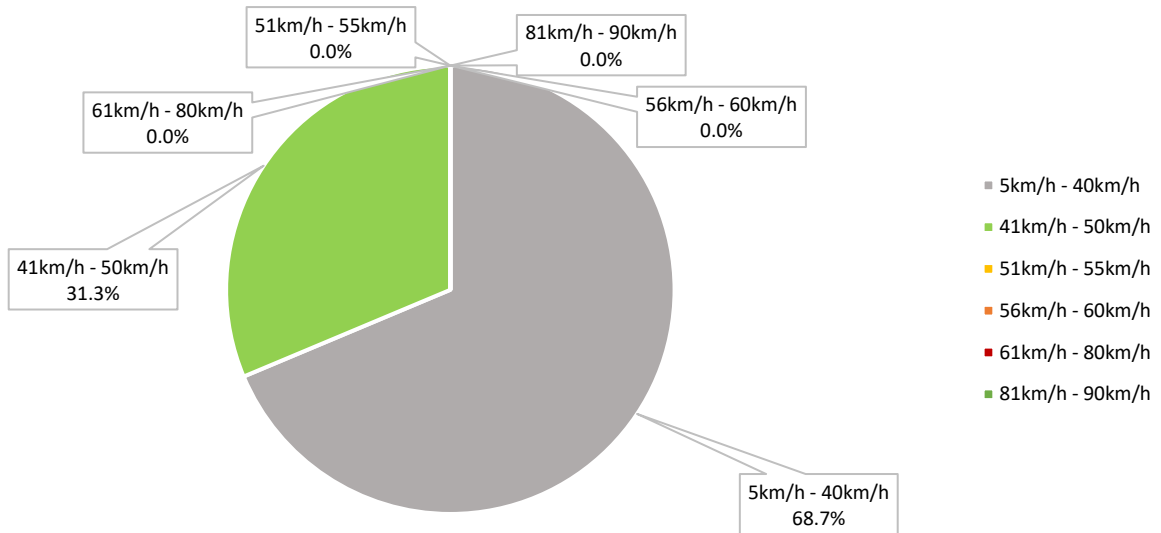
Figure 3. Ottawa St. Eastbound (speed limit: 50km/h)

Figure 3 represents when Ottawa St is 50km/hr and shows that 100% of vehicles were travelling below the posted speed limit, 0% of vehicles were travelling above 50km/h. When we consider the accepted speed limit is 10km/h over the posted speed limit, we find that a total of 100% of vehicles were travelling within the accepted speed limit.

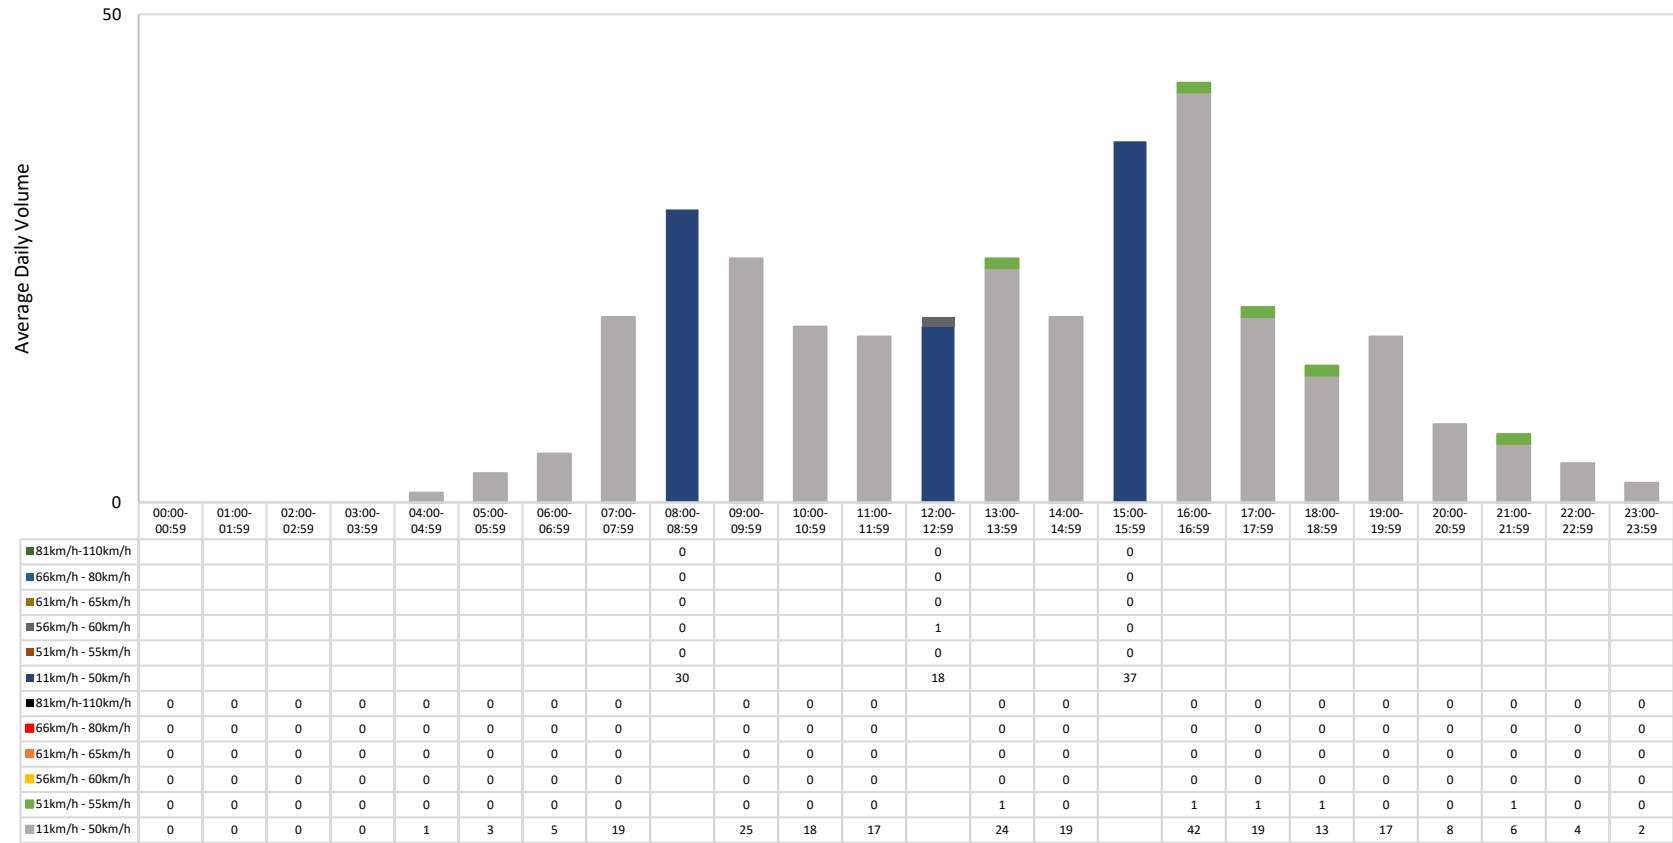
Figure 4. Speed by Hour Analysis for eastbound (weekday)

Figure 4 is the speed by hour graph in the eastbound direction from October 7th to October 14th (weekday).

Figures 4 and 5 are the speed by hour graph for weekdays (October 7th, 8th, 11th, 12th, 13th, and 14th) and the weekend (October 9th and 10th) in the eastbound direction.

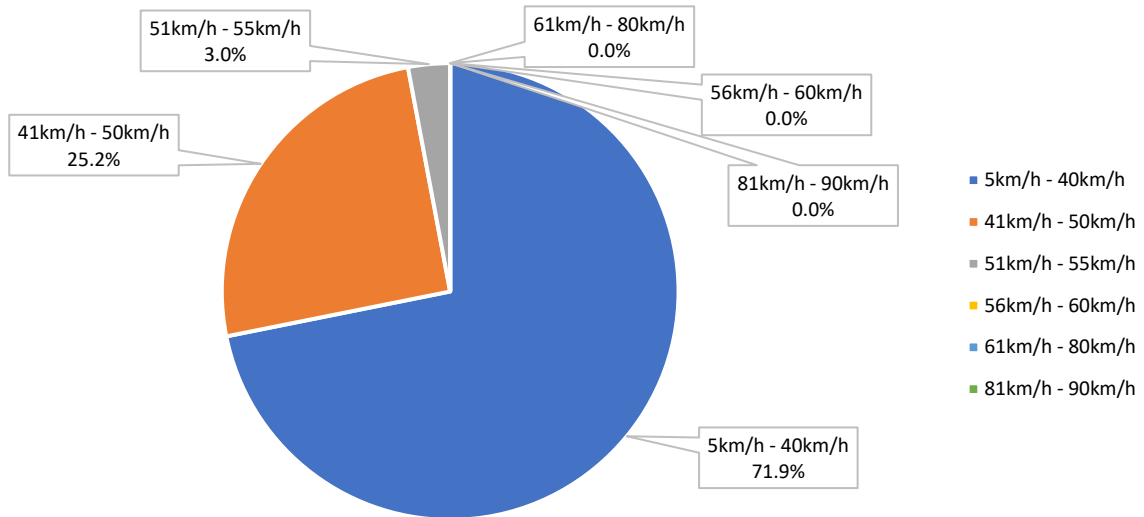
Figure 6. Ottawa St. Westbound (speed limit: 40km/h)

Figure 6 above shows that 71.9% of vehicles were travelling below the school times speed limit, 25.2% of vehicles were travelling between 41-50 km/h, and 3.0% of vehicles were travelling above 50km/h. When we consider the accepted speed limit is 10km/h over the school times speed limit, we find that a total of 97.1% of vehicles were travelling within the accepted speed limit in the community safety zone.

Figures 6 and 7 below are the speed summary for the southbound traffic.

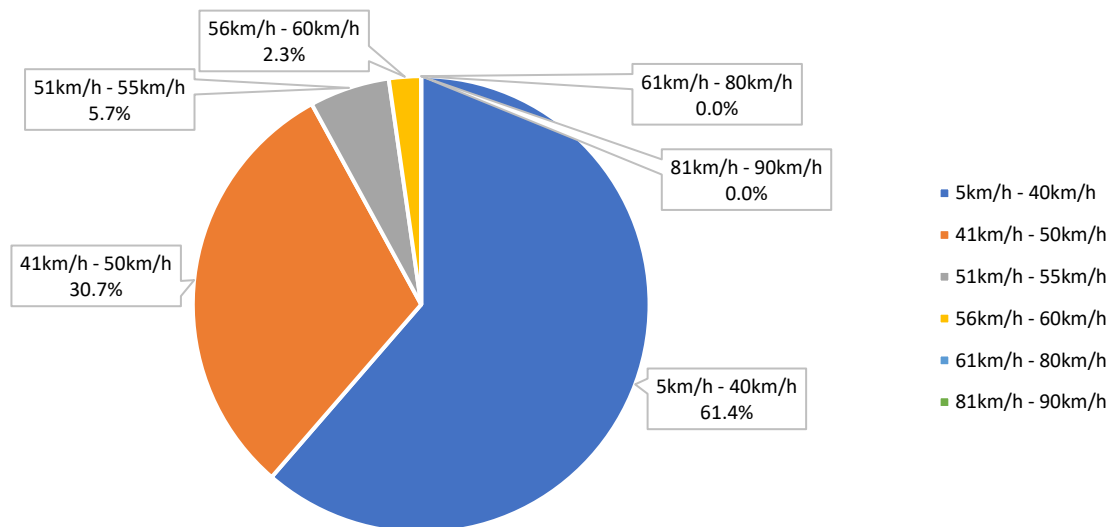
Figure 7. Ottawa St. Westbound (speed limit: 50km/h)

Figure 7 above shows that 92.1% of vehicles were travelling below the posted speed limit, 8.0% of vehicles were travelling between 51-60 km/h, and 0% of vehicles were travelling above 60km/h. When we consider the accepted speed limit is 10km/h over the posted speed limit, we find that a total of 100% of vehicles were travelling within the accepted speed limit.

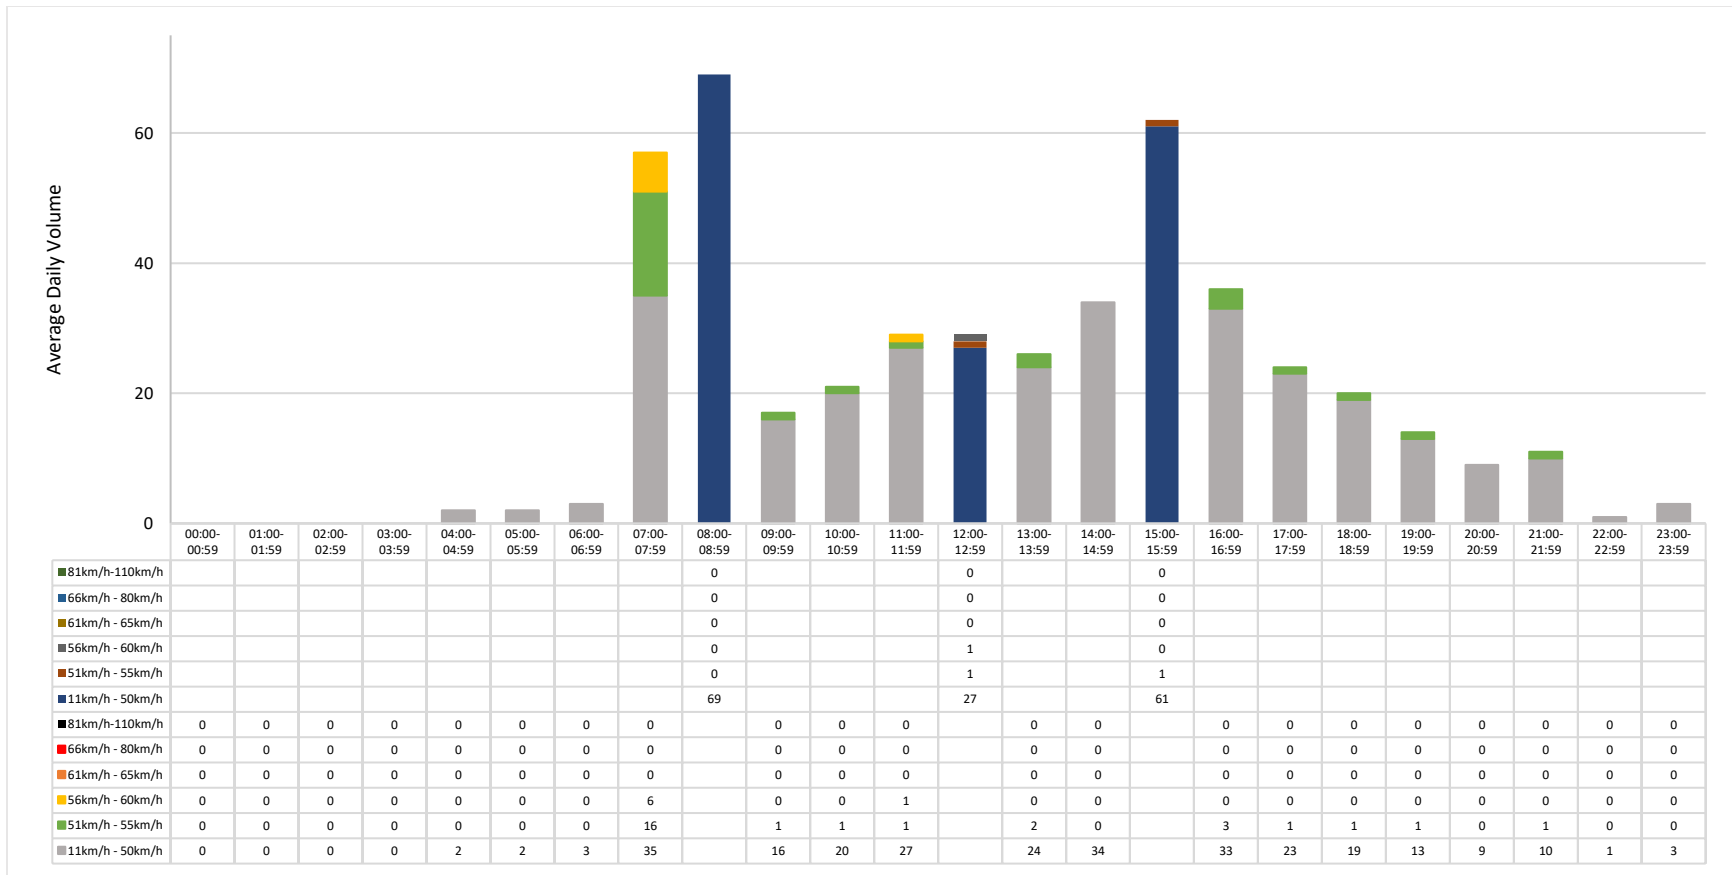
Figure 8. Speed by Hour Analysis for westbound (weekday)

Figures 8 and 9 below are the speed by hour graph for weekdays (October 14th, 15th, 18th, 19th, and 20th) and the weekend (October 16th and 17th) in the westbound direction.

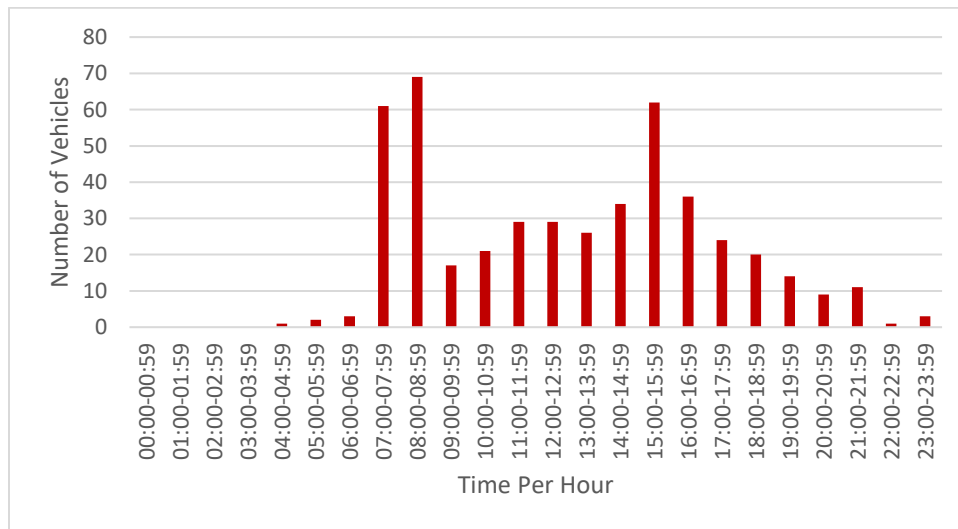
Figure 10. Average Volume by Hour on October 7th, 8th, 11th, 12th, 13th (weekday)

Figure 10 shows the average volume of vehicles travelling eastbound on Ottawa St on October 7th, 8th, 11th, 12th and 13th (weekday). It is noticed that the peak traffic occurs at typical morning and evening rush hours on a weekday in the eastbound direction with a spike around 7am.

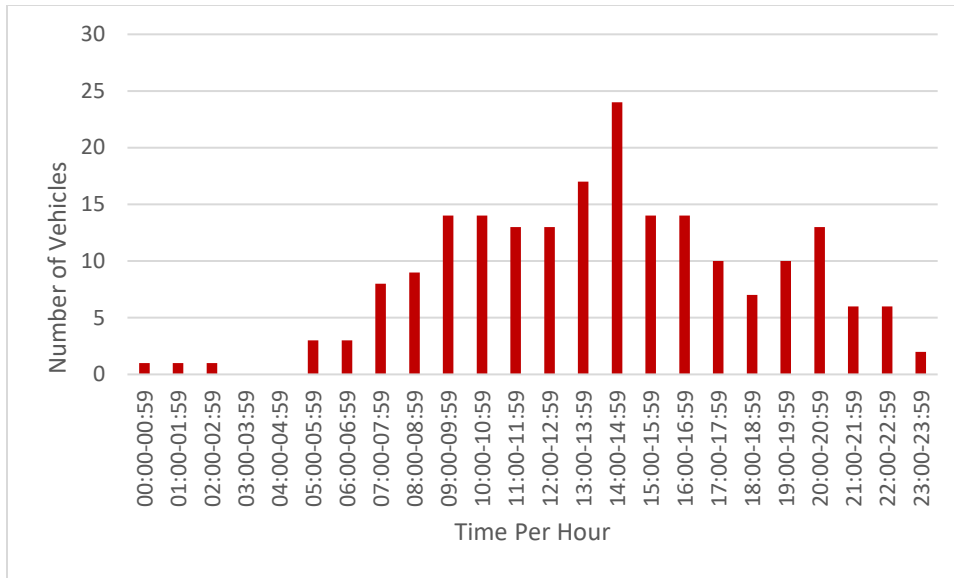
Figure 11. Average Volume by Hour on October 9th and 10th (weekend)

Figure 11 shows the average traffic volume on the weekend from October 9th and 10th. It is noticed that the traffic volume pattern is quite different from a weekday. The volume of the traffic on the weekend continues to increase in the morning with a peak at 2pm as it begins to decline into the evening.

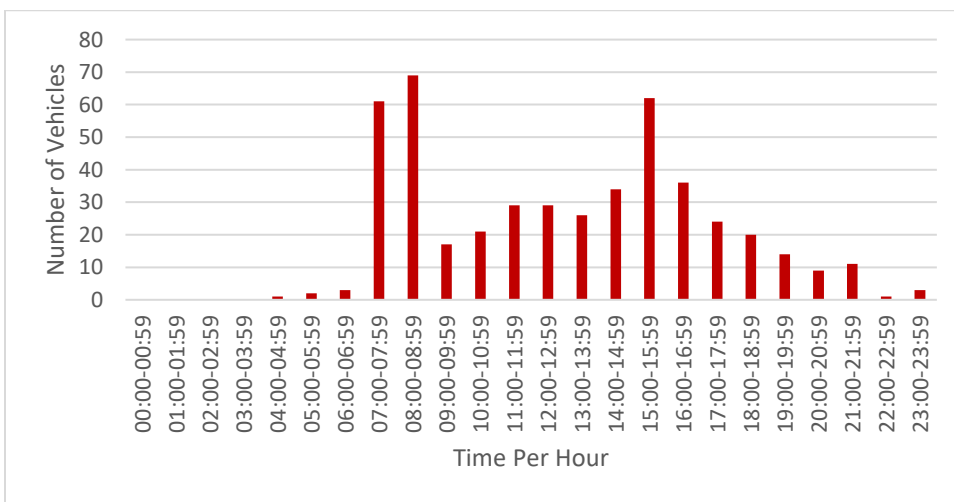
Figure 12. Volume by Hour on October 14th, 15th, 18th, 19th, and 20th (Weekday)

The data collected between October 14th, 15th, 18th, 19th and 20th (Weekday) is used to analyze the traffic volume by hour on a weekday in the westbound direction as shown in Figure 12. The school hours at the Bayview Public School are from 08:10 to 16:00, and it appears that the peak traffic in the westbound direction occurs at 7 and 8am and has a spike at 3pm.

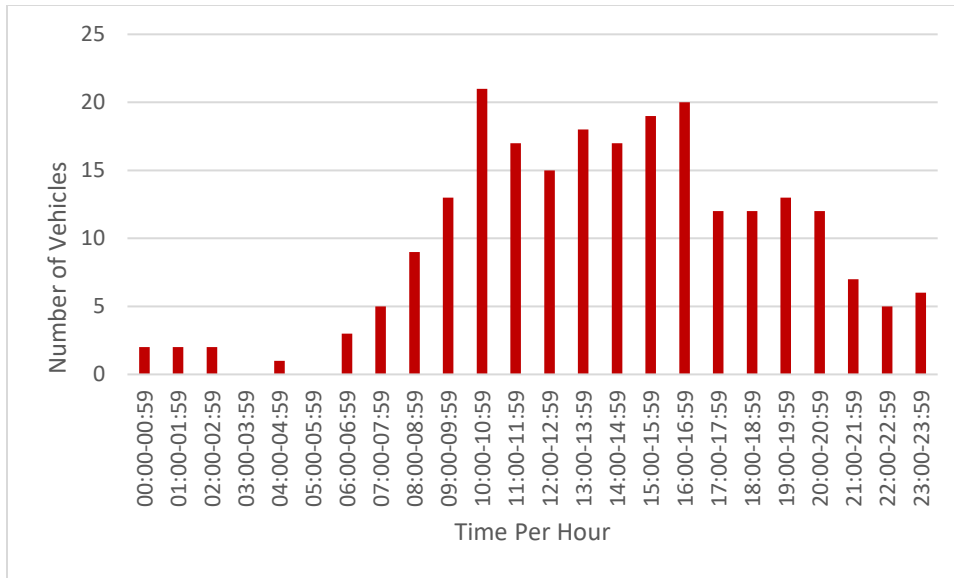
Figure 13. Average Volume by Hour on October 16th and 17th (Weekend)

Figure 13 shows the average traffic volume on the weekend from October 16th and 17th. It is noticed that the traffic volume pattern is quite different from a weekday. The volume of the traffic on the weekend continues to increase, peak at 10am and decrease in the late morning and afternoon.
