# Traffic Data Analysis

William St.

Northbound and Southbound

Town of Midland

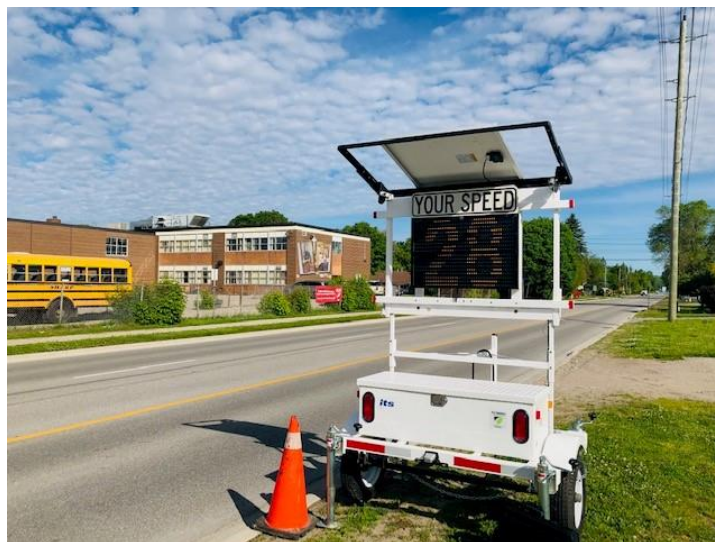
**Figure 1 Traffic Trailer**

The traffic trailer used was model ATS-3 as shown in the Figure 1. The traffic trailer is set to display the speed of the approaching vehicle and display short messages depending on the speed. The traffic trailer uses radar to detect vehicles and group collected data into 1-hour intervals. The speed limit in this community safety zone changes at different time of a day according to school times. Therefore, the challenge was to change the settings on the trailer to correspond this schedule.

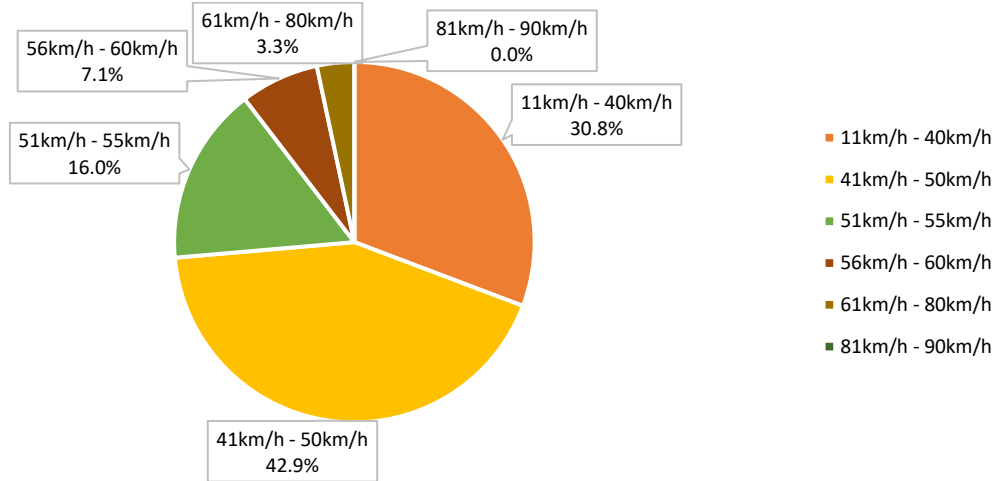
**Figure 2 William St. Northbound (speed limit: 40km/h)**

Figure 2 above shows that 30.8% of vehicles were travelling below the school times speed limit, 42.9% of vehicles were travelling between 41-50 km/h, and 26.4% of vehicles were travelling above 50km/h. When we consider the accepted speed limit is 10km/h over the school times speed limit, we find that a total of 73.7% of vehicles were travelling within the accepted speed limit.

Figure 2 below shows that 30.8% of vehicles were travelling below the school times speed limit, 42.9% of vehicles were travelling between 41-50 km/h, and 26.4% of vehicles were travelling above 50km/h. When we consider the accepted speed limit is 10km/h over the school times speed limit, we find that a total of 73.7% of vehicles were travelling within the accepted speed limit.

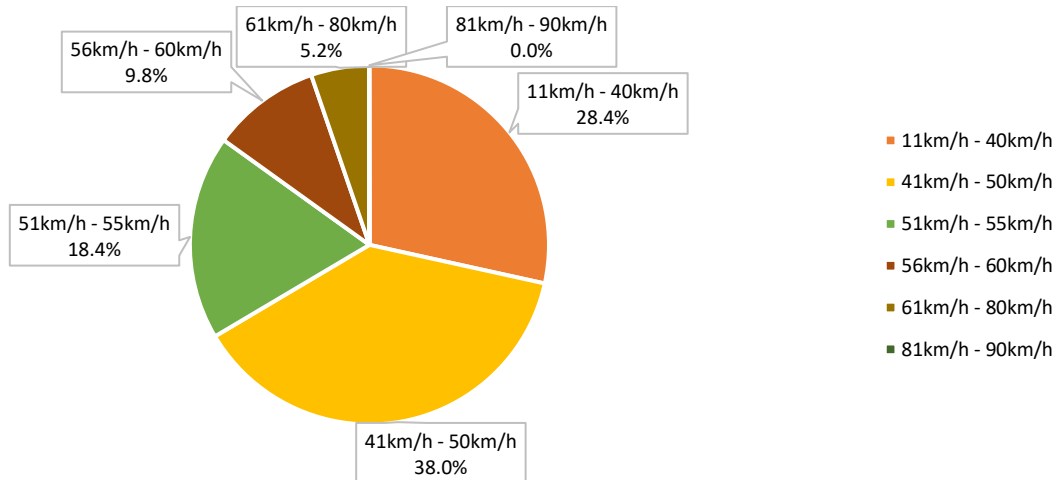
**Figure 3 William St. Northbound (speed limit: 50km/h)**

Figure 3 above shows that 66.4% of vehicles were travelling below the posted speed limit, 28.2% of vehicles were travelling between 51-60 km/h, and 5.2% of vehicles were travelling above 60km/h. When we consider the accepted speed limit is 10km/h over the posted speed limit, we find that a total of 94.6% of vehicles were travelling within the accepted speed limit.

Figure 3 below shows that 66.4% of vehicles were travelling below the posted speed limit, 28.2% of vehicles were travelling between 51-60 km/h, and 5.2% of vehicles were travelling above 60km/h. When we consider the accepted speed limit is 10km/h over the posted speed limit, we find that a total of 94.6% of vehicles were travelling within the accepted speed limit.

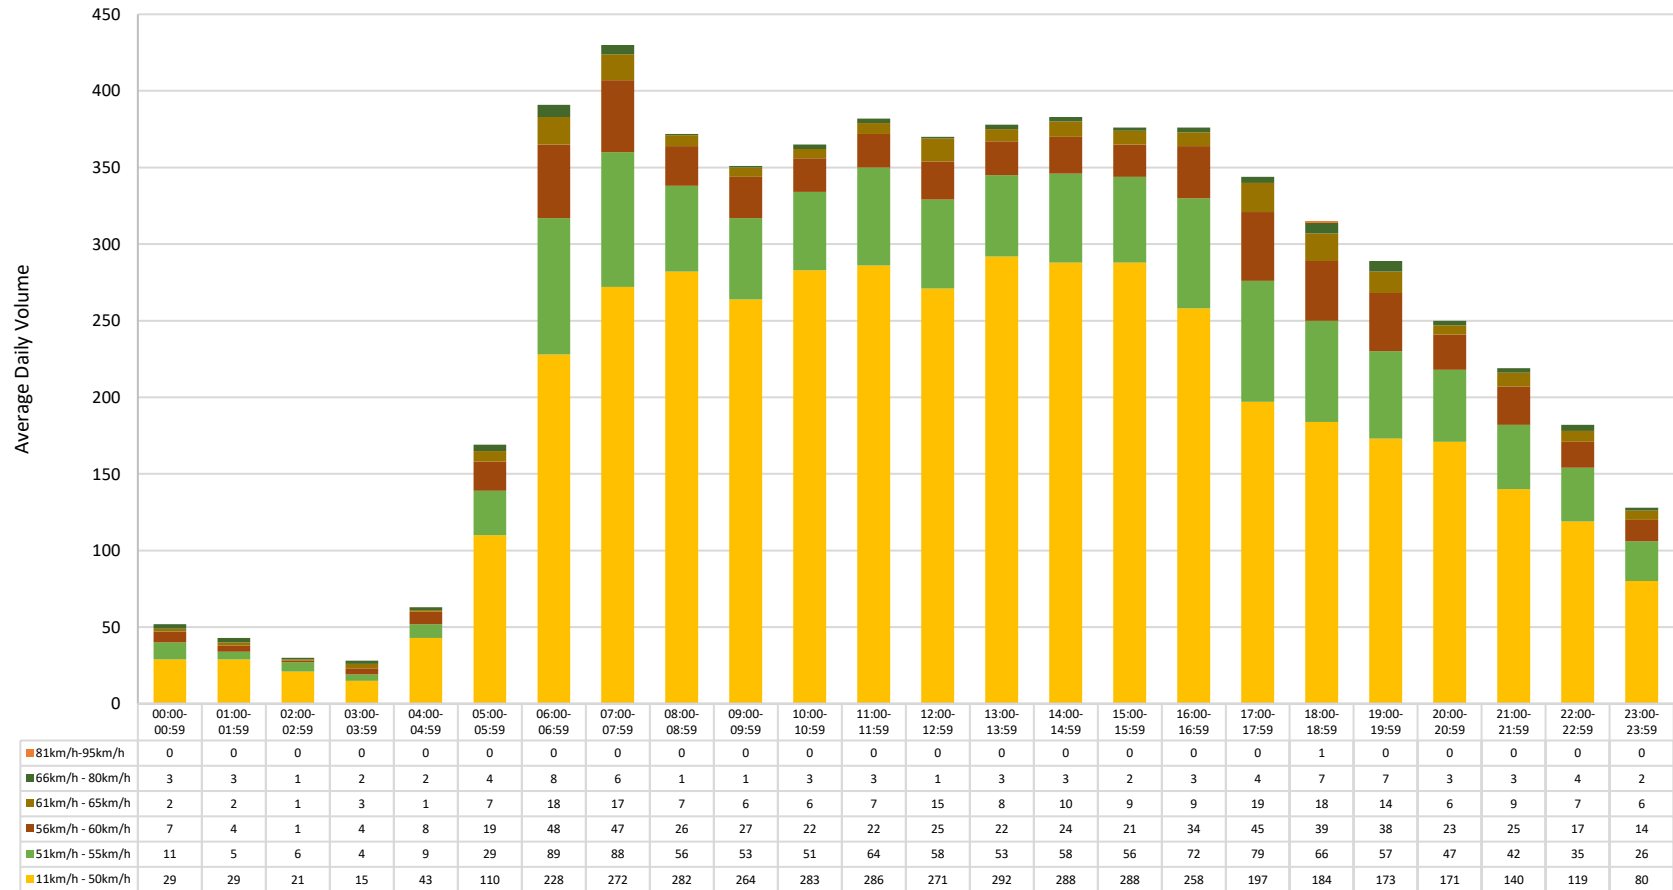
**Figure 4 Speed by Hour Analysis for Northbound Weekdays**

Figure 4 is the speed by hour graph in the northbound direction from May 13<sup>th</sup> to May 14<sup>th</sup> and from May 17<sup>th</sup> to May 18<sup>th</sup> (weekdays)

Figure 4 above is the speed by hour graph used to determine the time where most speeding occurs. The data shows that speeding was consistent throughout the day and into the evening, being between 6:00am to 10:00pm. The data shows that most of the speeding occurs during typical morning and evening commute time, which are 6:00am to 9:00am and 5:00pm to 7:59pm.

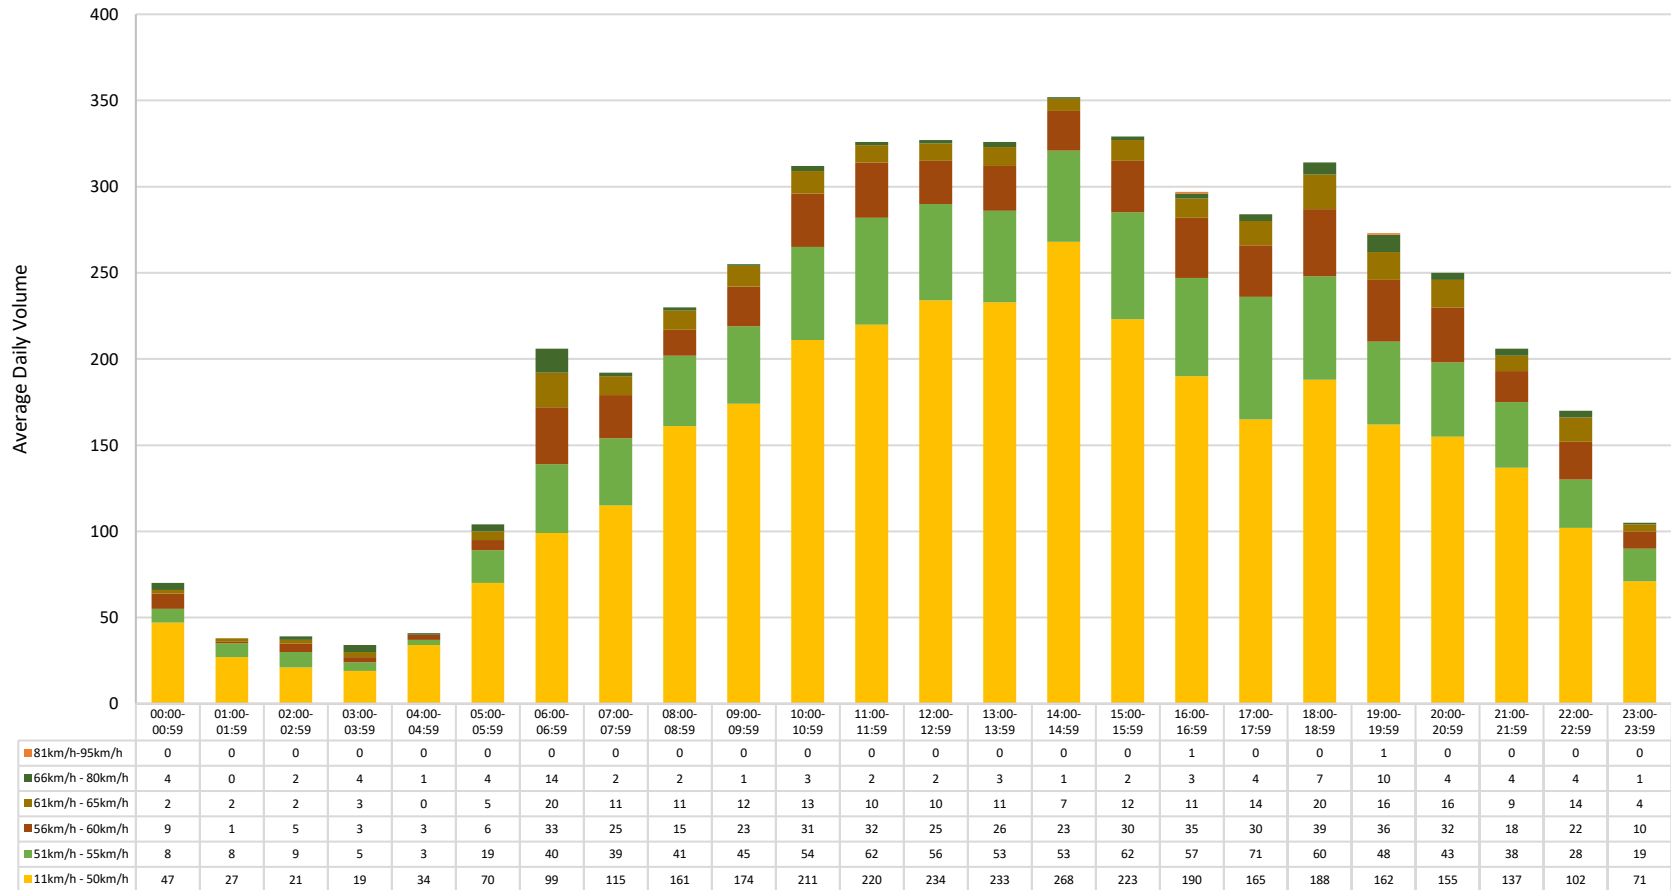
**Figure 5 Speed by Hour Analysis of Northbound Weekends**

Figure 5 is the speed by hour graph in the northbound direction from May 15<sup>th</sup> to May 16<sup>th</sup> (weekend)

Figure 5 above is the speed by hour graph used to determine the time where most speeding occurs. The data shows that speeding was consistent throughout the day and into the evening, being between 6:00am to 10:00pm. The data shows that most of the speeding occurs during typical morning and evening commute time, which are 6:00am to 9:00am and 6:00pm to 8:59pm.

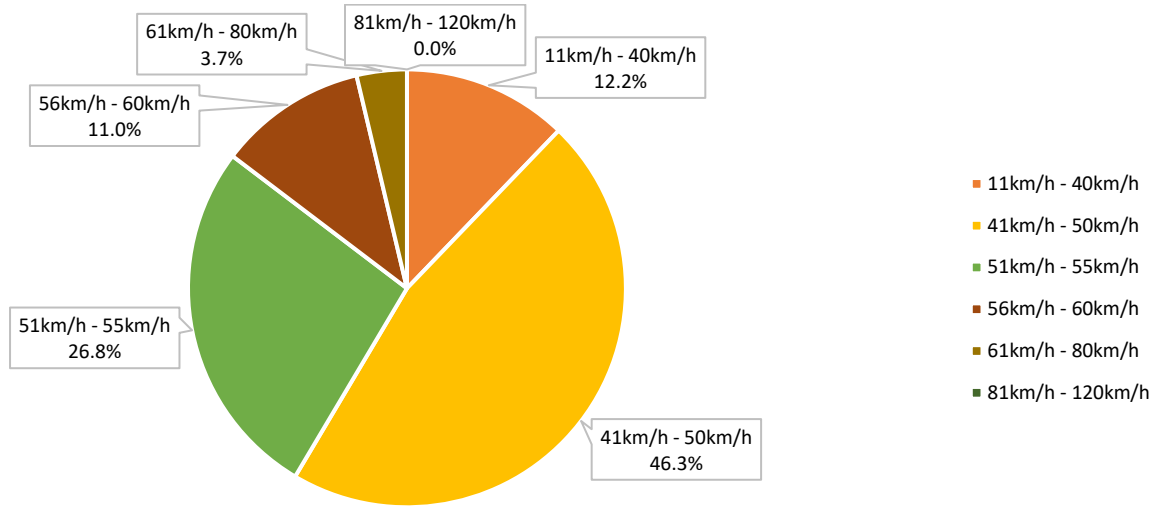
**Figure 6 William St. Southbound (speed limit: 40km/h)**

Figure 6 above shows that 12.2% of vehicles were travelling below the school times speed limit, 46.3% of vehicles were travelling between 41-50 km/h, and 41.5% of vehicles were travelling above 50km/h. When we consider the accepted speed limit is 10km/h over the school times speed limit, we find that a total of 58.5% of vehicles were travelling within the accepted speed limit.

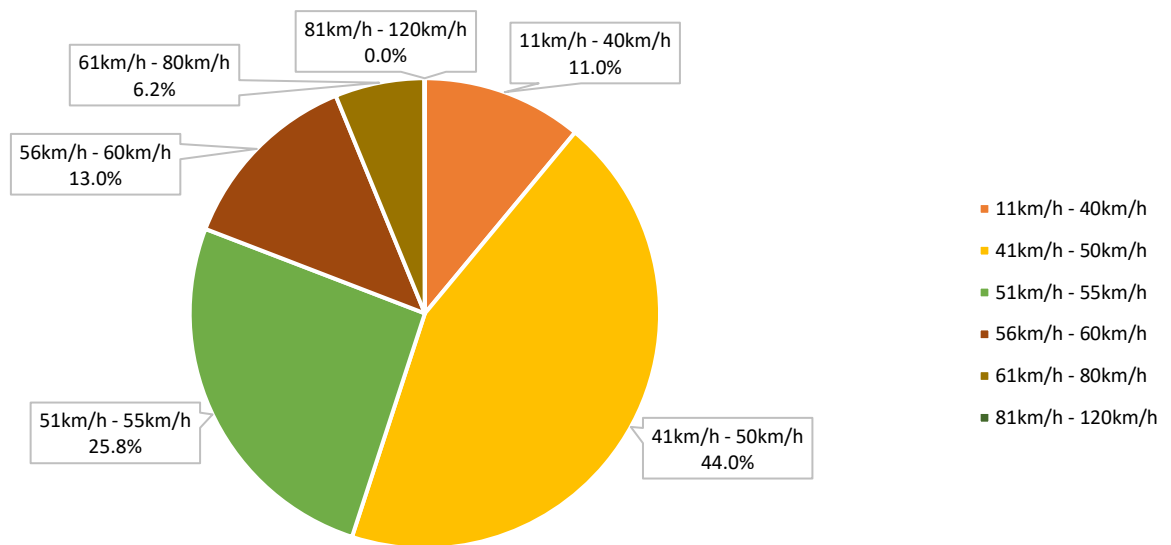
**Figure 7 William St. Southbound (speed limit: 50km/h)**

Figure 7 above shows that 55% of vehicles were travelling below the posted speed limit, 38.8% of vehicles were travelling between 51-60 km/h, and 6.2% of vehicles were travelling above 60km/h. When we consider the accepted speed limit is 10km/h over the posted speed limit, we find that a total of 93.8% of vehicles were travelling within the accepted speed limit.

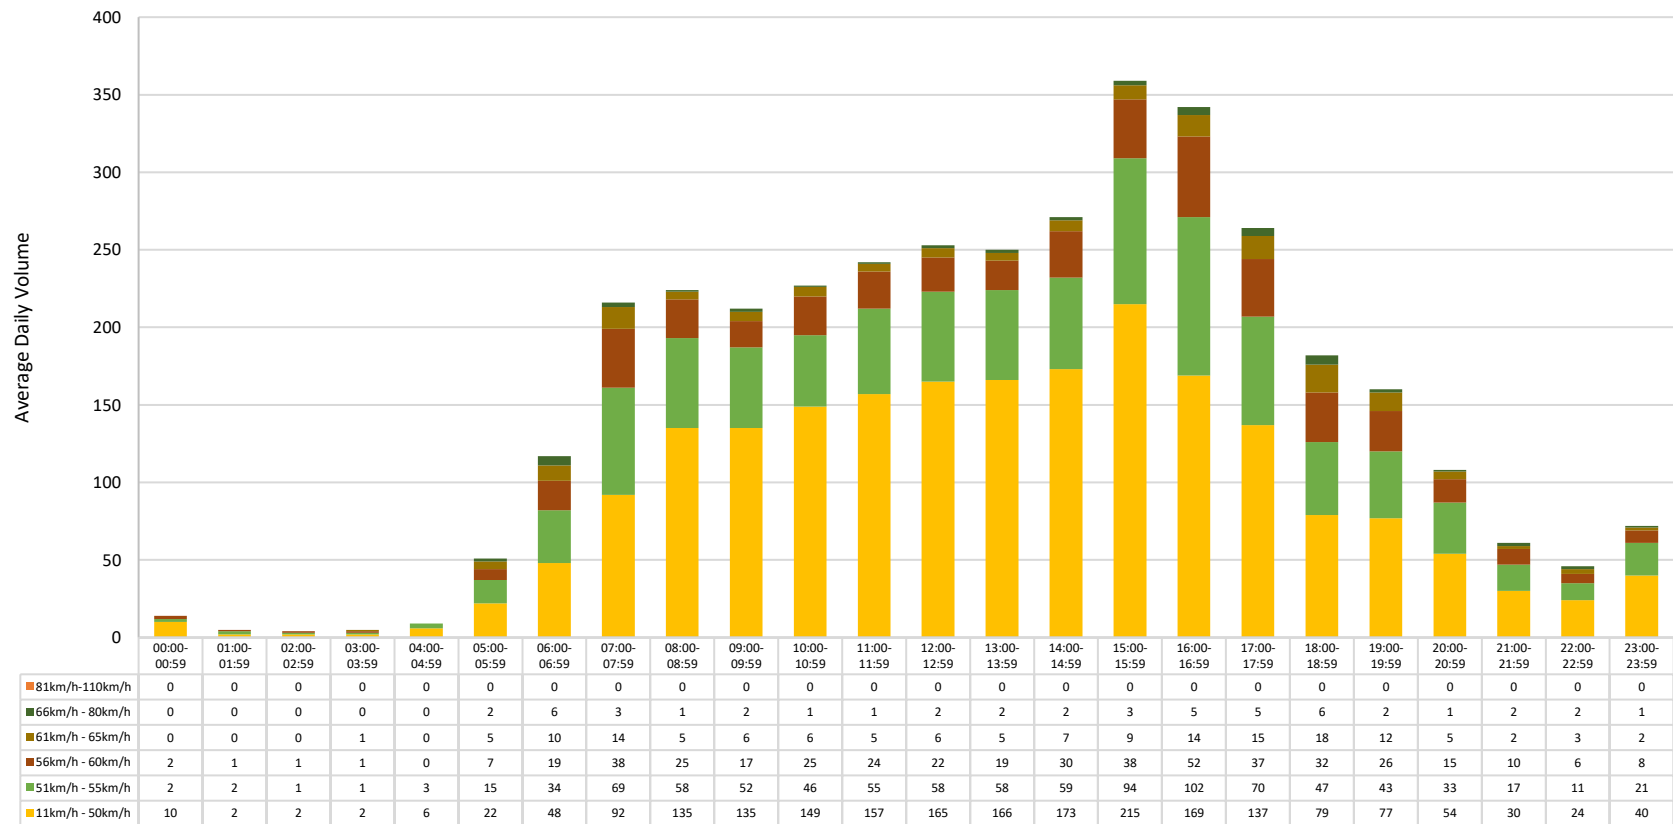
**Figure 8 Speed by Hour Analysis for Southbound (weekday)**

Figure 8 and 9 below are the speed by hour graph for weekdays (May 5<sup>th</sup>-May 7<sup>th</sup> and May 10<sup>th</sup>-May 11<sup>th</sup>) and the weekend (May 8<sup>th</sup>-May 9<sup>th</sup>) in the southbound direction.

Figure 8 (weekday) and Figure 9 (weekend) above are the speed by hour graphs used to determine the time where most speeding occurs. The data shows that speeding was relatively consistent from 6:00am to 7:00pm on weekdays and from 10:00am to 7:00pm. On the weekdays, there was an increase in speeding from 3:00pm to 6:00pm. On the weekend, there was an increase in speeding from 1:00pm until 4:00pm.

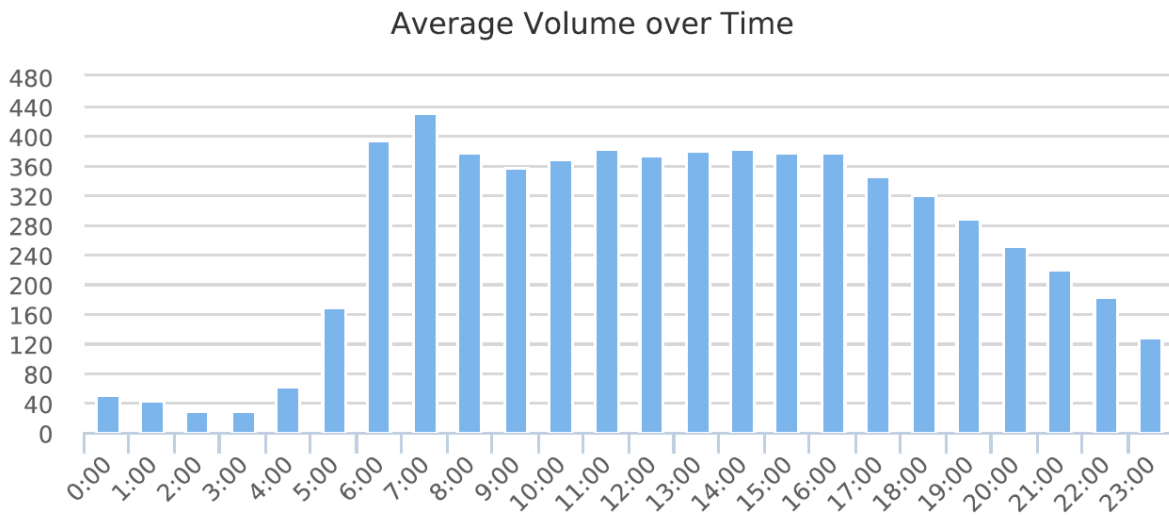
**Figure 12 Average Volume by Hour from May 13<sup>th</sup> to May 14<sup>th</sup> and from May 17<sup>th</sup> to May 18<sup>th</sup> (Northbound)**

Figure 12 shows the average volume of vehicles travelling northbound of William St from May 13<sup>th</sup> to May 14<sup>th</sup> and from May 17<sup>th</sup> to May 18<sup>th</sup>. It is noticed that the peak traffic occurs at typical morning rush hours on a weekday in the northbound direction.

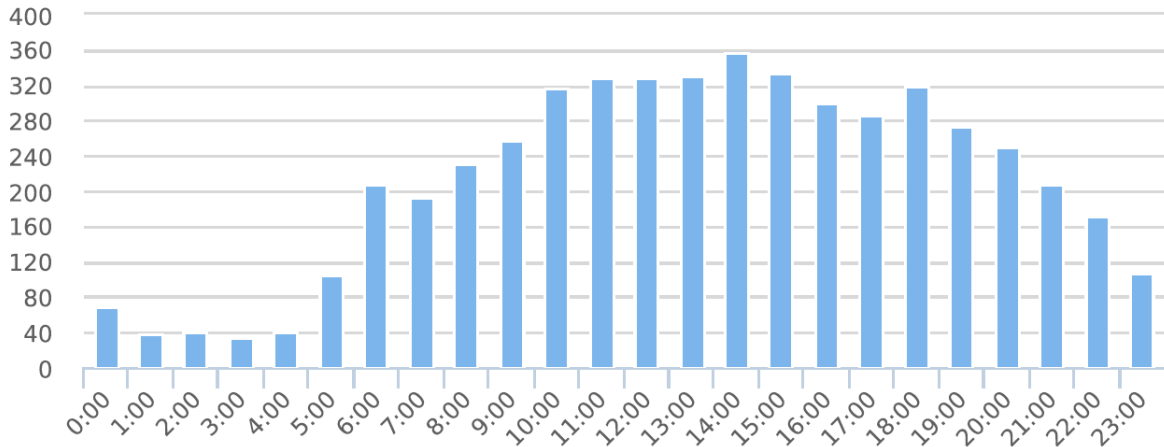
Figure 13 Average Volume by Hour from May 15<sup>th</sup> to May 16<sup>th</sup> (Northbound)

Figure 13 shows the average volume of vehicles travelling northbound of William St from May 15<sup>th</sup> to May 16<sup>th</sup>. It is noticed that the peak traffic occurs at typical evening rush hours on a weekday in the northbound direction.

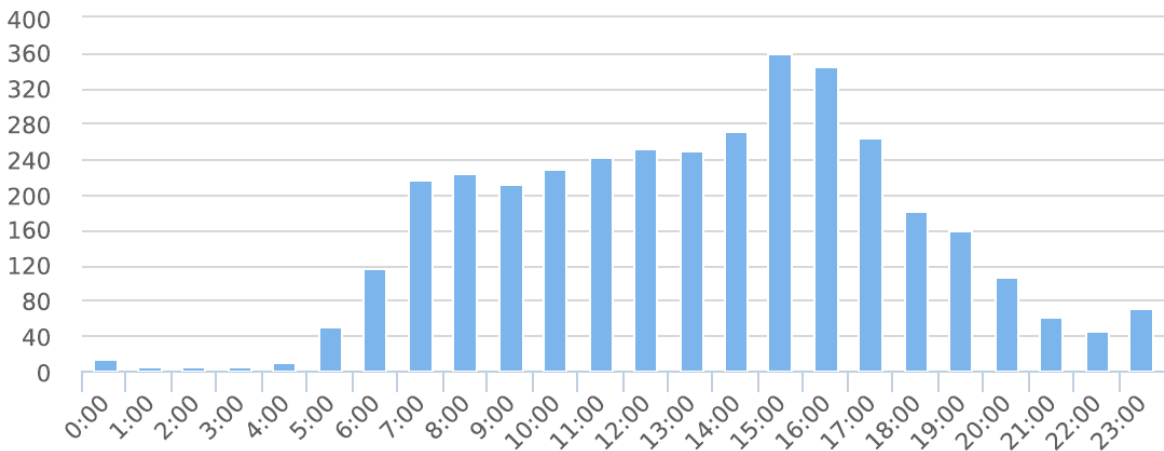
Figure 14 Volume by Hour from May 5<sup>th</sup> to May 7<sup>th</sup> and May 10<sup>th</sup> to May 11<sup>th</sup> (Southbound)

The data collected from May 5<sup>th</sup> to May 7<sup>th</sup> and May 10<sup>th</sup> to May 11<sup>th</sup> is used to analyze the traffic volume by hour on a weekday in the southbound direction as shown in Figure 14. The school hours at the Sacred Heart Catholic School are from 08:45 to 15:00, and it appears that the peak traffic in the southbound direction occurs during when school starts and ends.

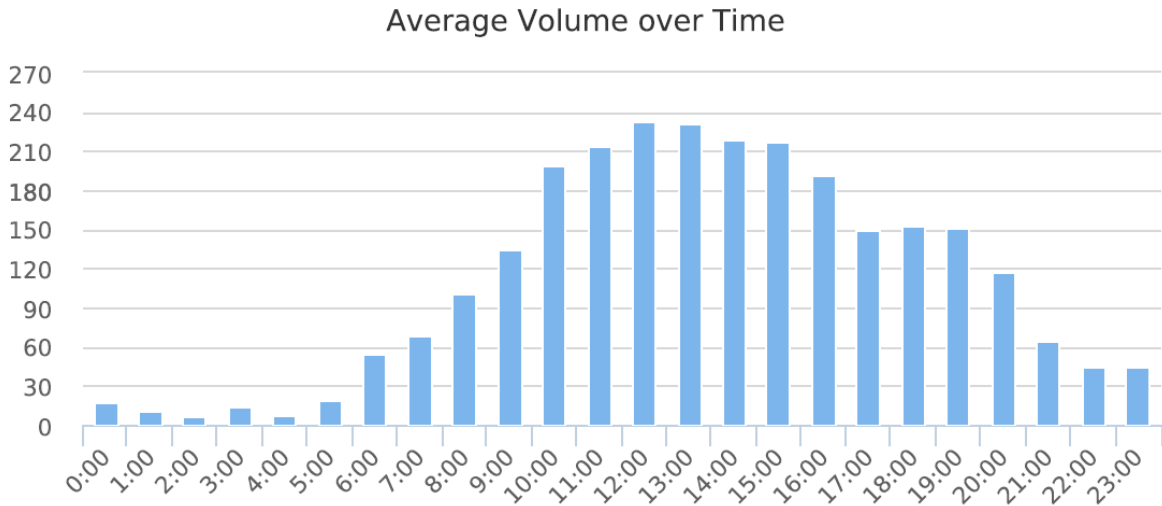
**Figure 15 Average Volume by Hour from May 8th to May 9th (Southbound)**

Figure 15 shows the average traffic volume on the weekend from May 8<sup>th</sup> to May 9<sup>th</sup>. It is noticed that the traffic volume pattern is quite different from a weekday. The volume of the traffic on the weekend continues to increase, peak around noon, and decrease in the afternoon.
