# **APPENDIX B**

## **EXISTING PARKS INVENTORY AND CONDITION ASSESSMENT**

The inventory and condition assessment in this report were documented through physically visiting each of the sites, and recorded through photographs and notes. This information was documented on December 4 and 5, 2017 by two team members from thinc design.

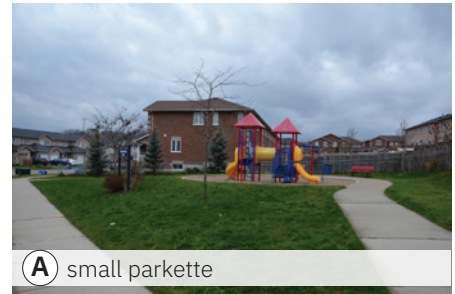
**A** small parkette

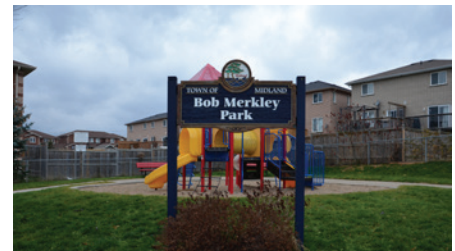
**B** park sign

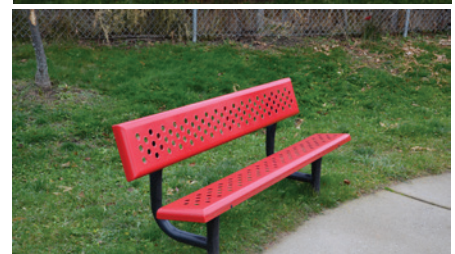
**C** park bench

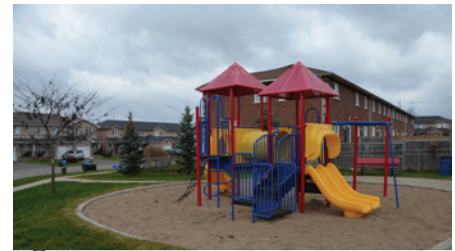
**D** climber

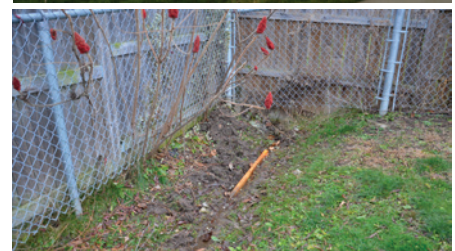
address	139 Southwinds Cres	topography	mostly flat
size	0.17 ac / 0.07 ha	hydrology	ponding in NW corner

**E** water flowing into park

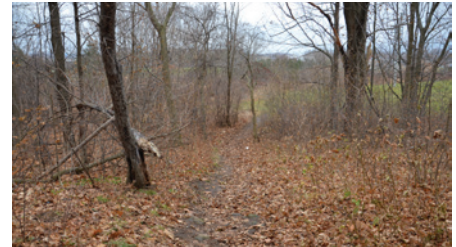
**A** woodlot trail

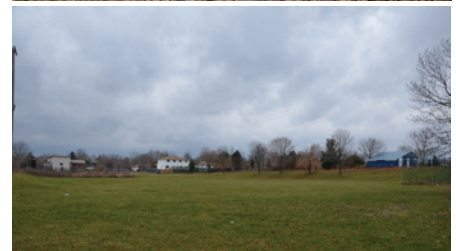
**B** open lawn

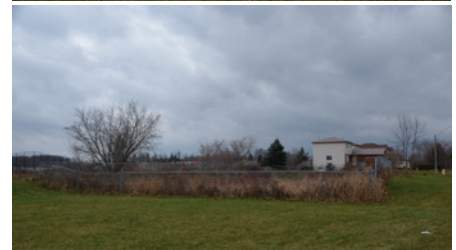
**C** stormwater management pond

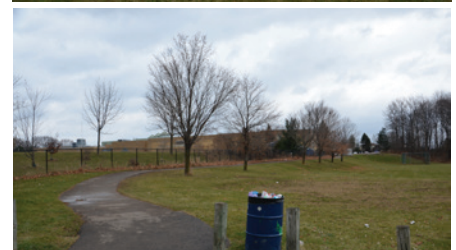
**D** asphalt trail

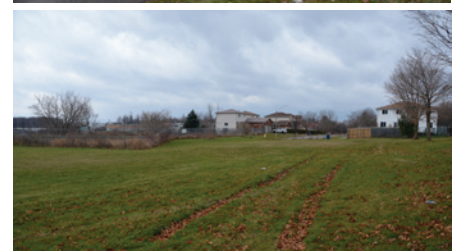
**E** open lawn

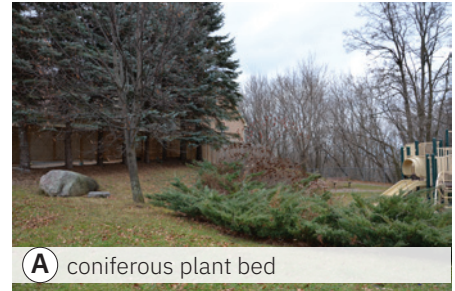
**A** coniferous plant bed

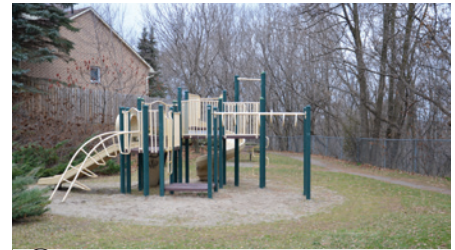
play structure(s)	<span style="color: yellow;">■</span>	junior play- 2 slides
play surfacing	<span style="color: red;">■</span>	sand- inadequate safety zone
furnishing(s)	<span style="color: red;">■</span> <span style="color: green;">■</span>	park bench (2) park sign
stair	<span style="color: green;">■</span>	wooden stairs down to Tiffin Park connection
vegetation	<span style="color: green;">■</span> <span style="color: green;">■</span> <span style="color: yellow;">■</span>	woodlot ornamental planting at park sign coniferous plant bed
pathway(s)	<span style="color: yellow;">■</span>	granular pathway from roadway to wooden stairs
fence	<span style="color: green;">■</span>	chain link fence at top of slope

**B** play equipment

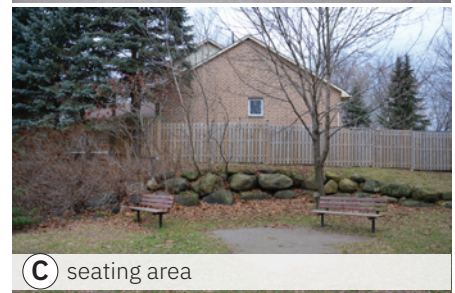
**C** seating area

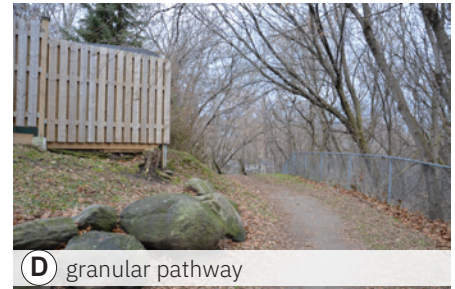
**D** granular pathway

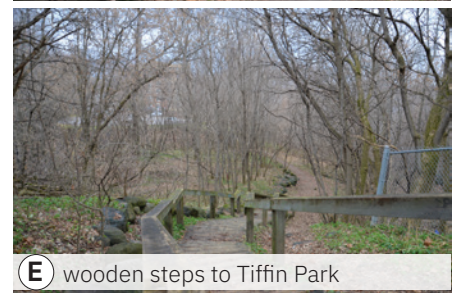
**E** wooden steps to Tiffin Park

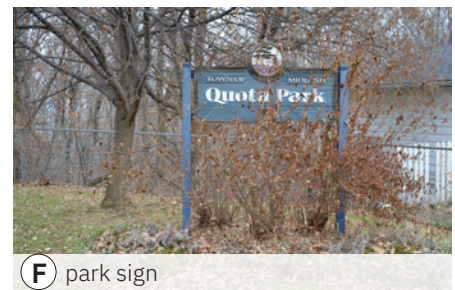
**F** park sign

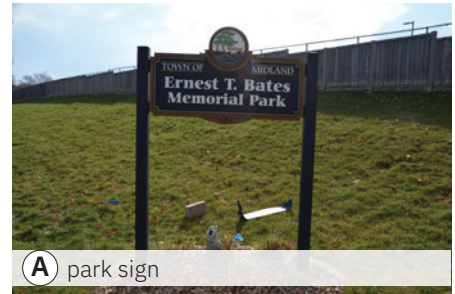
**A** park sign

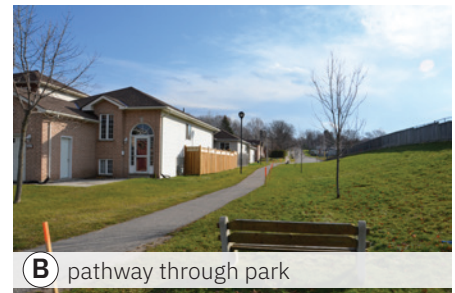
**B** pathway through park

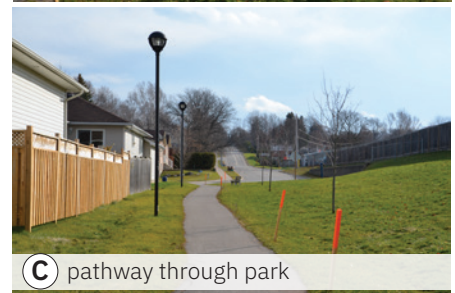
**C** pathway through park

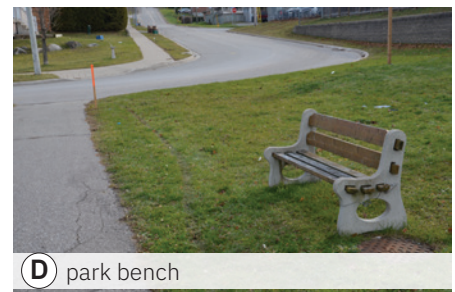
**D** park bench

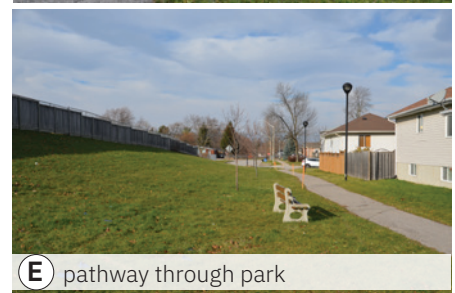
**E** pathway through park

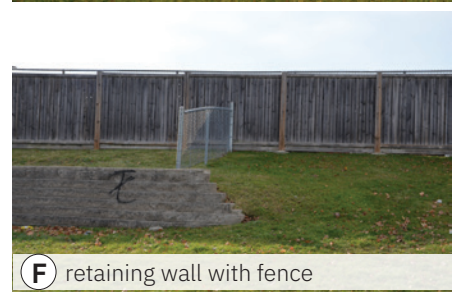
**F** retaining wall with fence

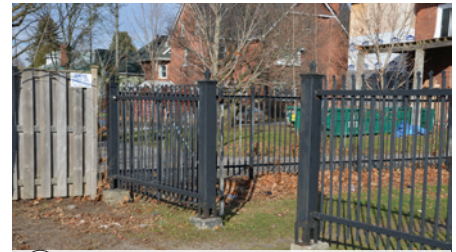
**A** minor entrance

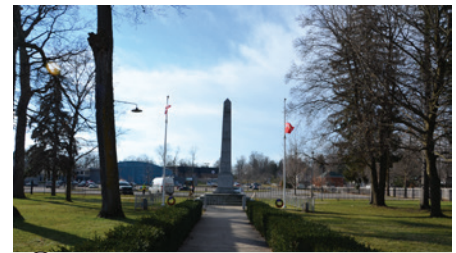
**B** concrete pathway

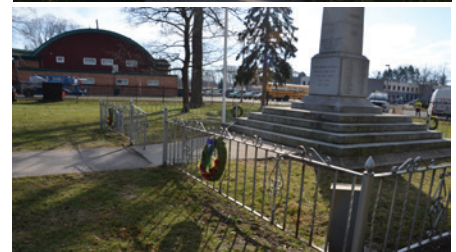
**C** decorative fence

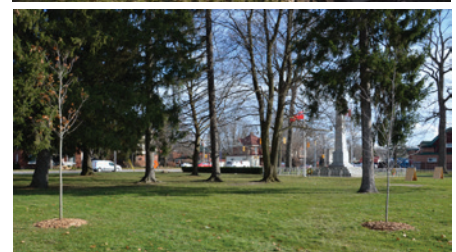
**D** lawn area with old and new trees

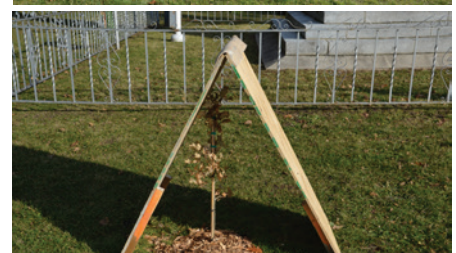
**E** protected oak tree

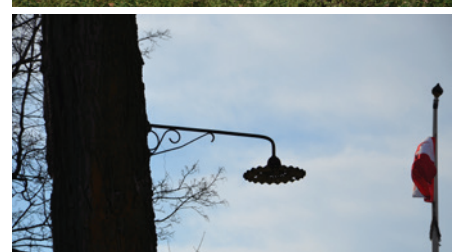
**F** light fixture fastened on tree

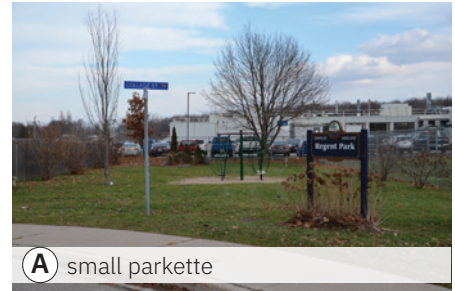
**A** small parkette

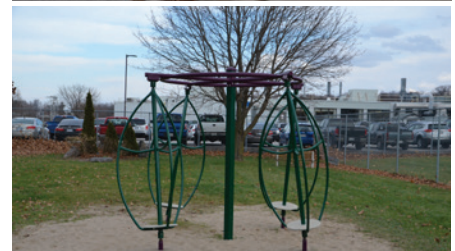
play structure(s)	<span style="color: yellow;">■</span>	junior play- 4 twists
play surfacing	<span style="color: red;">■</span>	sand- inadequate safety zone
furnishing(s)	<span style="color: green;">■</span> <span style="color: green;">■</span>	wood/concrete benches (2) park sign
vegetation	<span style="color: green;">■</span> <span style="color: green;">■</span> <span style="color: green;">■</span>	open lawn display planting bed ornamental planting at park sign
fence	<span style="color: green;">■</span> <span style="color: green;">■</span>	chain link fence on two sides (industrial) wood fence along residential side

**B** play equipment

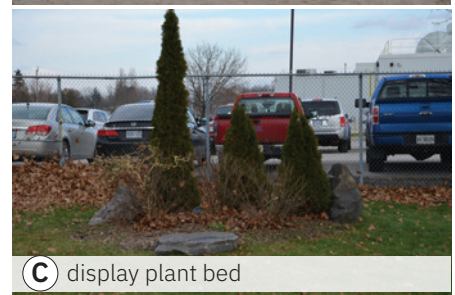
**C** display plant bed

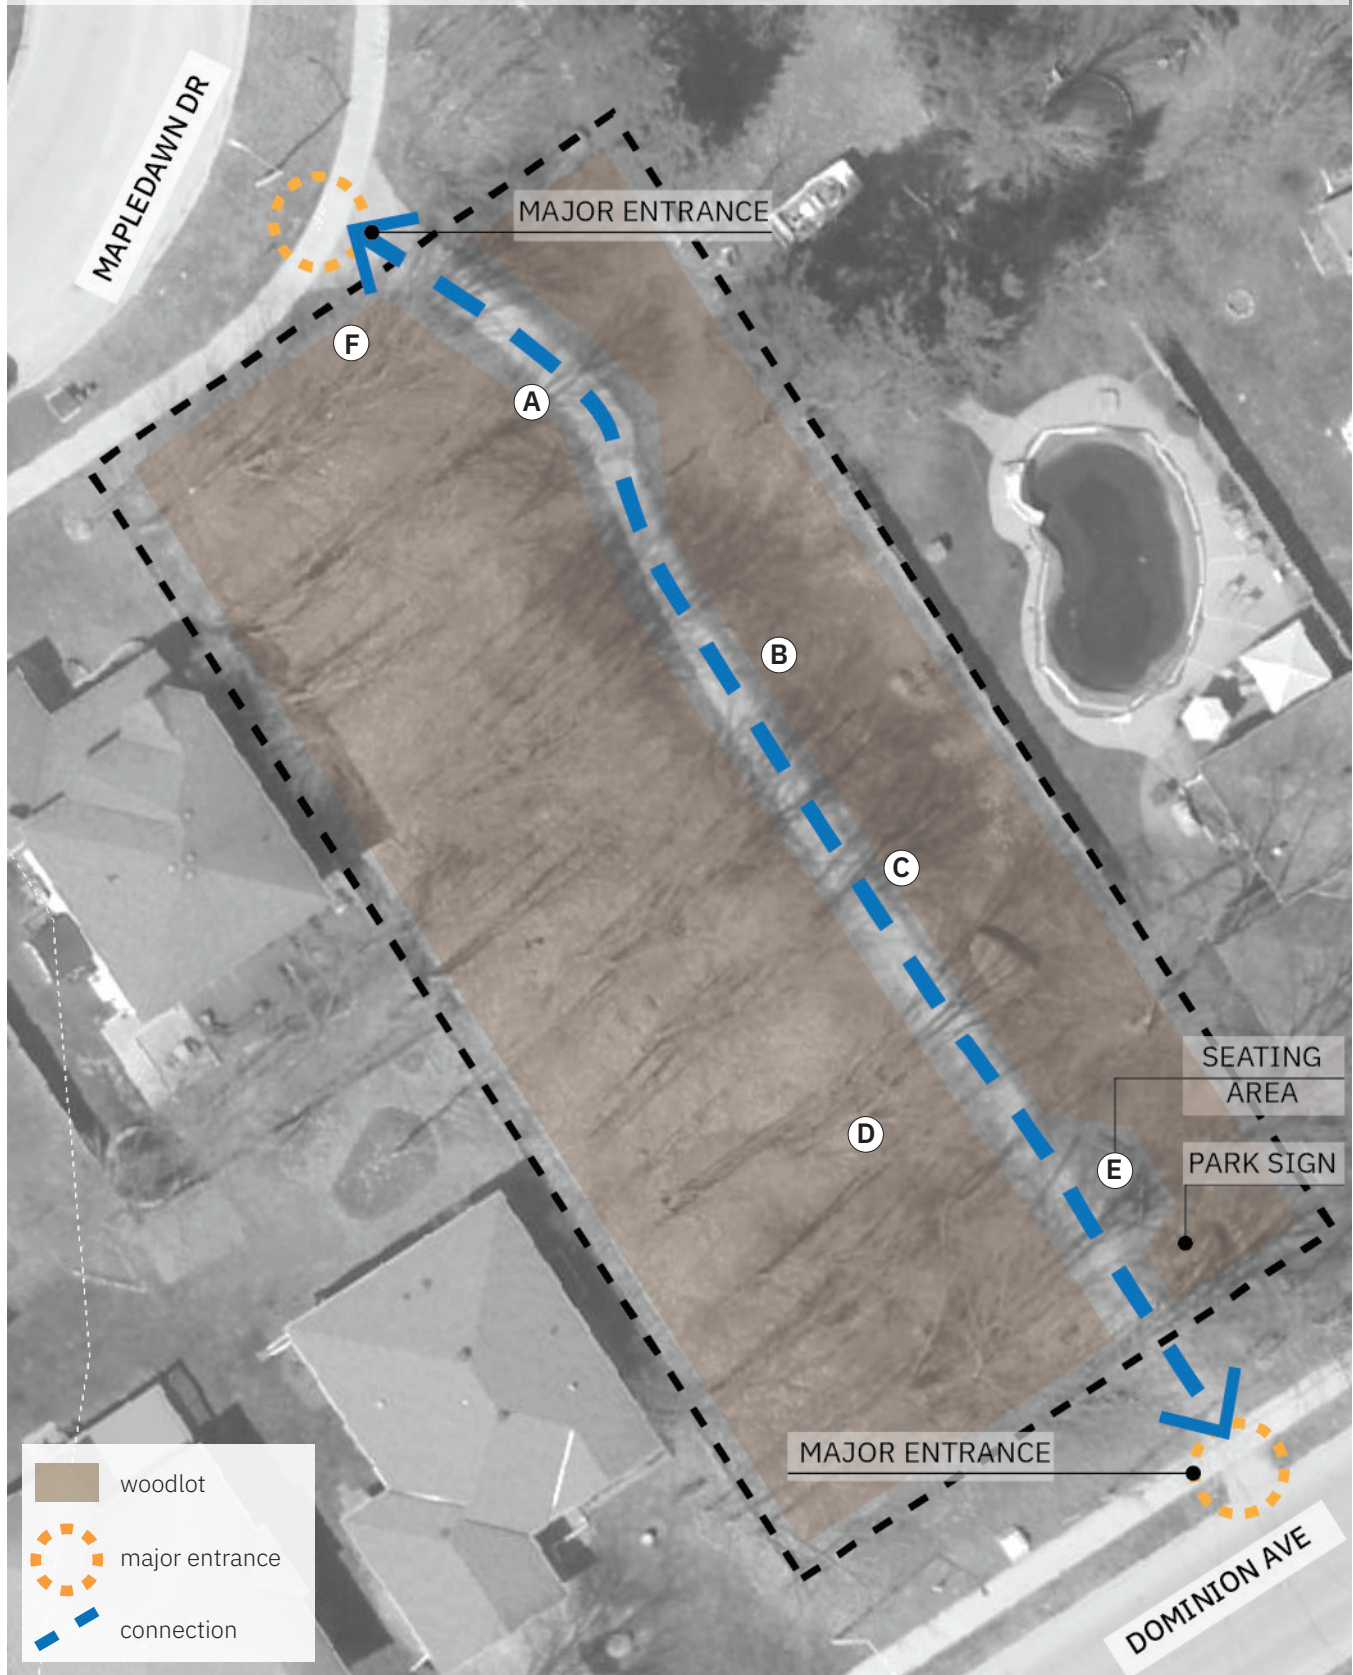
Figure AB.11: Carpenter Park Existing Conditions

fence(s)	<span style="color: green;">■</span>	chainlink along adjacent residential
furnishing(s)	<span style="color: yellow;">■</span> <span style="color: green;">■</span> <span style="color: green;">■</span>	two wooden benches on unit paver park sign decorative boulders
vegetation	<span style="color: green;">■</span> <span style="color: green;">■</span>	woodlot small lawn space
pathway(s)	<span style="color: green;">■</span>	asphalt
lighting	<span style="color: yellow;">■</span>	5 light poles

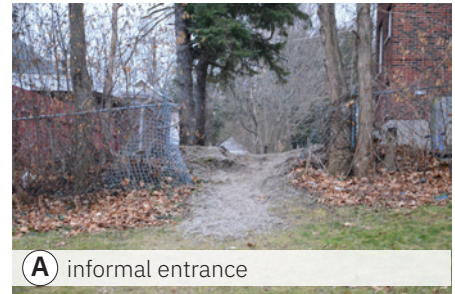
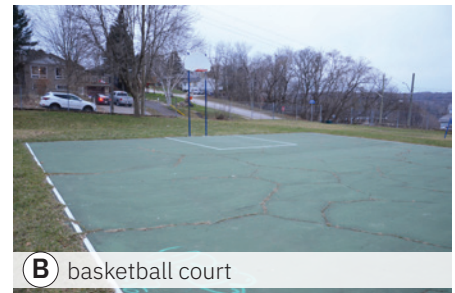
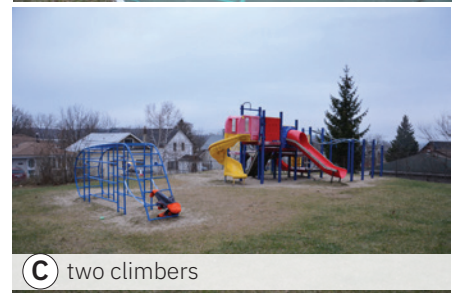
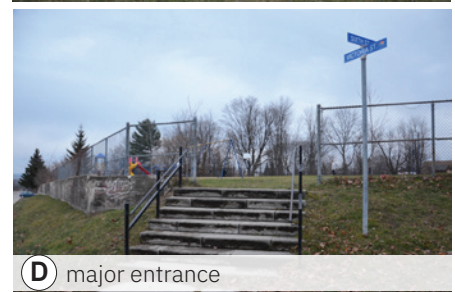
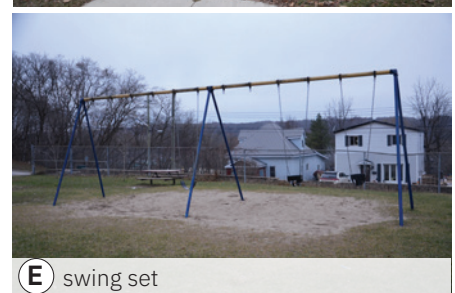
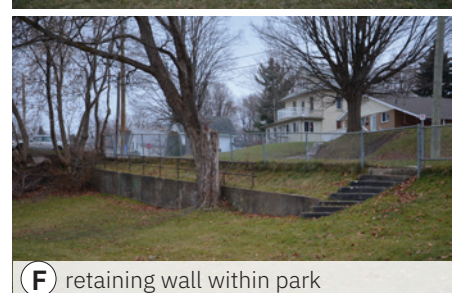
play structure(s)	<div style="display: flex; flex-direction: column; gap: 5px;"> <div><span style="color: yellow;">■</span> one large climber- 3 slides</div> <div><span style="color: yellow;">■</span> one small climber- elephant</div> <div><span style="color: red;">■</span> double swing set with 2 baby, 1 regular and 3 missing swings</div> </div>
play surfacing	<span style="color: red;">■</span> sand - inadequate zone
fence(s)	<span style="color: green;">■</span> chainlink around park
sports field + type	<span style="color: yellow;">■</span> asphalt basketball court with green paint and white linework
stairs	<div style="display: flex; flex-direction: column; gap: 5px;"> <div><span style="color: green;">■</span> concrete stairs into the park (with railing)</div> <div><span style="color: yellow;">■</span> stairs along SW retaining wall (leads into chainlink fence)</div> </div>
furnishing(s)	<span style="color: red;">■</span> picnic table

retaining wall(s)	<div style="display: flex; flex-direction: column; gap: 5px;"> <div><span style="color: yellow;">■</span> south west interior of the park</div> <div><span style="color: red;">■</span> north exterior of the park</div> </div>
vegetation	<div style="display: flex; flex-direction: column; gap: 5px;"> <div><span style="color: yellow;">■</span> open lawn</div> <div><span style="color: green;">■</span> 4 newly planted trees</div> </div>

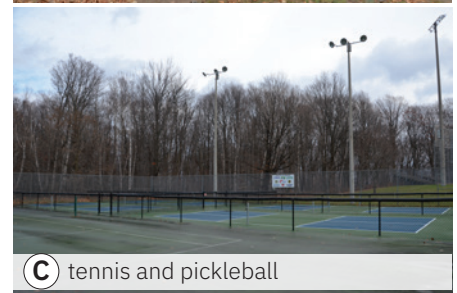
C tennis and pickleball

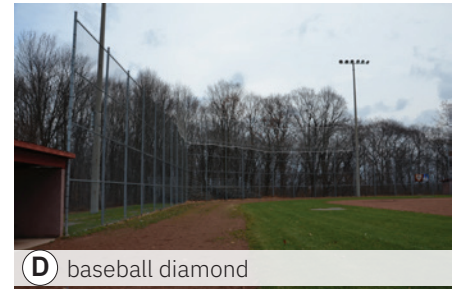
D baseball diamond

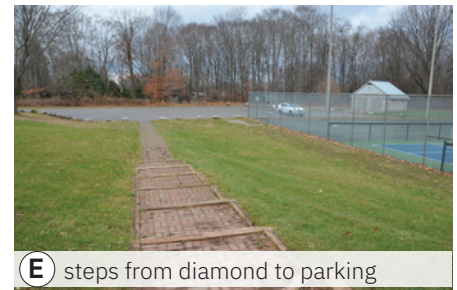
E steps from diamond to parking

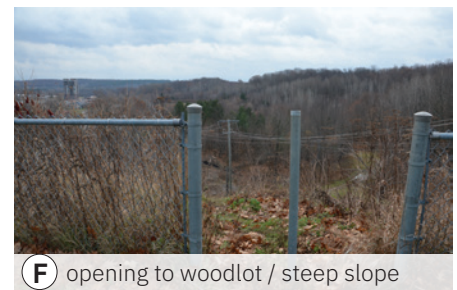
F opening to woodlot / steep slope

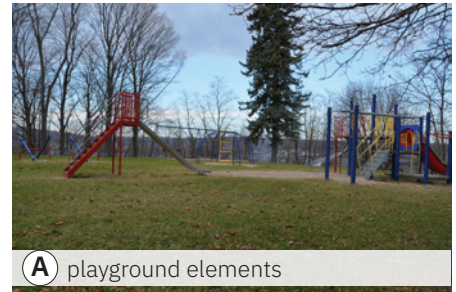
**A** playground elements

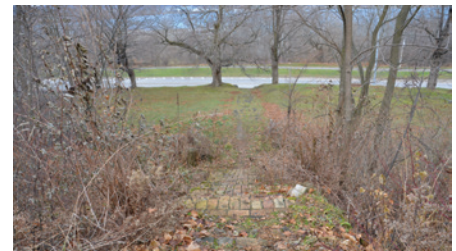
**B** historic brick steps

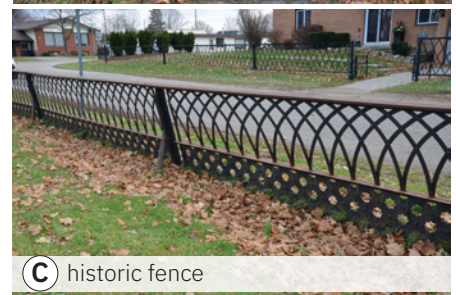
**C** historic fence

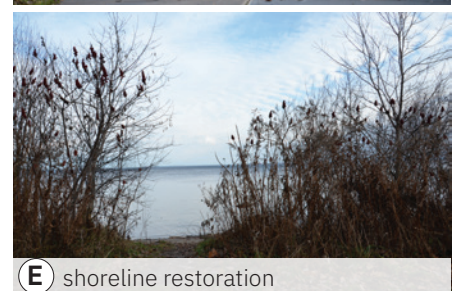
**E** shoreline restoration

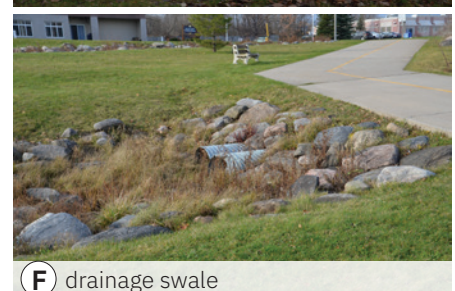
**F** drainage swale

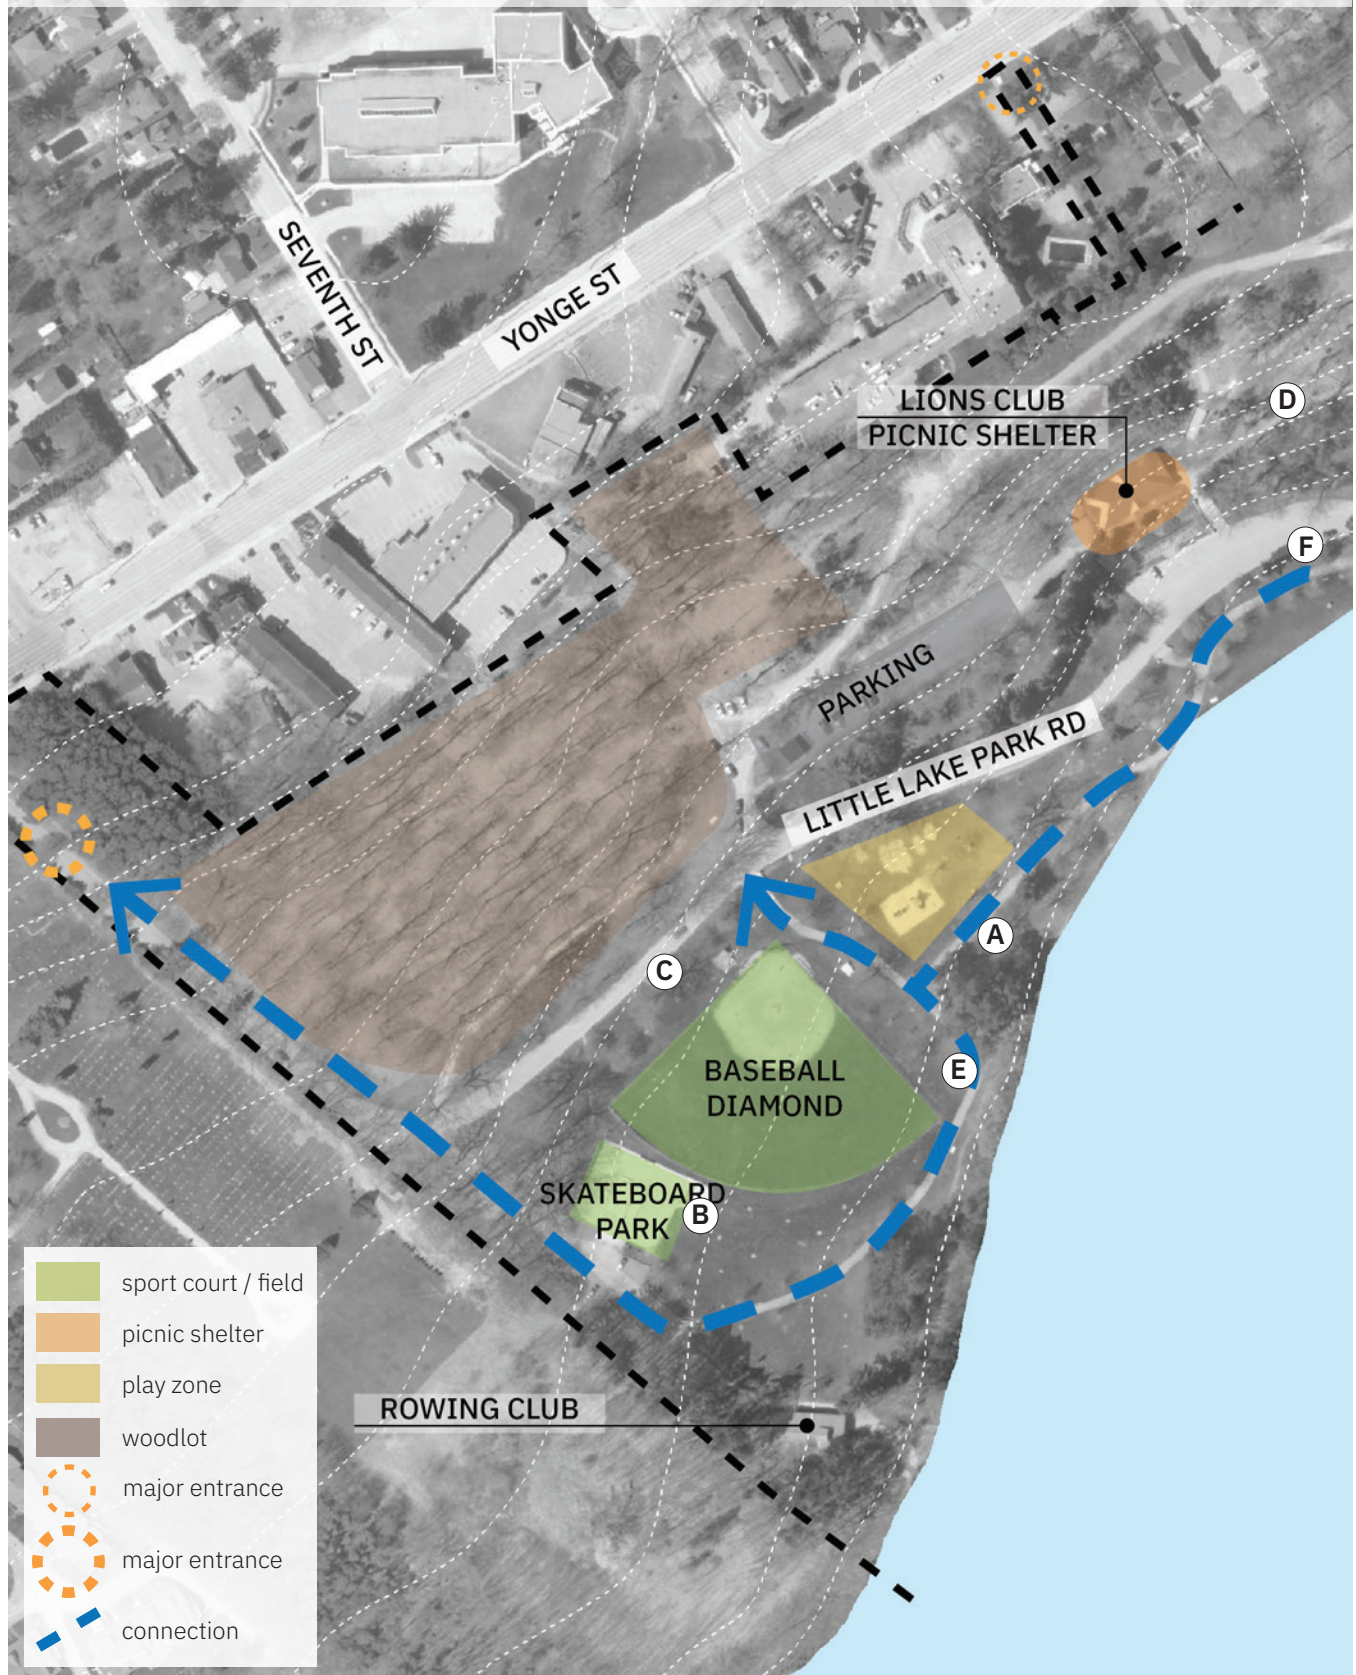
Figure AB.22: Little Lake Existing Conditions Key Map

play structure(s)	<span style="color: green;">■</span> junior play- 2 slides <span style="color: green;">■</span> senior play- large slide <span style="color: green;">■</span> spring toys (2) <span style="color: green;">■</span> teeter totter <span style="color: green;">■</span> monkey bars <span style="color: yellow;">■</span> two bay swingset <span style="color: yellow;">■</span> single bay swing
play surfacing	<span style="color: red;">■</span> sand- inadequate safety zone
furnishing(s)	<span style="color: green;">■</span> wood/concrete bench <span style="color: yellow;">■</span> interpretive signage
sports field + type	<span style="color: green;">■</span> disc golf <span style="color: green;">■</span> one baseball diamond <span style="color: green;">■</span> one skateboard park
vegetation	<span style="color: green;">■</span> woodlot <span style="color: green;">■</span> prescribed burn area

pathway(s)	<span style="color: green;">■</span> asphalt multi-use pathway <span style="color: yellow;">■</span> dirt trail within woodlot
lighting	<span style="color: green;">■</span> lighting along waterfront trail
roadway	<span style="color: green;">■</span> roadway throughout the park
fence	<span style="color: yellow;">■</span> wood fence along roadway
parking	<span style="color: yellow;">■</span> parking lot above Little Lake Park Rd, adjacent to Lions Club Picnic Shelter gazebo <span style="color: yellow;">■</span> six parking stalls adjacent to skateboard park
structure	<span style="color: green;">■</span> Lions Club Picnic Shelter
stairs	<span style="color: green;">■</span> concrete stair to Lions Club Picnic Shelter <span style="color: red;">■</span> concrete stair behind Picnic Shelter

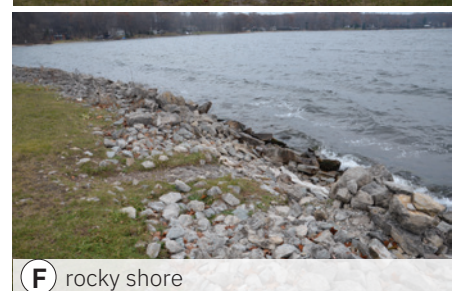
**F** rocky shore

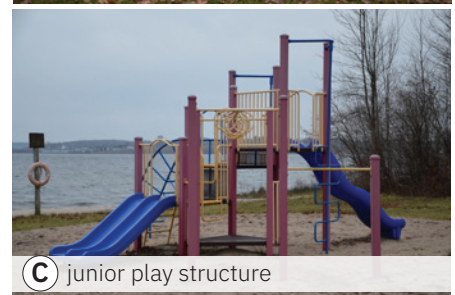
**C** junior play structure
